Technical Service Bulletin

91 Complaints about GPS or satellite radio reception, repair coaxial cable

91 16 75 2045106/1 September 20, 2016.

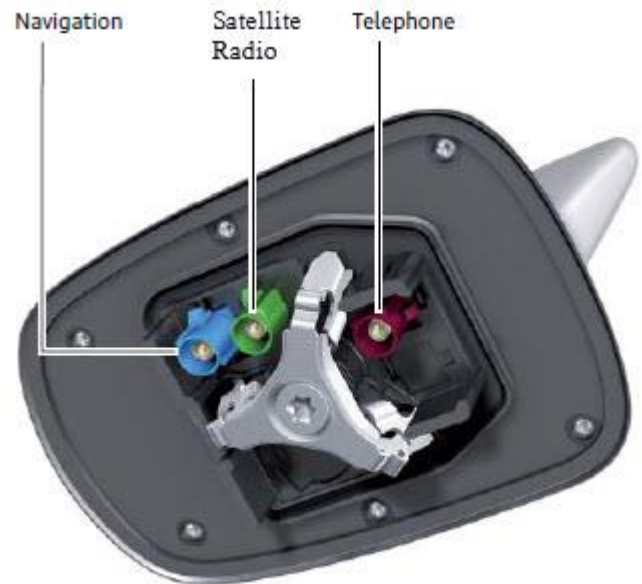
The correct circuit can be identified by the color on the antenna connector. See Figure 1. Not all antenna connectors are laid out the same.

Figure 1. Identify the correct circuit by the color of the antenna connector. Blue: Navigation, Green: Satellite Radio. Connector placement on antenna will change by vehicle options, reference the wiring diagram for your specific vehicle.

4. Replace the FAKRA connector and coaxial connection at the shark fin antenna for the applicable circuit, see instructions below.

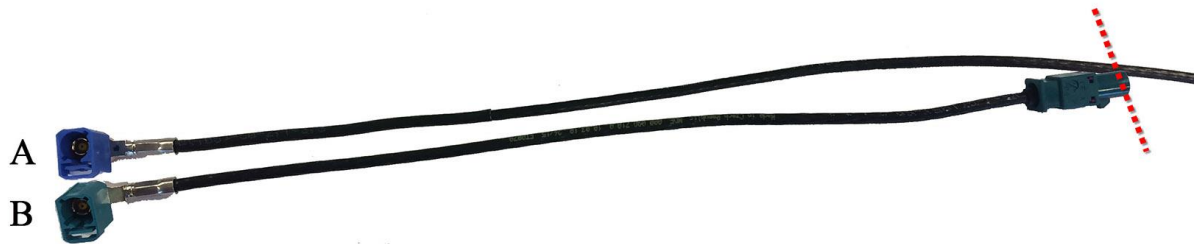
Figure 2. Measure you're the cut point on the vehicle's antenna coaxial wiring (A) based off the length of the replacement coaxial "Adapter Antenna Cable" (B). The removed length of cable from A should be equal to the length of cable B.

5. Follow instructions located in the repair manual to access the FAKRA connectors for the shark fin antenna. Only disconnect the connector for the circuit associated with the customer's complaint.
6. Cut off a section from the vehicle's coaxial wiring for the applicable antenna circuit. Make sure the removed section is the same length as the Adapter Antenna Cable (part number 000098710A). Measure this cut based off the cabling you receive, see Figure 2.

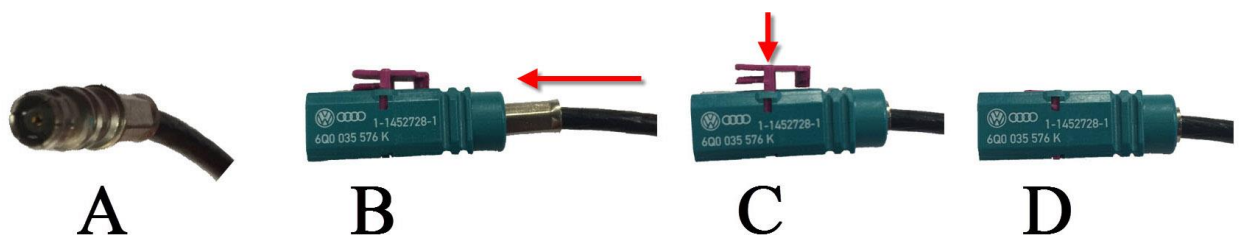
Figure 3. A: Coaxial wire with female coaxial terminal end installed. B: Insert female coaxial terminal end into FAKRA connector until fully seated. C: Coaxial female terminal is fully seated in FAKRA connector, press down the locking tab of the FAKRA connector. D: Completed assembly.

- Utilizing VAS6720 (Aerial Cable Repair Set), identify the coaxial wiring type used in your application (RG174 or RTK031). Reference the vehicle repair manual, or the instructions provided with the VAS6720 and install a female coaxial terminal onto the vehicle side of the coaxial harness. See Figure 3, item A for visual of coaxial cable with female coaxial terminal installed.

- Install FAKRA connector part number 6Q0035576K onto the female coaxial terminal you installed in the previous step. Ensure the FAKRA connector is fully seated onto the coaxial connector and the locking tab is pressed all the way down. See Figure 3 for example.

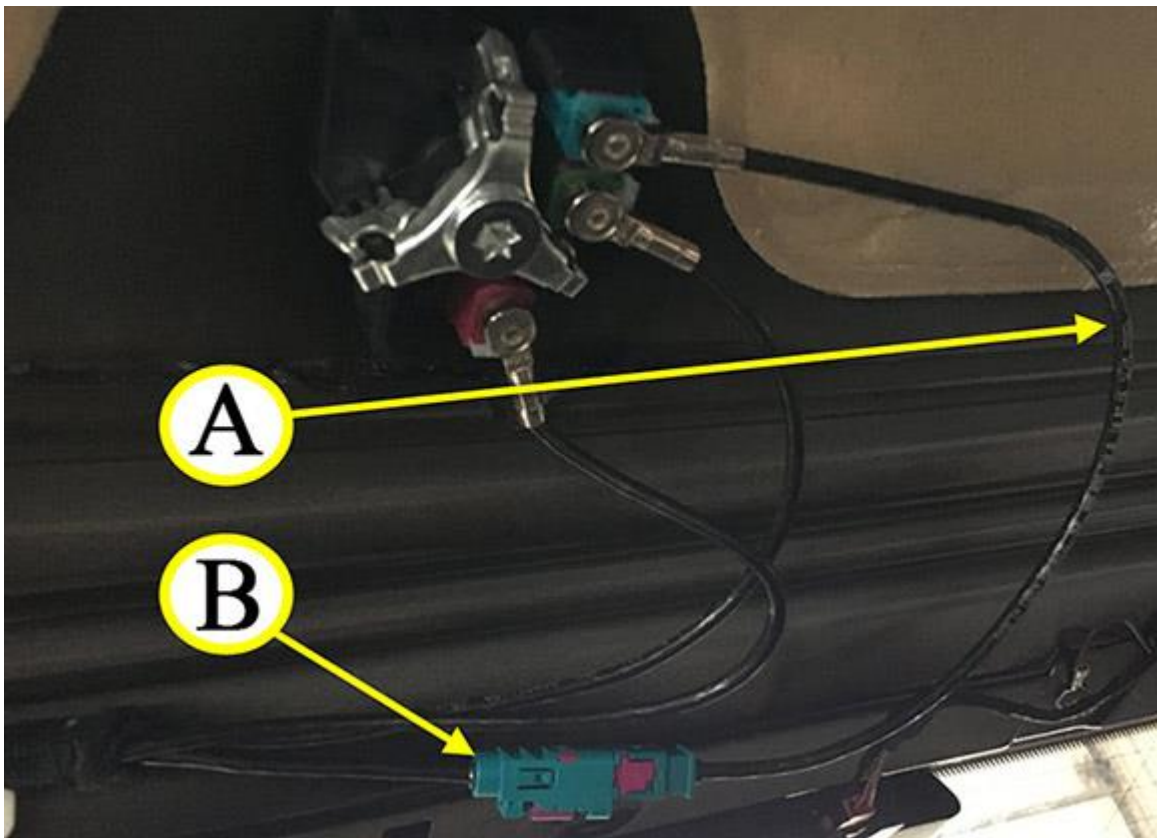
Figure 4. Install the Adapter Antenna Cable (A) onto the shark fin antenna and connect to the newly created FAKRA connection (B). Wrap a layer of cloth tape around FAKRA connection B to avoid any unwanted noises.

9. Install the Adapter Antenna Cable onto the shark fin antenna and connect it to the newly installed FAKRA connector from the previous step. Wrap the new FAKRA connection with cloth tape (part number 000979950) to avoid any unwanted noises.
