# Technical Service Bulletin

## 94 Daytime running light (DRL) inoperative (DTC 02895 or 02897)

94 16 80 2032184/7 September 7, 2016. Supersedes Technical Service Bulletin Group 94 number 15-72 dated August 19, 2015 for reasons listed below.

Model(s)	Year	VIN Range	Vehicle-Specific Equipment
Q5	2013-2017	All	LED Daytime Running Lights

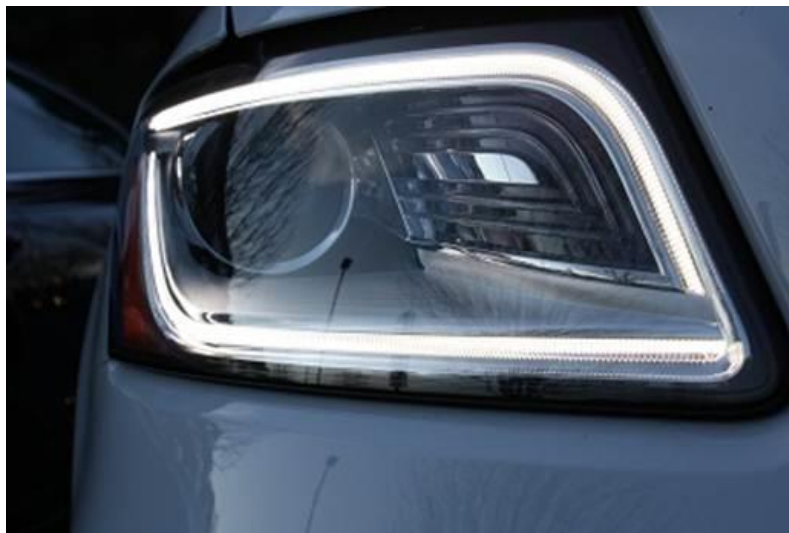
The MY2013+ Audi Q5 LED DRLs use light-emitting “pipes” or “guides” instead of multiple, individual LEDs. There are two light pipes per headlight. Each light pipe uses a single LED for illumination (Figure 1).

**Figure 1.** Upper and Lower light pipes illuminated.

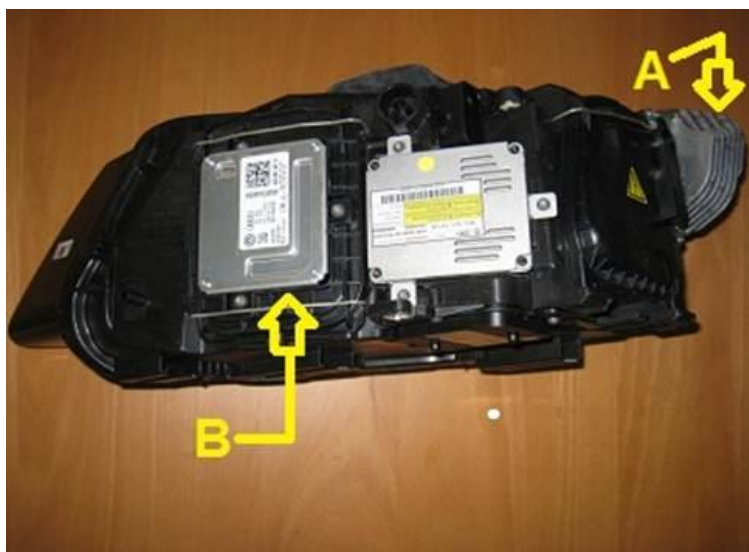
The LEDs with heatsinks are contained in a single module (Figure 2, A) mounted to the outer backside of each headlight.

**Figure 2.** Backside of headlight with LED heat sink (A) and LED control module (B).

The LED unit with heat sink utilizes a gasket and is keyed into the headlight housing to maintain proper alignment of each LED and light pipe. The LED units (L176 and L177, left and right, respectively) are controlled via a control module

(J860 and J861, left and right, respectively) located separately on the backside of the headlight (Figure 2). These LED units and LED control modules are electrically interchangeable from side to side, but the LED units are mechanically specific to each headlight side.

1. With the ignition off, remove the DRL control module (Figure 2, B). See repair manual for instructions.
2. Check the connector at the module and secure if loose. If necessary, remove connector and reinstall to be sure connector is engaged properly. The wiring harness guide of the terminal housing may impede connector engagement.
3. With ignition still off, remove LED unit with heat sink from headlight housing (Figure 7). See repair manual for instructions. Inspect and secure all electrical connectors, if loose. Remove and secure the white connectors, even if they do not appear to be loose.

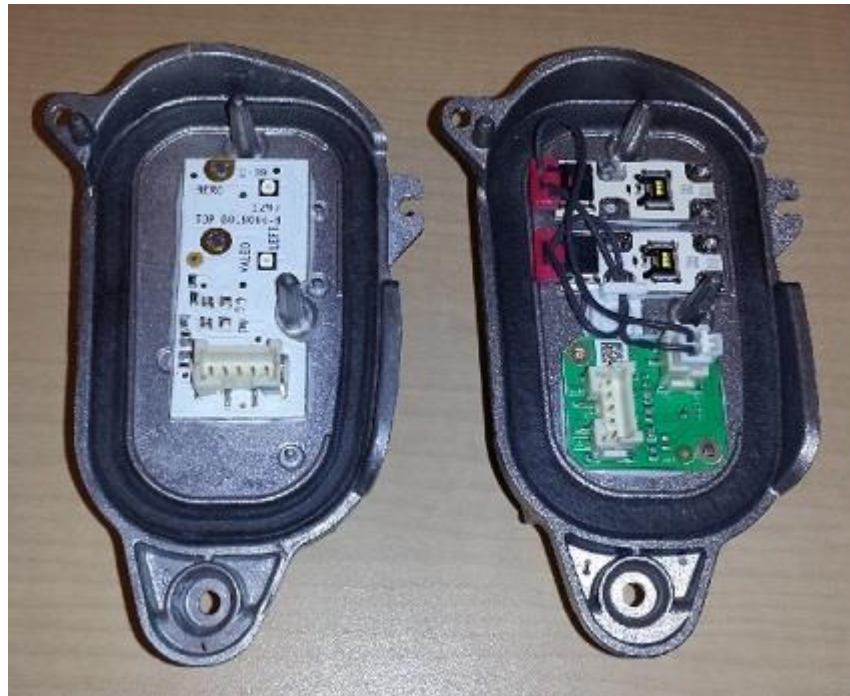
As of March 12<sup>th</sup>, 2013 production, the LED unit with heat sink has been updated (Figure 3). If a failure occurs, these parts do *not* need to be replaced in pairs.

**Figure 3.** Current (left) and early (right) style LED DRL units.

The appearance of the replacement part for the LED DRL has changed, but functionality is the same. If an LED DRL needs to be replaced, they do not need to be replaced as a pair.

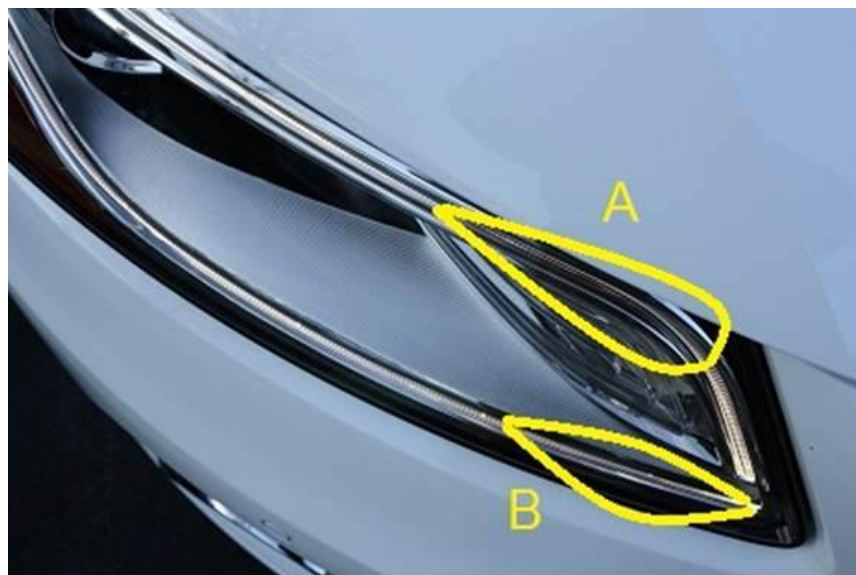
- A defect may be perceived for top-down viewing angle (Figure 4).

**Figure 4.** Upper light pipe perceived defect (A). Lower light pipe

*perceived defect (B).*

Explain to the customer that the LED illumination appears differently to someone standing in front of the vehicle than it appears to oncoming traffic. The viewing angle of someone standing in front of the vehicle will give a visual effect of an LED DRL inoperative or partially-inoperative condition.

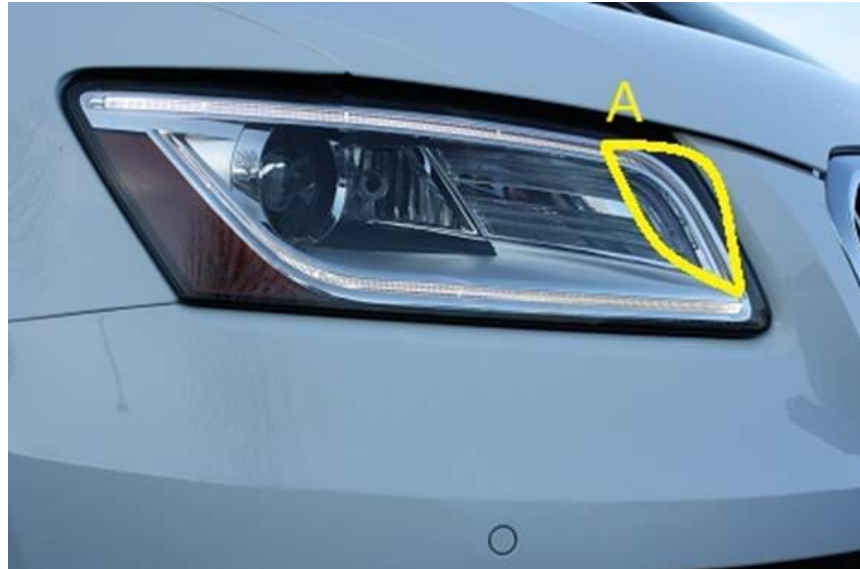
- A defect may be perceived for corner viewing angle (Figure 5).

**Figure 5.** Upper light pipe perceived defect (A).

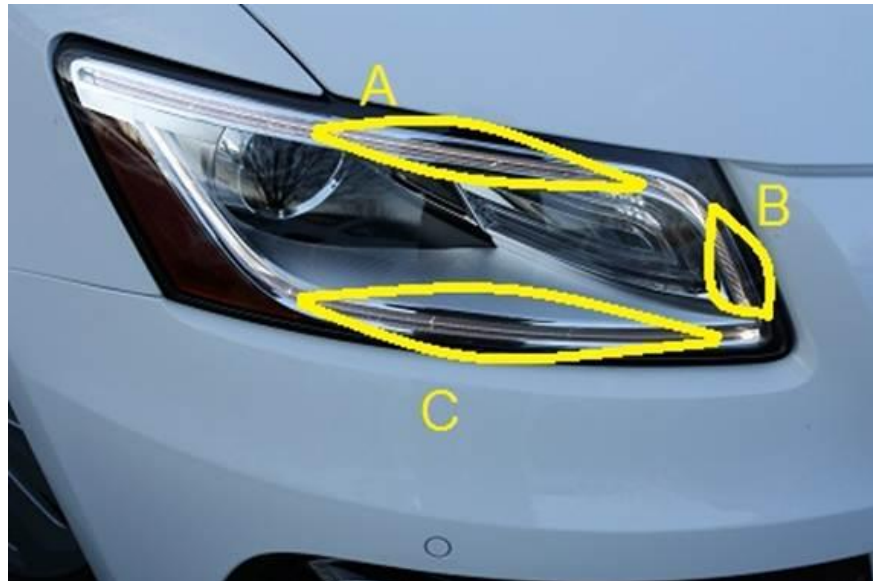
- A defect may be perceived for acute corner viewing angle (Figure 6).

**Figure 6.** Upper light pipe perceived defect (A, B). Lower light pipe perceived defect (C).

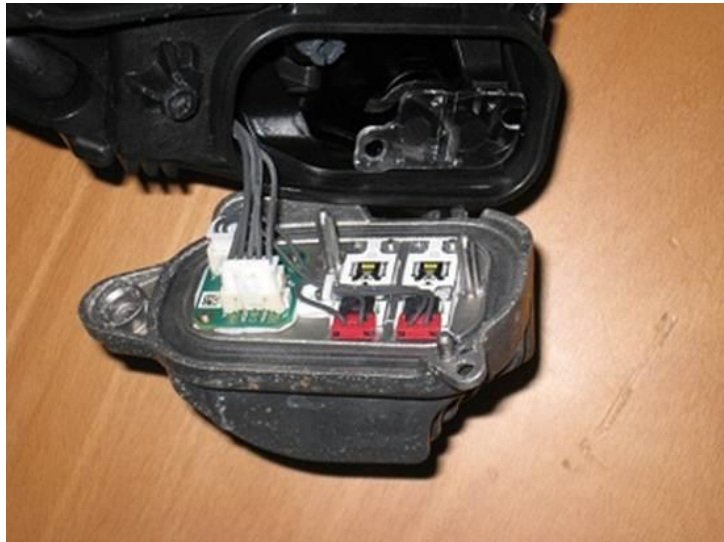
*Figure 7: Dual surface mount LED unit exposed.*

Be extra careful with red surface mount connectors. In general, a repair kit is not available for any internal headlight connectors.
