TECHNICAL BULLETIN

JTB00523NAS1
04 OCT 2016

SECTION: 501-05

Luggage Compartment Lid Latch Cover Detached

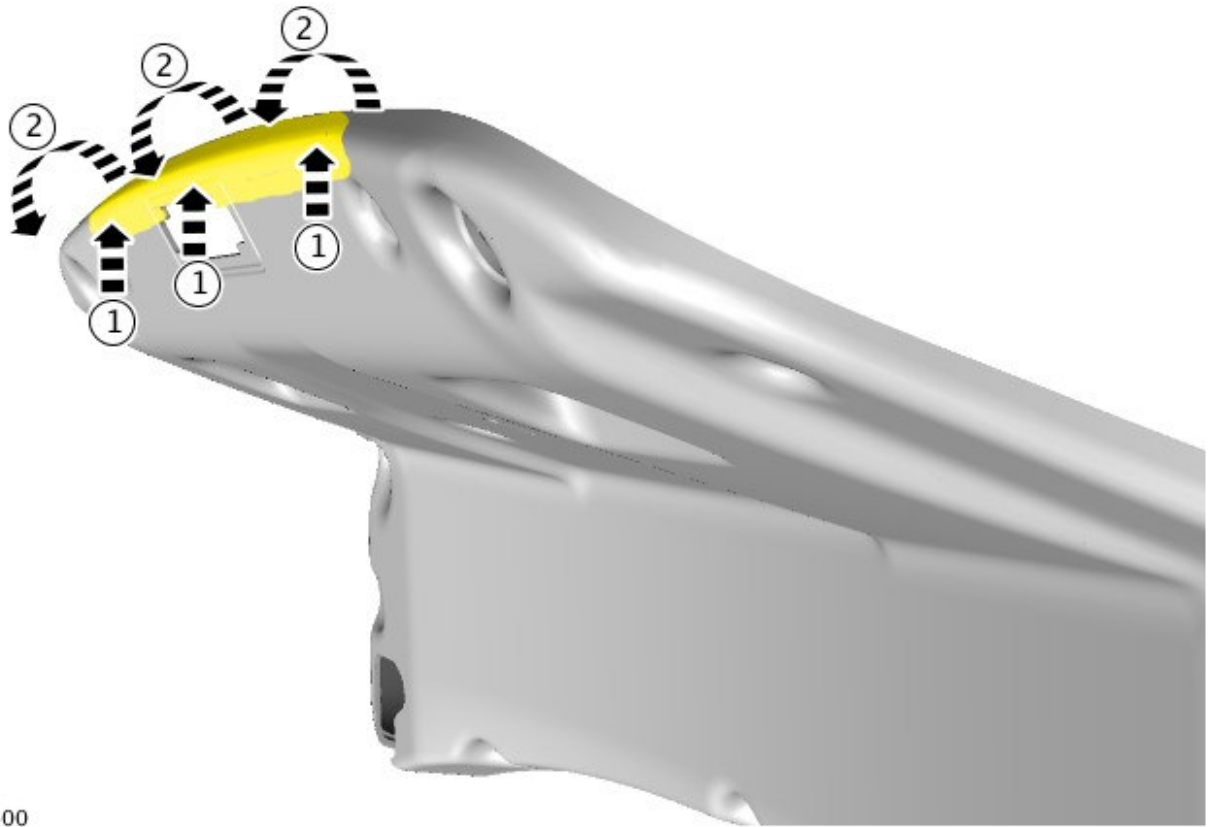
E197400

Cause: This may be caused by the carpet on the luggage compartment lid holding off the latch cover and preventing the clips from fully latching.

**NOTE: Working on the luggage compartment lid carpet trim and starting from one end of the area shown.**

Push in at (1) while bending the top edge (2) towards you to flatten any high points on the return edge.

- Work along the area shown.
