# TECHNICAL BULLETIN

## K432 UPS7116-3bNAS1

### 04 OCT 2016

Update Prior to Sale: Vacuum Pipe and Exhaust Gas Recirculation Pipe Contact

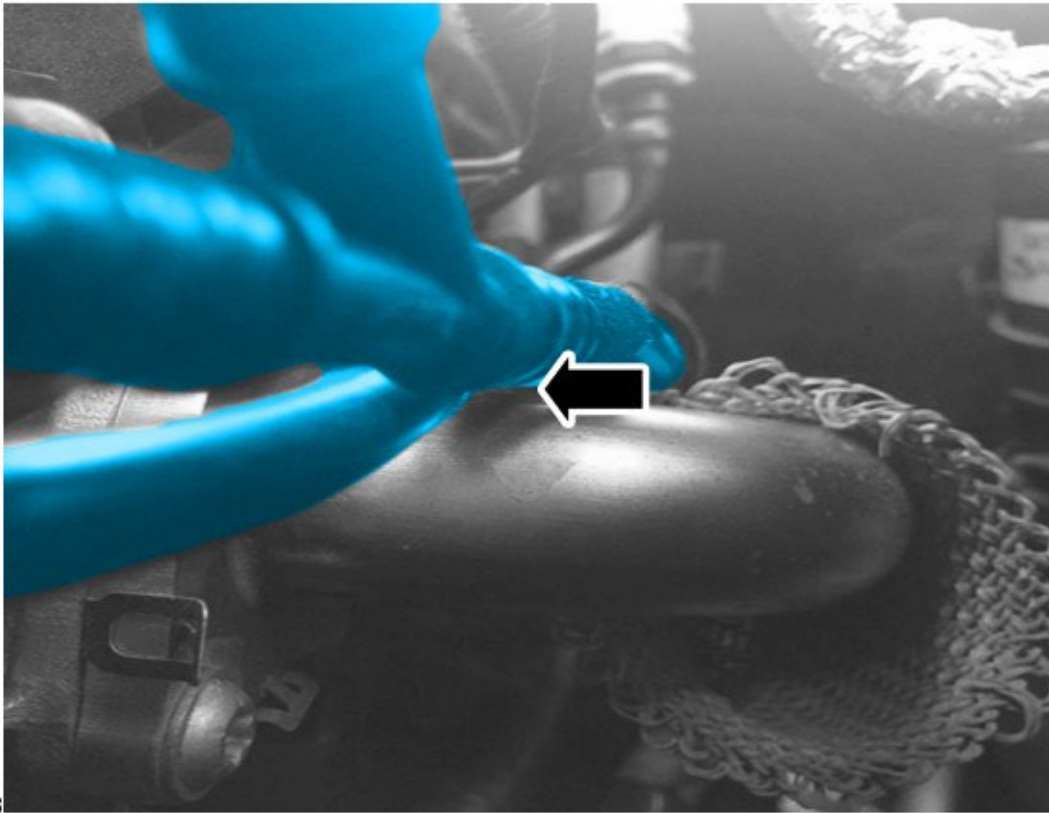
E197358

1. Visually check the condition of the vacuum pipe for damage from the Exhaust Gas Recirculation (EGR) pipe.
  - If the vacuum pipe is not damaged, go to Step 3.
  - If the vacuum pipe is damaged, go to Step 2.

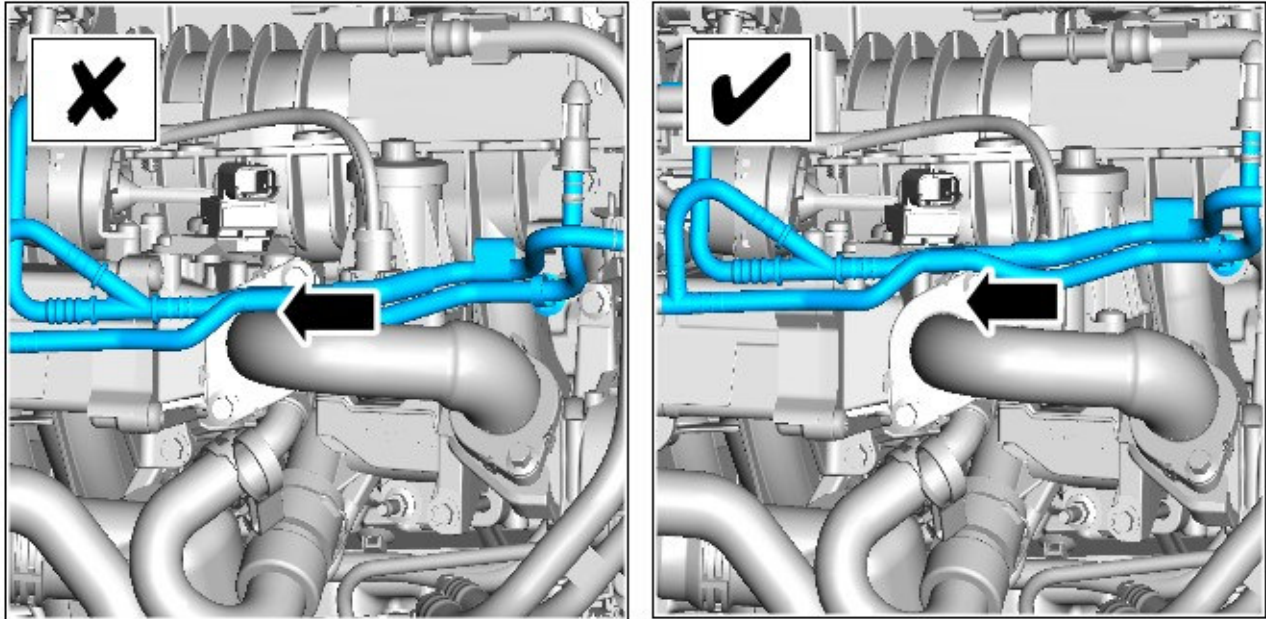
E198102

3. Check for a 10mm gap between the vacuum pipes and the EGR cooler pipe (✓).

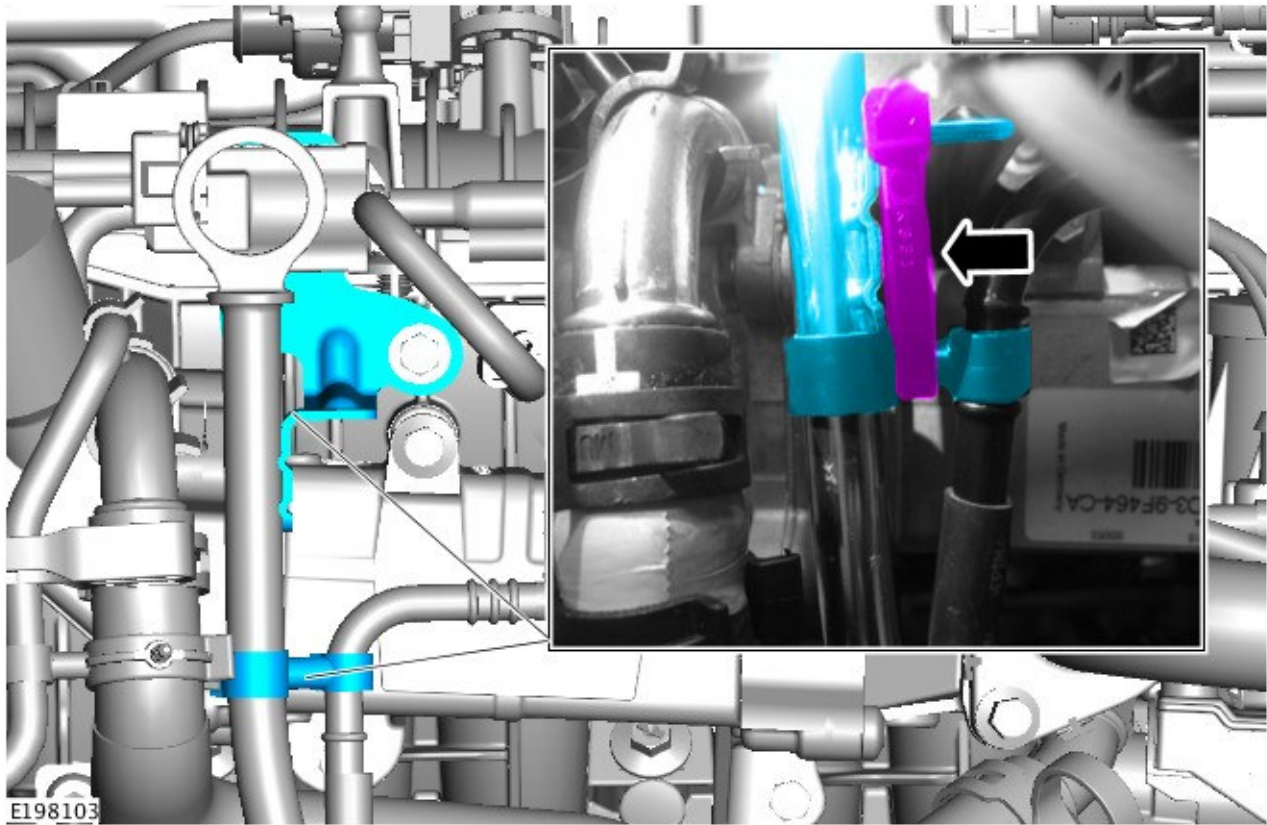
Check that there is a cable tie fitted and that there is a 10mm gap between the vacuum pipes and the EGR cooler pipe as shown in Step 3 (✓).

- If a cable tie is fitted, make sure there is a 10mm gap between the vacuum pipes and the EGR cooler pipe as shown in Step 3 (✓).
  - Go to SERVICE INSTRUCTION B.
- If a cable tie is not fitted, install a cable tie as shown, making sure there is a 10mm gap between the vacuum pipes and the EGR cooler pipe as shown in Step 3 (✓).
  - Trim excess cable tie.
  - Go to SERVICE INSTRUCTION B.

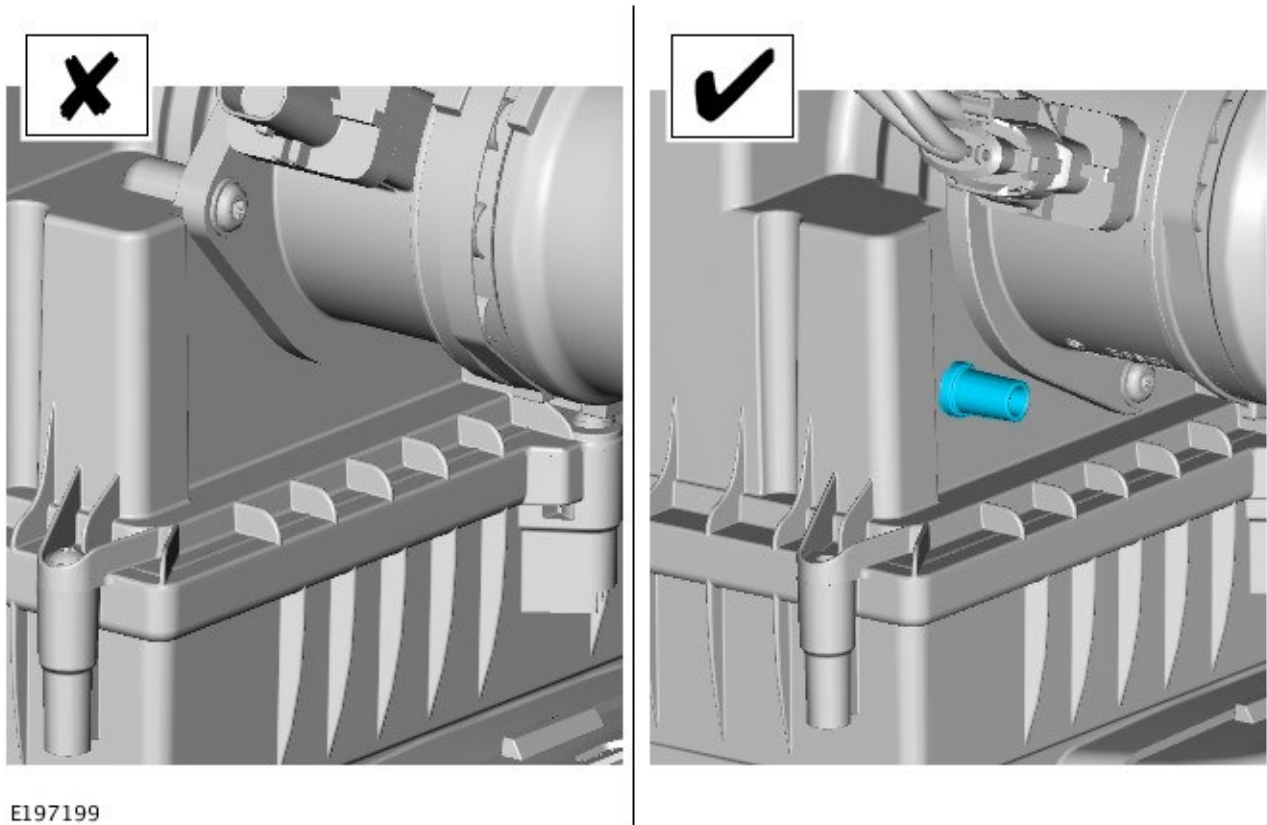
1. Visually check the air cleaner.

- If the air cleaner does have the outlet installed (✓), go to Step 3.
- If the air cleaner does not have the outlet installed (✗), go to Step 2.

**2.** Replace the air cleaner (see TOPIx Workshop Manual section 303-12: Intake Air Distribution and Filtering).

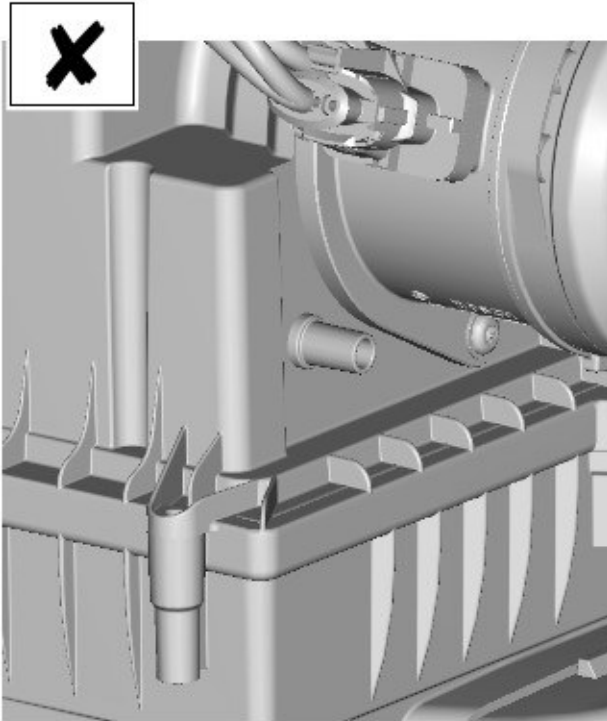
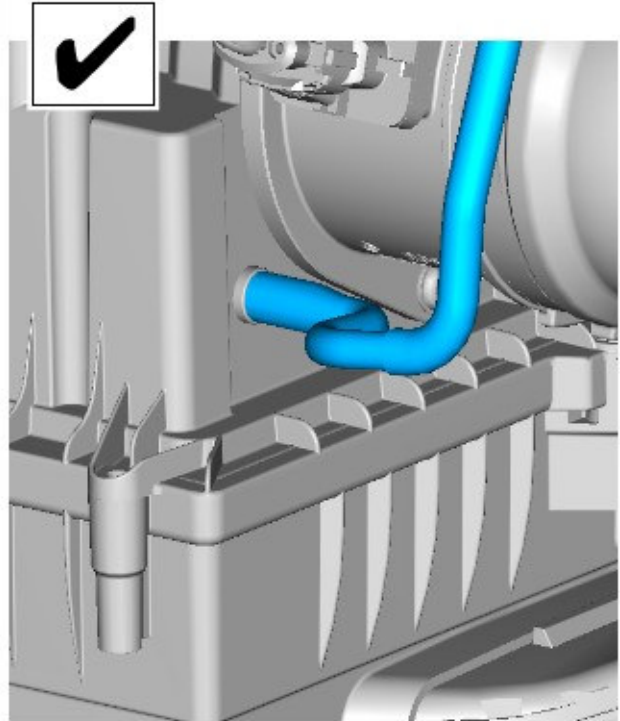
E197175

**3.** Visually check the air cleaner.

- If the air cleaner pipe is installed correctly (✓), go to SERVICE INSTRUCTION D.
- If the air cleaner pipe is not installed correctly (✗), go to Step 4.

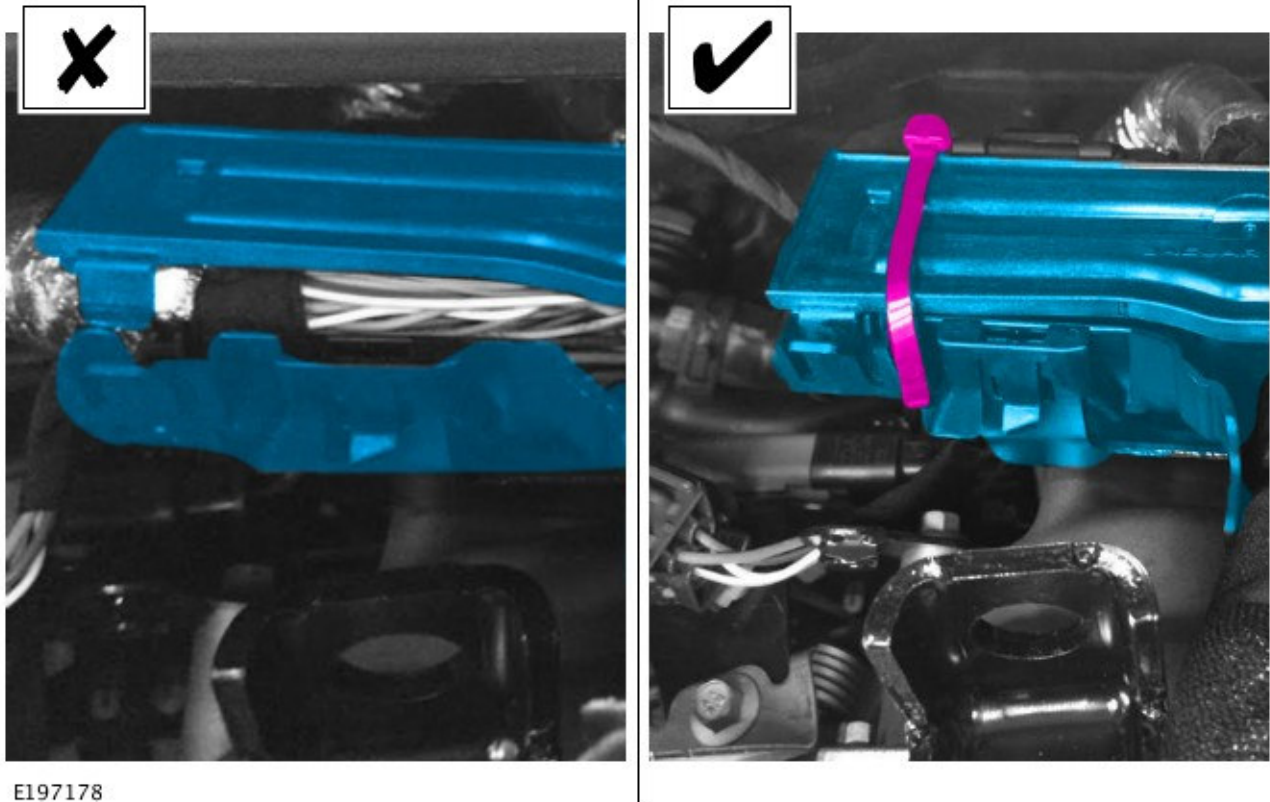
1. Remove engine cover (see TOPIx Workshop Manual section 501-05: Interior Trim and Ornamentation).
2. Visually check the harness carrier is installed correctly.
  - If the harness carrier is installed correctly (✓), go to SERVICE INSTRUCTION E.
  - If the harness carrier is not installed correctly (✗), go to Step 3.

3. Install a cable tie to the harness carrier as shown in Step 2 (✓).

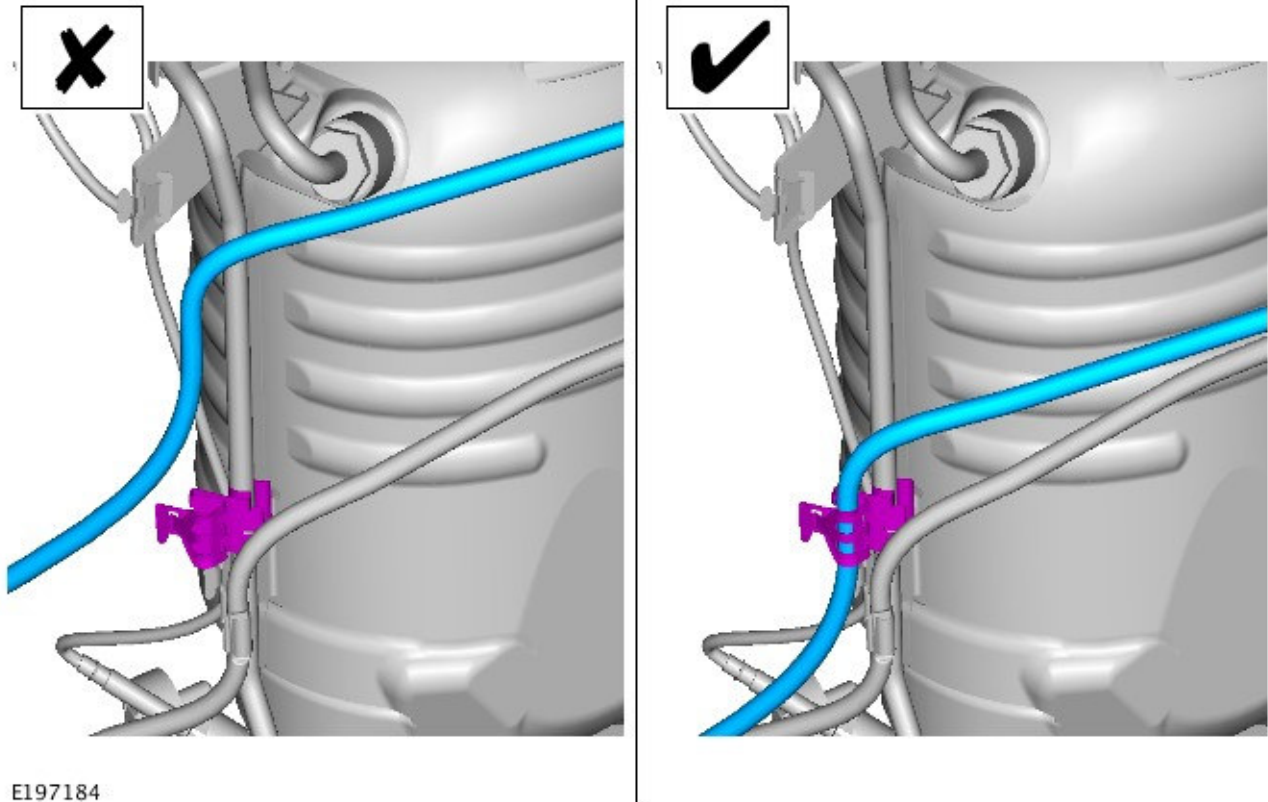
1. Visually check the NOx wiring is installed correctly to the Diesel Particulate Filter (DPF).

- If the NOx wiring is installed correctly (✓), go to SERVICE INSTRUCTION F.
- If the NOx wiring is not installed correctly (✗), go to Step 2.

2. Install the NOx wiring correctly as shown in Step 1 (✓).

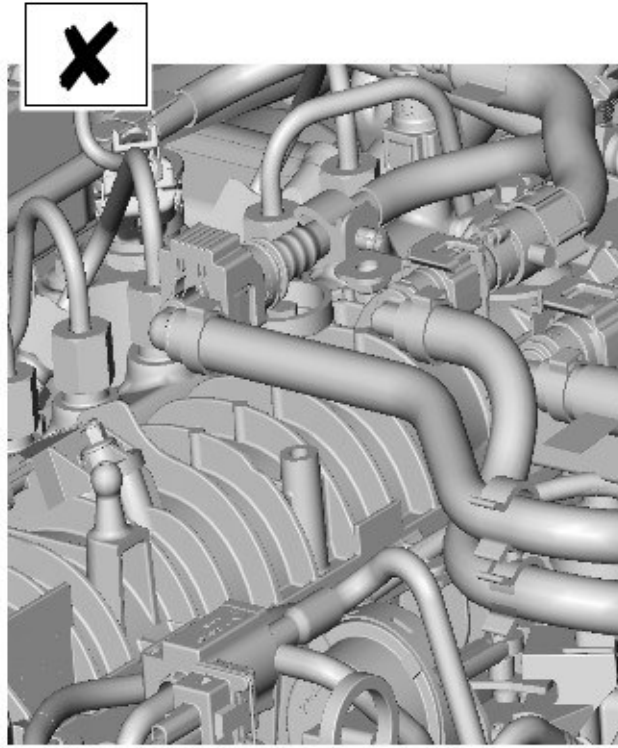
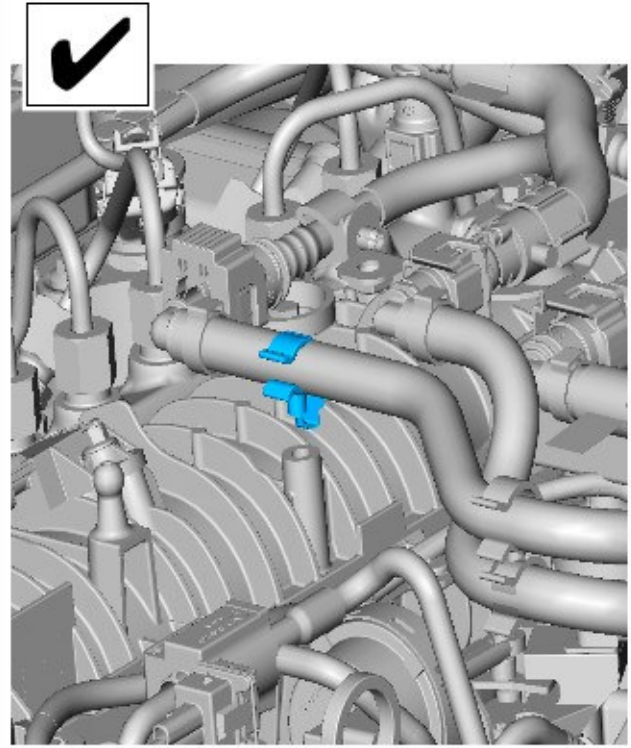
E197186

1. Visually check the fuel line and clip are installed correctly.

- If the fuel pipe and clip are installed correctly (✓) and all the other SERVICE INSTRUCTIONS are complete, go to Step 5.
- If the fuel line and clip are not installed correctly (✗), go to Step 2.

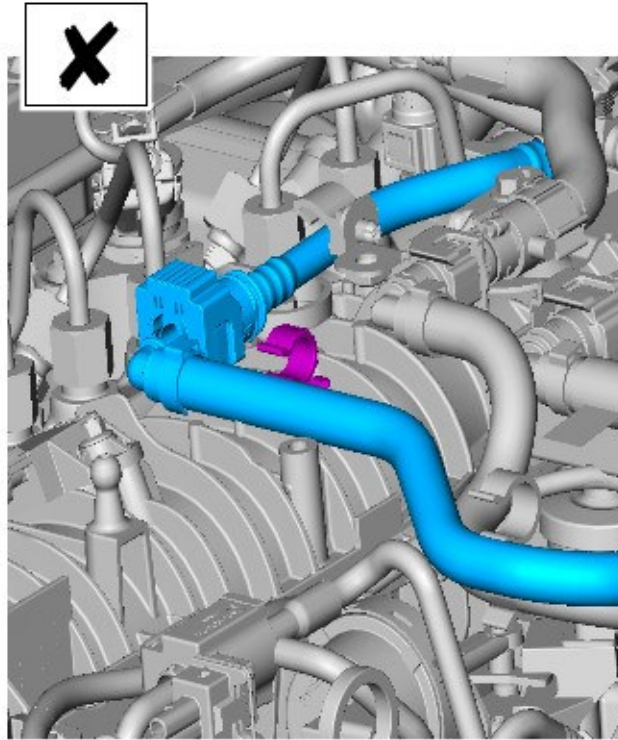
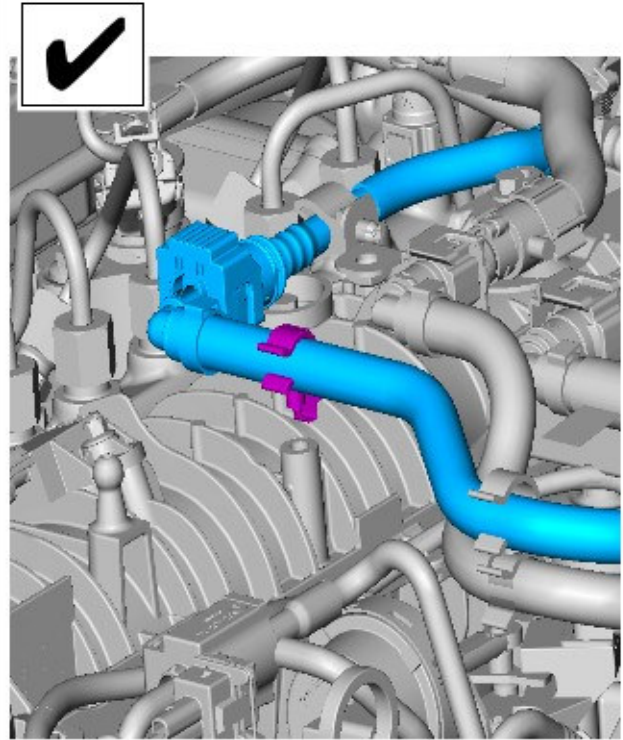
E197185

Visually check the fuel line is installed correctly as shown.

- If the fuel line is installed (✓), go to Step 5.
- If the fuel line is not installed correctly (✗), go to Step 4.
