Technical Service Bulletin

21 Miscolored pipe on turbocharger

21 16 23 2034999/3 August 2, 2016. Supersedes Technical Service Bulletin Group 21 number 14-19 dated October 16, 2014 for reasons listed below.

Model(s)	Year	VIN Range	Vehicle-Specific Equipment
S6, S7, RS 7, A8, S8	2013 - 2017	All	4.0T

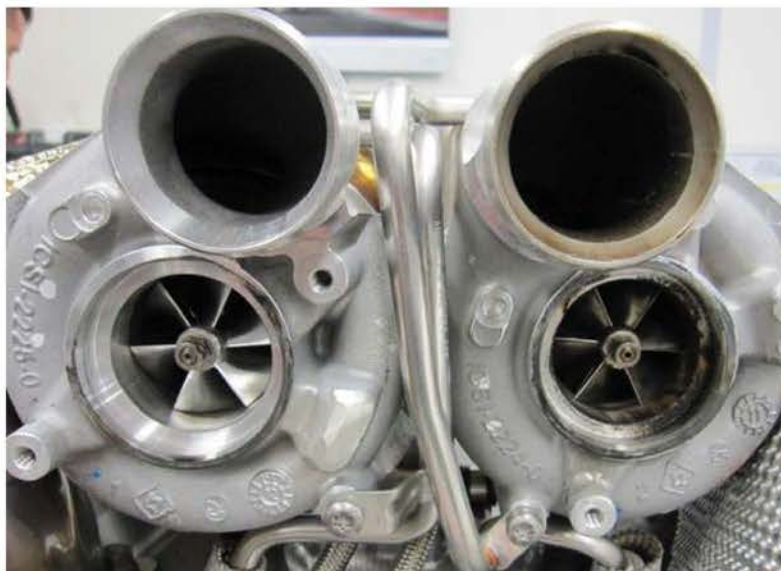
On 4.0l bi-turbo FSI engines, the pipe on the impeller side of the bank 2 turbocharger looks discolored when compared to the pipe on the bank 1 turbocharger.

The crankcase breather is only connected to the bank 2 turbocharger inlet. Blow-by gases from the crankcase breather discolor the pipe (Figure 1). This is a normal condition.

Figure 1. The pipe on the impeller side of the bank 2 turbocharger is discolored due to blow-by gases from the crankcase breather.

1. If necessary, explain to the customer that this is a normal condition.
2. Do not replace any parts due to this condition.
