# Service Campaign Bulletin

Campaign No. 2014010002, January 2014

SUBJECT: **Model 204 (C-Class), Model Year 2014**  
**Rework Seam Seal at Right Tail Lamp**

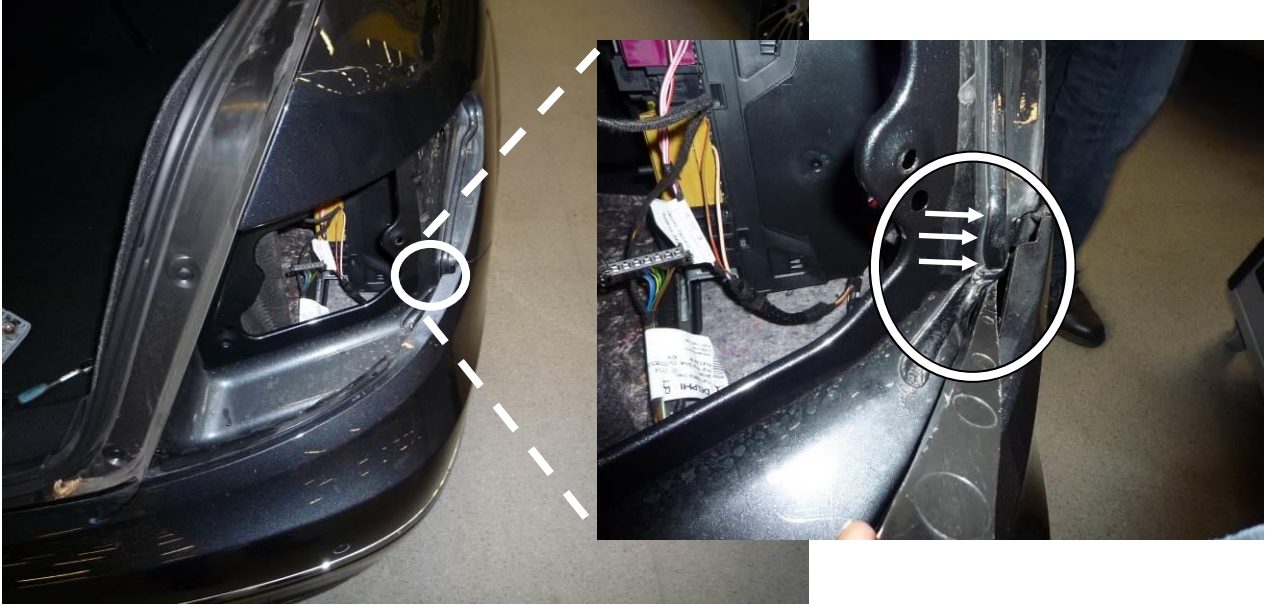
**Figure 1**

This Service Campaign has been initiated because Daimler AG (DAG), the manufacturer of Mercedes-Benz vehicles, has determined that the seam seal at the right rear tail lamp may not be to specification. To verify and correct this condition, an authorized Mercedes-Benz dealer will rework the seam seal at the right rear tail lamp at the next workshop visit.

- Be careful not to damage tail lamp seals when removing tail lamp.
2. Thoroughly clean seal seam and then degrease with silicone remover (shop supply).
  3. Apply missing sealant (Figure 1).
