Service Campaign Bulletin

Campaign No. 2013120004, January 2014

SUBJECT: **Model 204 (C-Class), Model Year 2013**
Correct Left Tail Lamp Connector Locks

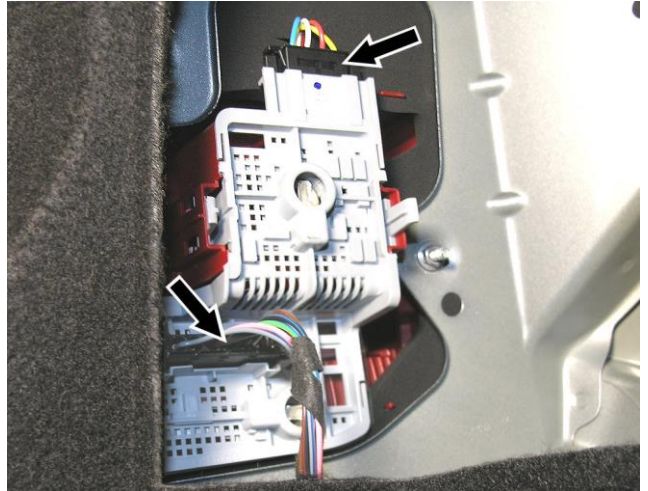
Figure 2

This Service Campaign has been initiated because Daimler AG (DAG), the manufacturer of Mercedes-Benz vehicles, has determined that the lock connectors of the left tail lamp may not be engaged correctly. An authorized Mercedes-Benz dealer will check and engage the locks correctly at the next workshop visit.

Open service flap (arrow, Figure 1).
2. Correct locks at tail lamp connectors (arrow, Figure 2).

Ensure that tail lamp connectors (arrows, Figure 2) are correctly engaged into tail lamp housing.
