TECHNICAL BULLETIN  
K248 UPS5714-1bNAS2  
15 OCT 2014

Update Prior to Sale: Luggage Compartment Lid Interior Trim Loose

**F-TYPE (X152)**

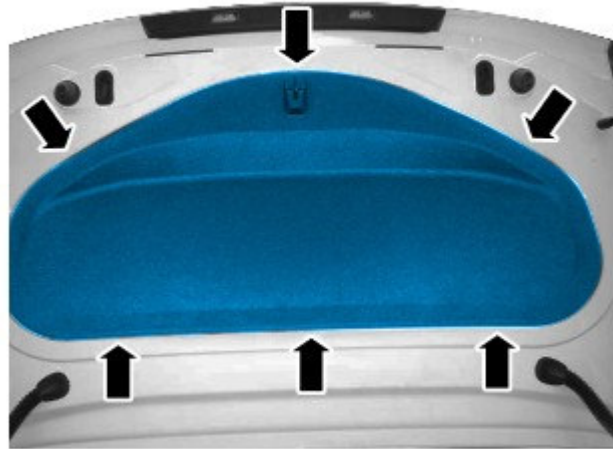
E169942

2. Open the luggage compartment lid and make sure the luggage compartment lid trim is securely in place.

- If the luggage compartment lid trim is securely held in place, continue to step 5.
- If the luggage compartment lid trim is not securely held in place, continue to step 3.

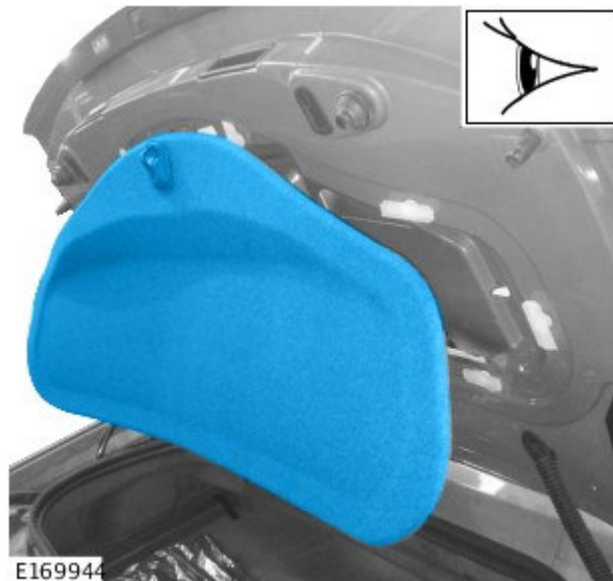
E169944

3. If the luggage compartment lid trim is loose / hanging / detached from **any** of the retaining clips, continue to step 4.
