Reference	SSM71995
Models	XK / X150
Title	XK Vehicles - Damaged Armrest Liner
Category	Body
Last modified	05-Nov-2014 00:00:00
Symptom	107000 Interior Trim
Attachments	11Liner damage - PIC 1.pdf 11Removal process - PIC 2.pdf

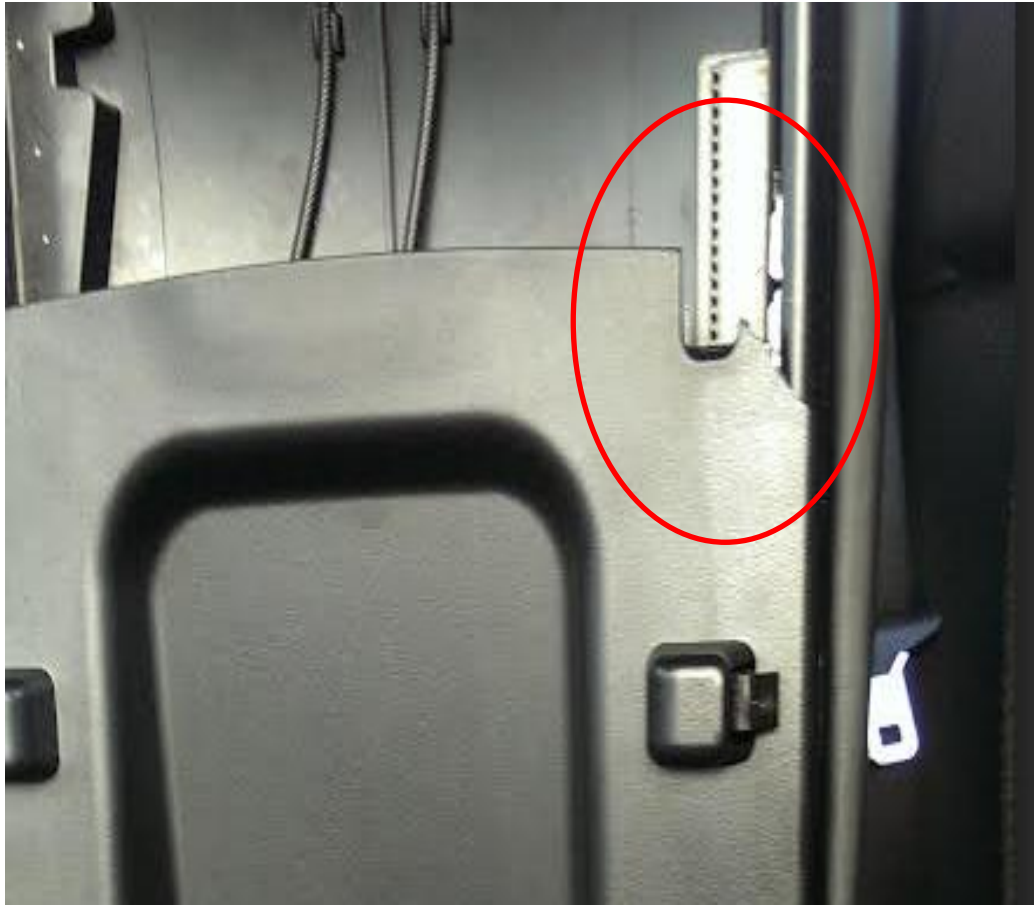
Customers have reported that the Armrest liner is damaged – eg: Corner broken – See pic 1 as an example

Poor initial fit / interference contact

If any damage is found on the armrest liner only, then replace the liner assembly, which is available as a separate part, having the service number C2C18467
