# Technical Service Bulletin

## 61 Water leak at front corners of convertible top

61 16 25 2024108/5 August 12, 2016. Supersedes Technical Service Bulletin Group 61 number 16-24 dated June 8, 2016 for reasons listed below.

Model(s)	Year	VIN Range	Vehicle-Specific Equipment
A5 Cabriolet	2010 - 2016	All	Not Applicable
A5 Cabriolet	2017	000001 - 001289	Not Applicable

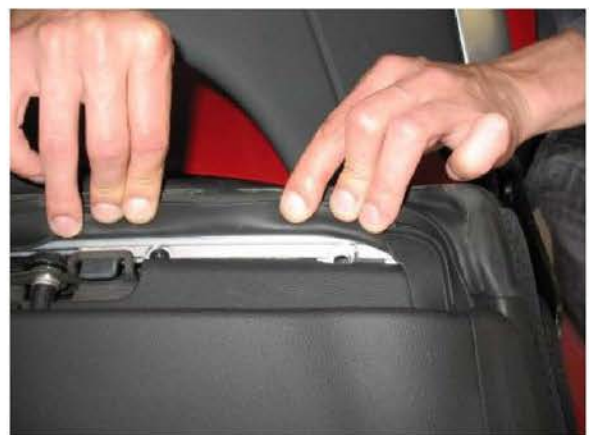
*Figure 3. Folding back the seal bar.*

2. Make sure that the convertible top is in such a position that the working area can remain accessible.
3. Fold back the seal lip and loosen the bolts for the retaining strip (Figure 3).

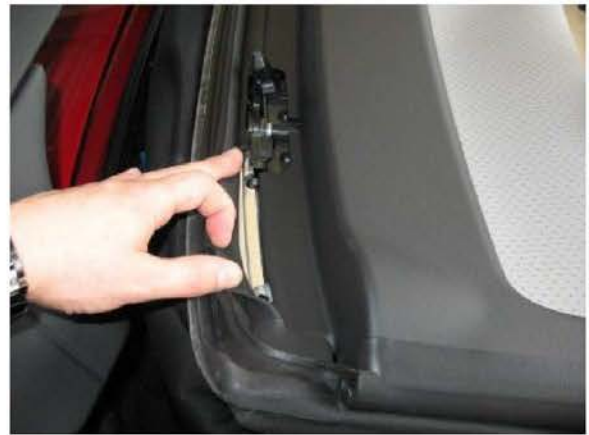
*Figure 4. Lifting the corner.*

4. Remove the bolts securing the retaining strip (Figure 4).

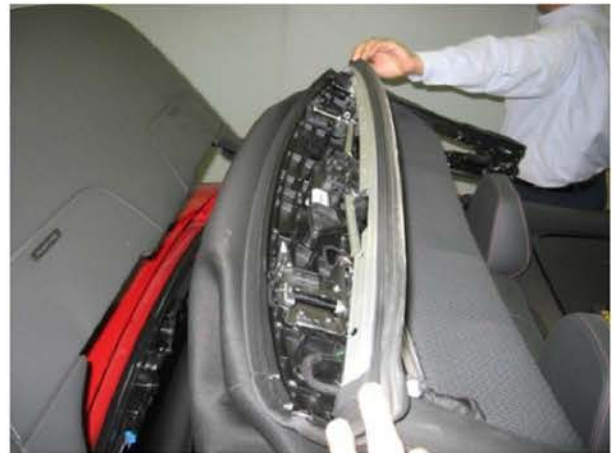
*Figure 5. Retaining strip and seal pulled back.*

5. Lift the retaining strip and seal away from the top cover (Figure 5).

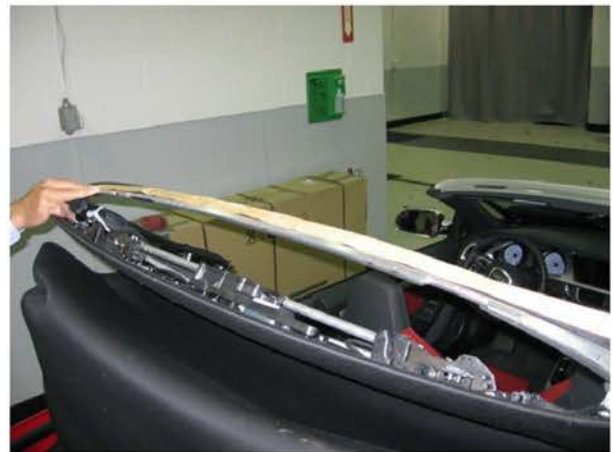
*Figure 6. Butyl cord application.*

6. Install a section of butyl cord (part number AKL45000505) between the seal and the top cloth across the front and into the corners. The section will be approximately 135 cm long (Figure 6).

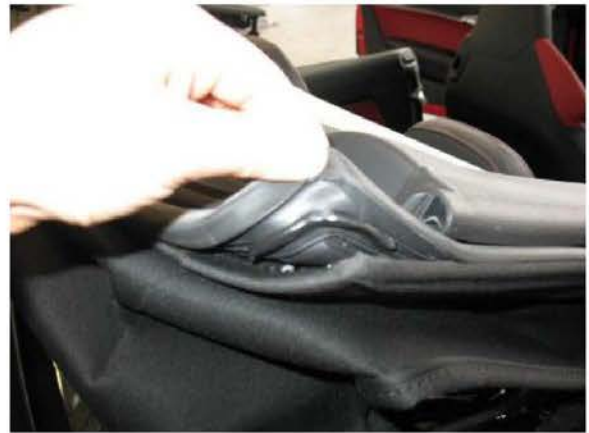
**Figure 7.** Pushing excess butyl cord into the end chambers.

7. Install a length of cord long enough to wrap around and past the corners, and extend 40 mm past the roof line. Make sure that the butyl cord is evenly spread between both edges in the outer groove of the seal. Kneading the cord may ease installation. Push any excess into the end chambers (Figure 7).

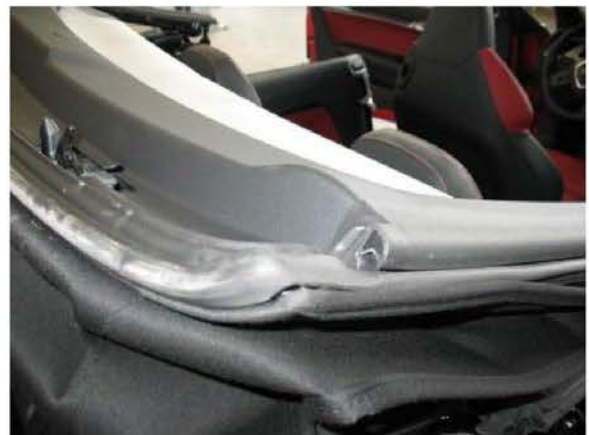
**Figure 8.** The seal, correctly positioned.

8. Press the seal on the cover and press firmly to ensure a good seal. Make sure the seal is correctly positioned on the cover (Figure 8).
