Reference	SSM72516
Models	XF / X260
Title	X260 XF Boot spring bracket detaching
Category	Body
Last modified	23-Nov-2015 00:00:00
Symptom	111000 Body Panel(s)/Unibody
Attachments	BIW Spring bracket SSM 2 (1).pdf (BIW Spring bracket SSM 2 (1).pdf)

X260 Boot spring detaching from Body In White bracket and / or spigot bracket

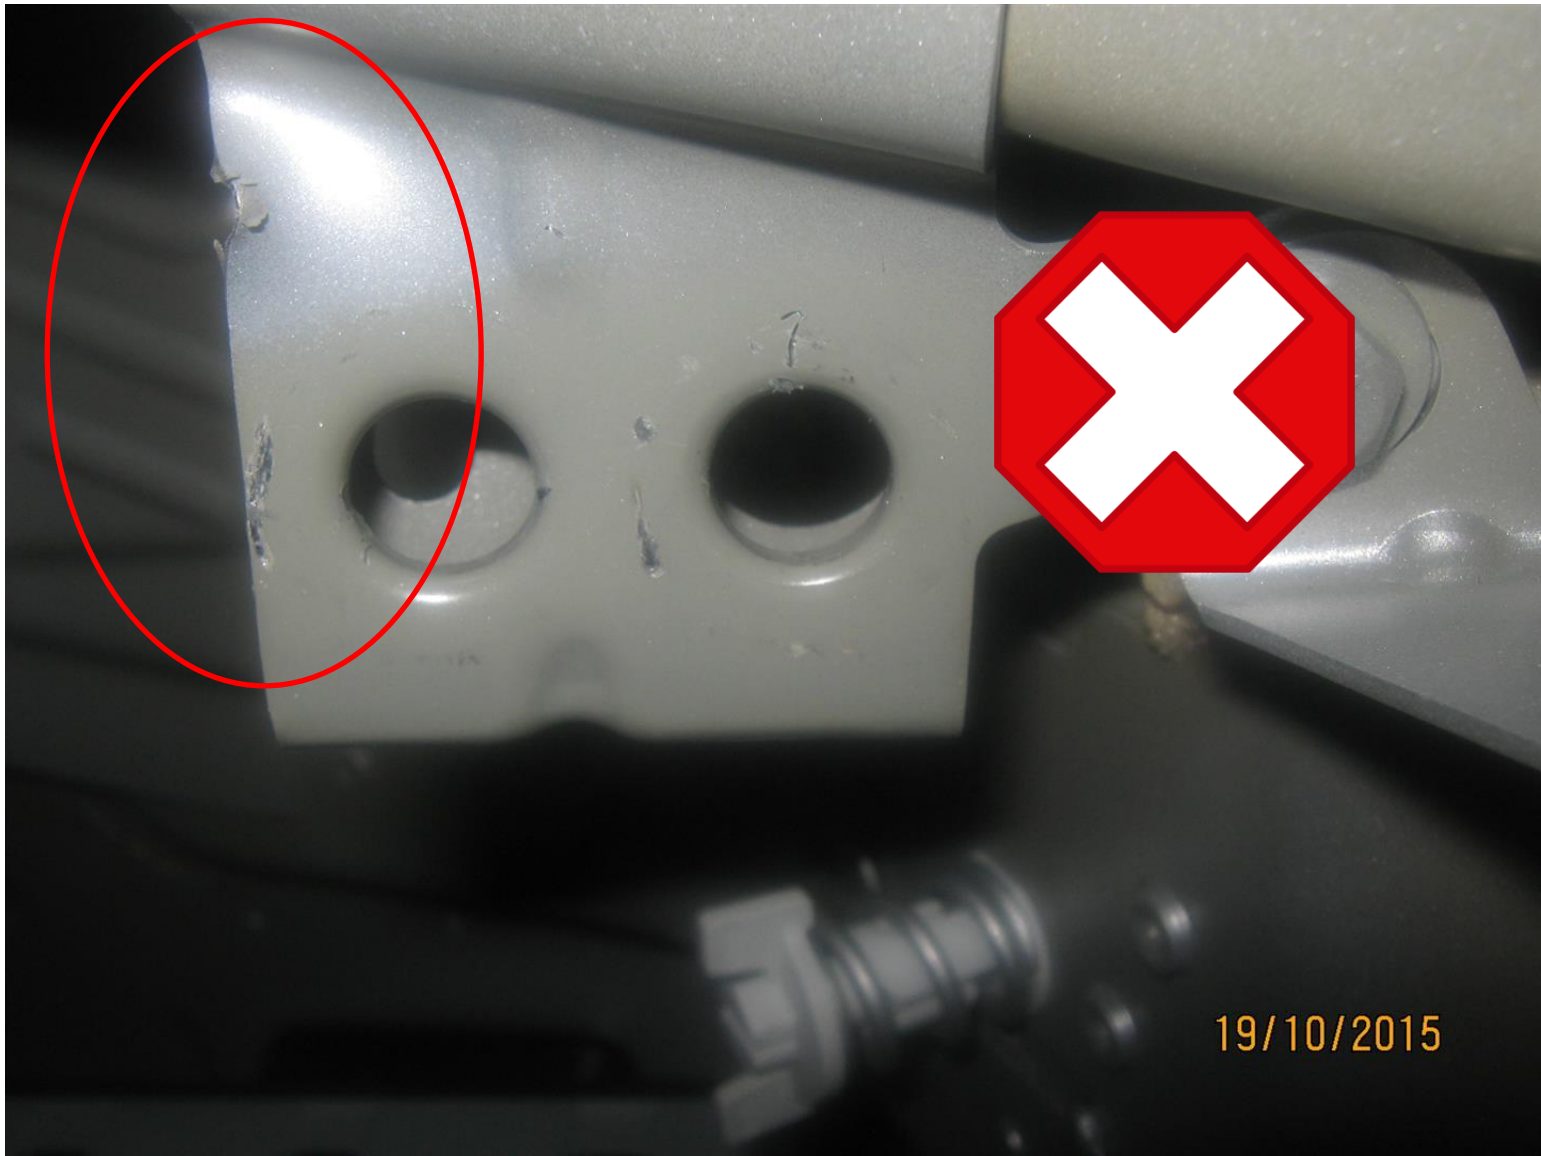
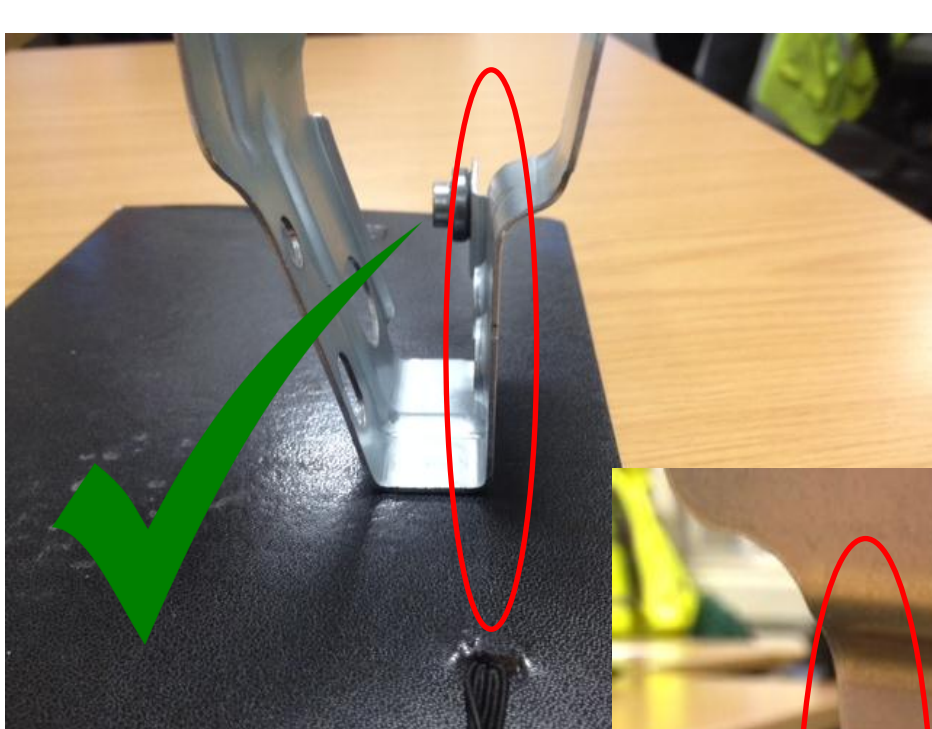
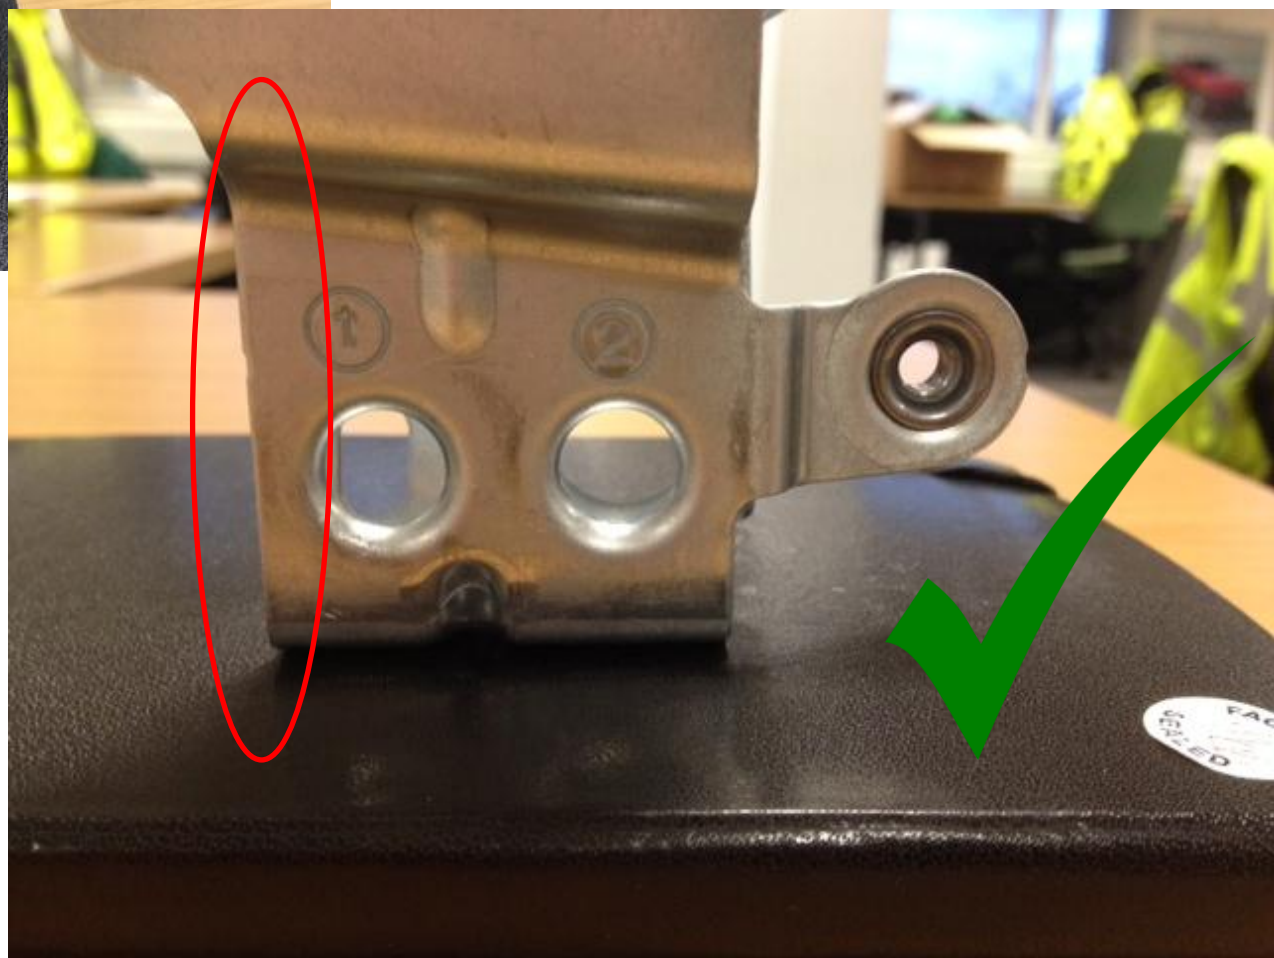
Tolerance between fulcrum points on components

If you have a X260 where the boot spring has detached, please order replacement assistance springs and spigot / ball fixing brackets located on the swan neck assemblies and replace both sides regardless of which has failed.

In addition, please check the integrity and condition of the Body In White bracket on both sides for any damage and re-work / rectify to bring them to the acceptable condition, particularly the profiling and alignment, as shown on the attachment - before installing new components.
