TECHNICAL BULLETIN  
JTB00472NAS1  
18 FEB 2016

Engine Intermittently Will Not Start

**F-TYPE (X152)**

**Model Year:** 2014-2016  
**VIN:** K05320-K25432  
**Assembly Plant:** Castle Bromwich

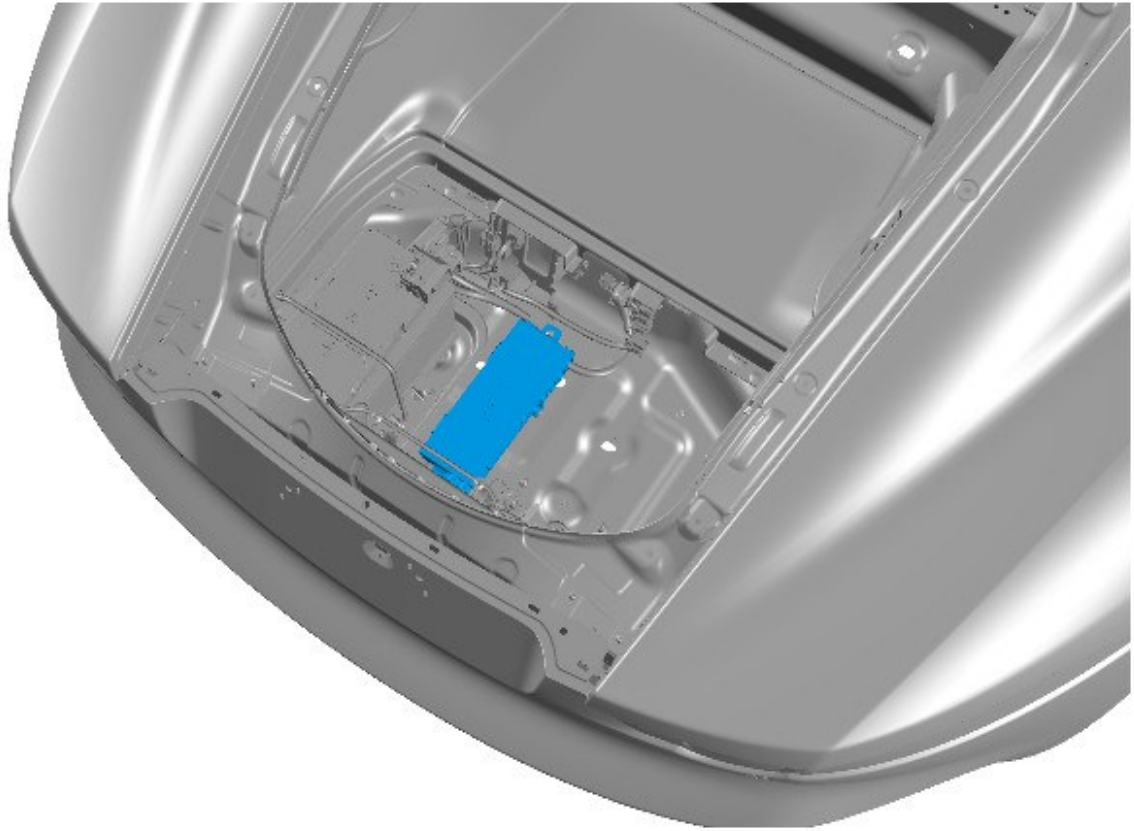
E186896

**Cause:** This may be caused by the Battery Junction Box (BJB) connection not being tightened to correct torque value.

Battery Junction Box (BJB) location.
