TECHNICAL BULLETIN
JTB00463NAS1
28 JAN 2016

Front Brake Pad Wear Warning Lead Fouls On The Road Wheel

XF (X260)

Model Year: 2016
VIN: Y00461-Y07677
Assembly Plant: Castle Bromwich

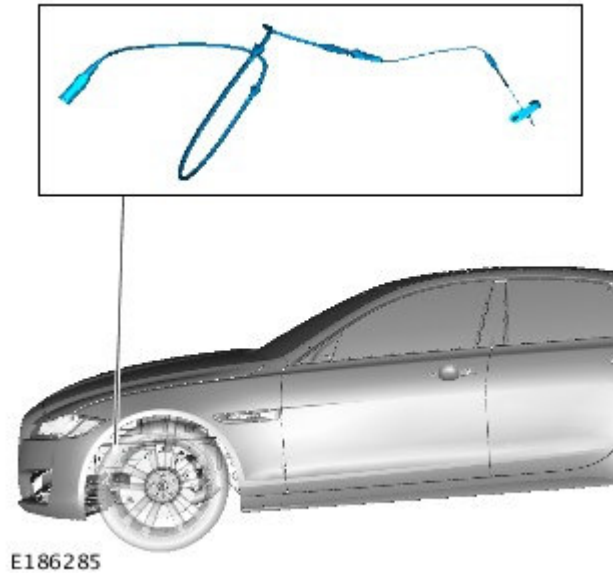
1Component location.

Cause: This may be caused by the front brake pad wear sensor lead contacting the front left road wheel.
