Reference	SSM72581
Models	XJ / X351
Title	X351 XJ Centre Console Cup Holder Cover Split
Category	Body
Last modified	08-Jan-2016 00:00:00
Symptom	107000 Interior Trim
Attachments	Cup Holder Cover.jpg (Cup Holder Cover.jpg)

Content**Applicable VIN Range****V00325 - V93401****Issue**

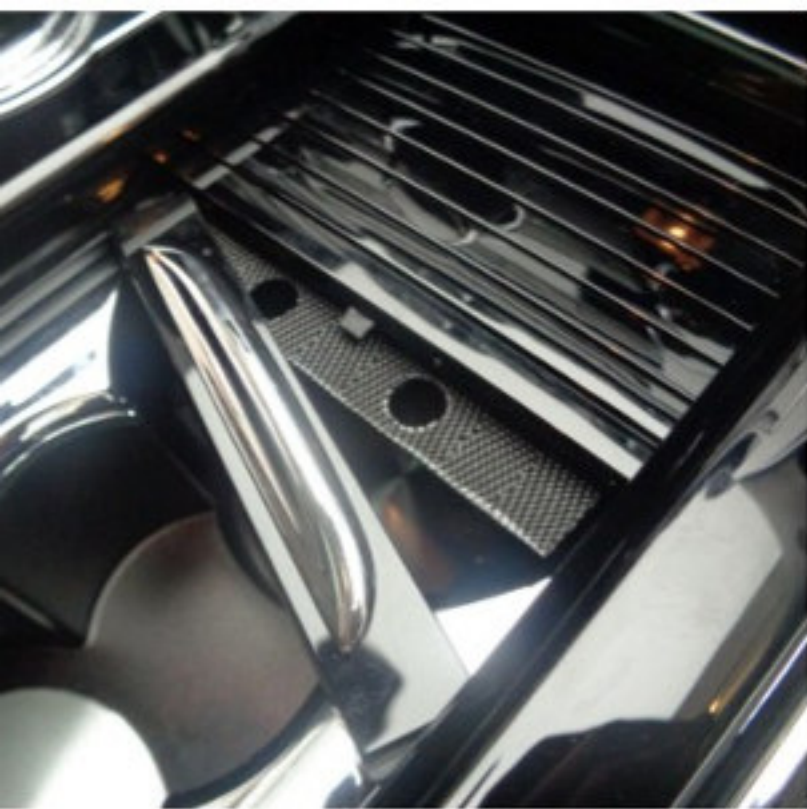
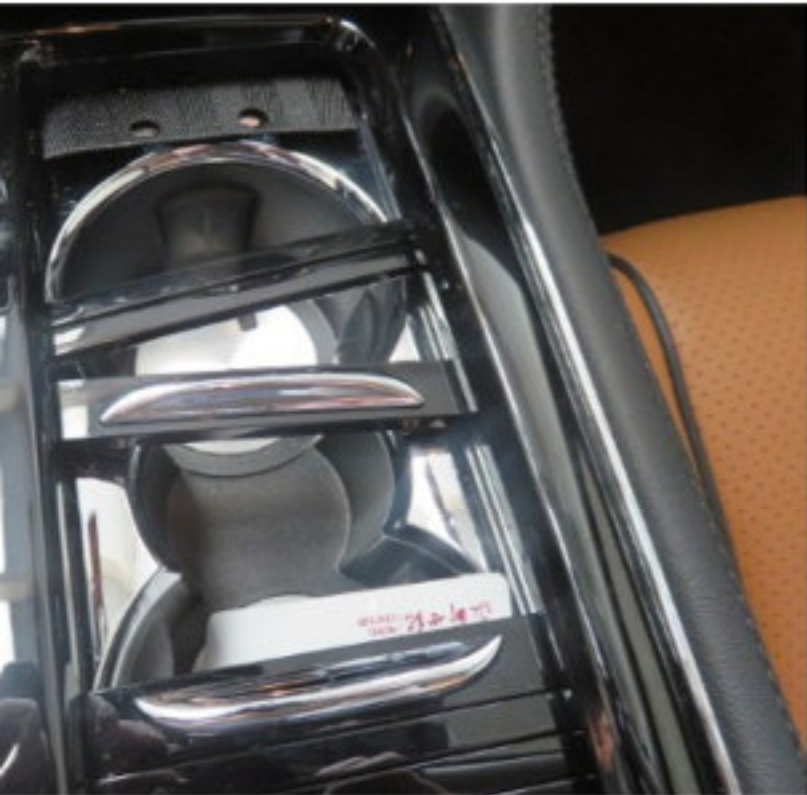
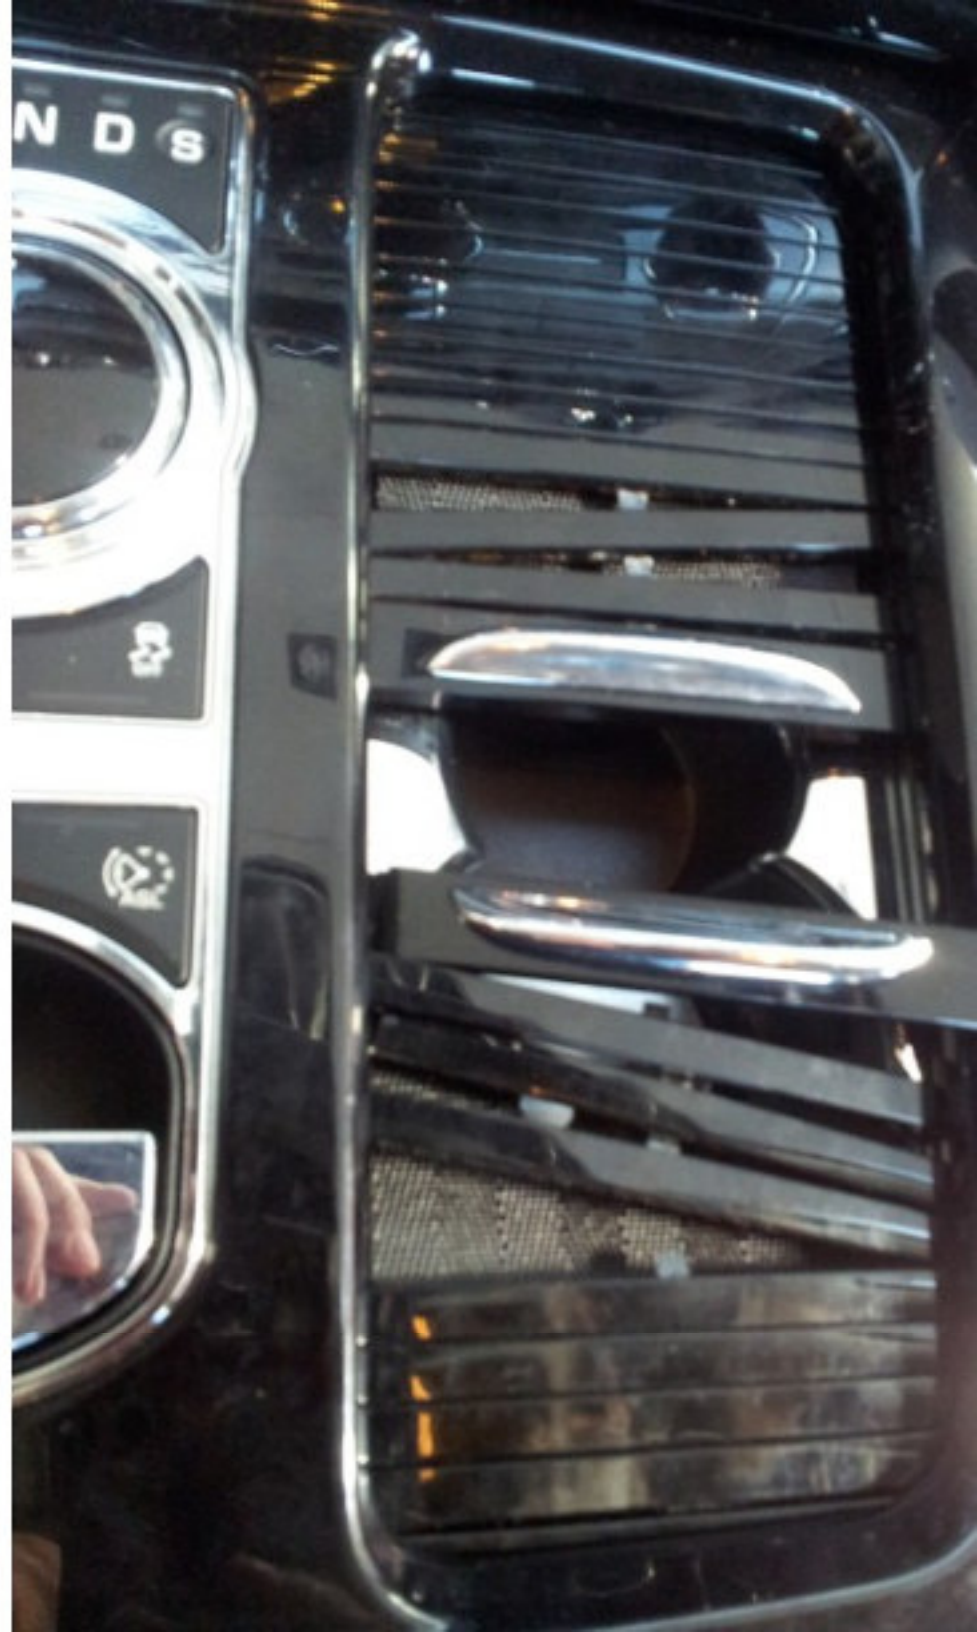
Centre Console Cup Holder Cover Split (See attachment)

Insufficient retention between cup holder cover bars and substrate material. Mechanical fixings (plugs) to the leading handle bar and substrate have been added to improve the bond from VIN No.V93401.

Ensure that there are no other factors that have caused the cup holder to fail, for example spilled drinks that have contaminated the sliding mechanism causing it to stick. The only repair option is to replace the cup holder.
