Subject: VIBRATION DURING ACCELERATION	Bulletin No: 03-001/13
	Last Issued: 01/30/2013

2007-2012 CX-7 4WD vehicles with VINs lower than JM3ER*****422257 (produced before Dec. 22, 2011)

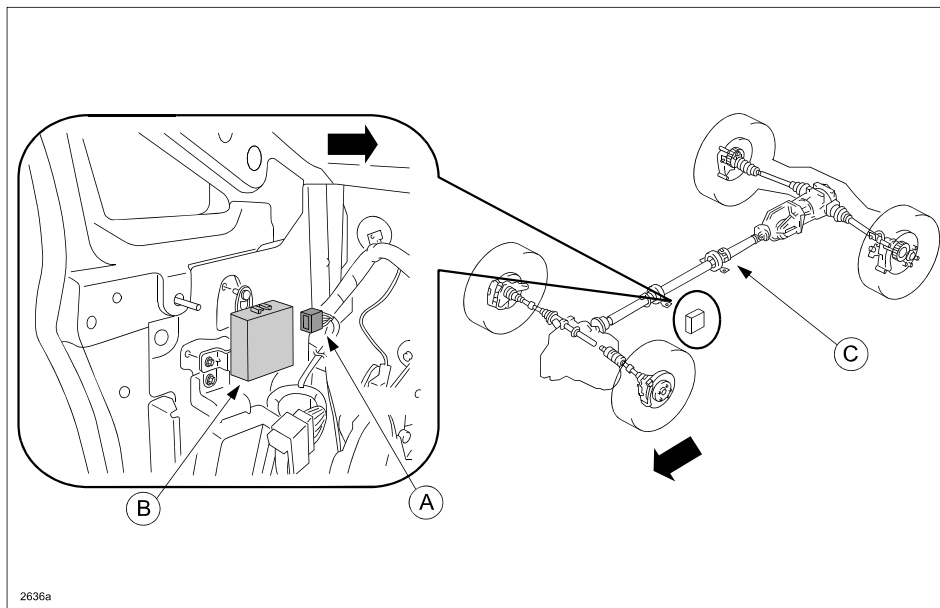
2636a

1. Before test driving the vehicle, remove the drivers side front scuff plate (inner) and front side trim to gain access to the 4WD control module.
2. Drive the vehicle to confirm the vibration occurs in 4WD.
3. Disconnect the connector (A) for the 4WD control module (B).

4. Test drive the vehicle again.
 - If the vibration is gone, replace the propeller shaft with a new one according to the online instructions on MS3 or the Workshop Manual (section 03-15 PROPELLER SHAFT REMOVAL/INSTALLATION).
 - If the vibration remains, continue troubleshooting according to the online instructions on MS3 or the Workshop Manual.
5. Reconnect the 4WD control module connector and install the other parts in the reverse order of removal.
6. Connect the M-MDS and clear the DTCs (U0114.8 and/or U0114.20) that were stored when the 4WD control module connector was disconnected in Step 3.
7. Verify repair.
