<b>Subject:</b> <b>2009-2012 MAZDA6 - RATTLE NOISE AND/OR EXHAUST LEAK NOISE FROM REAR OF VEHICLE</b>	<b>Bulletin No:</b> 01-002/13
	<b>Last Issued:</b> 01/14/2013

2009-2012 Mazda6 vehicles produced before June 7, 2012

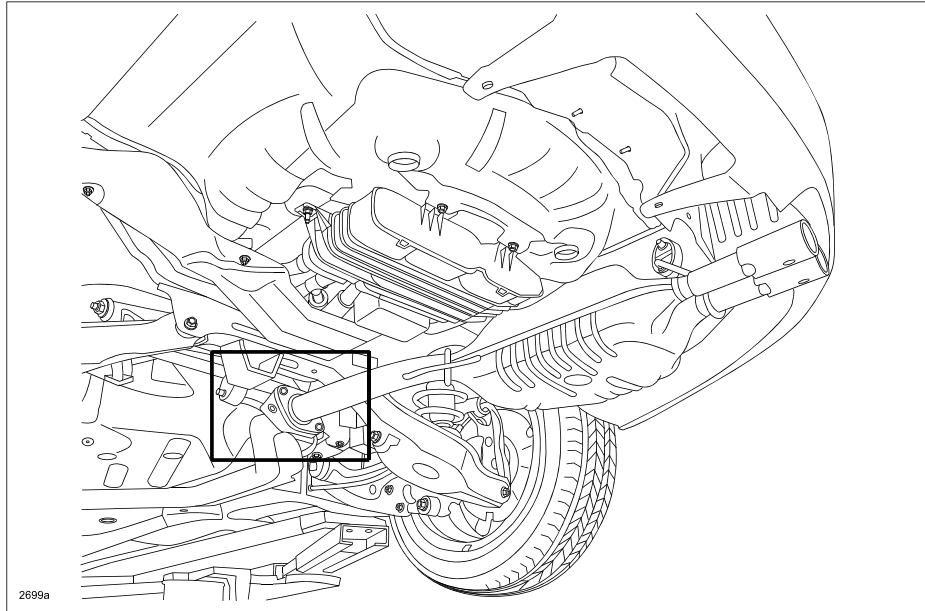
### 2.5L Engine:

1. Verify customer concern.
2. Safely raise vehicle on hoist.
3. Locate the exhaust joint between the main silencer and pre-silencer as shown below.

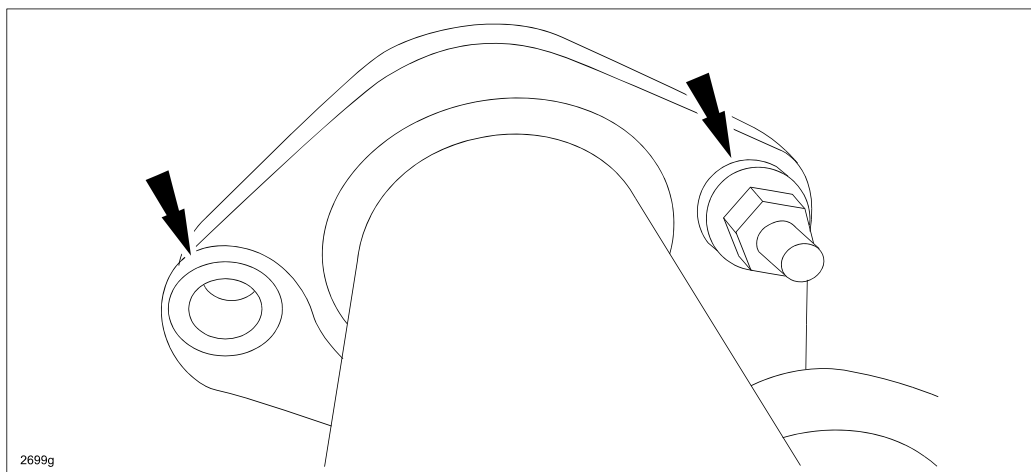
4. Inspect for broken or missing exhaust studs:

- If either stud is broken or missing, proceed to the next step.
- If neither stud is broken or missing, refer to the instructions on MS3 online or the Workshop Manual for further troubleshooting information.
