TECHNICAL BULLETIN
JTB00461NAS1
06 JUN 2016

Sunglasses Holder Inoperative

F-PACE (X761)

XE (X760)

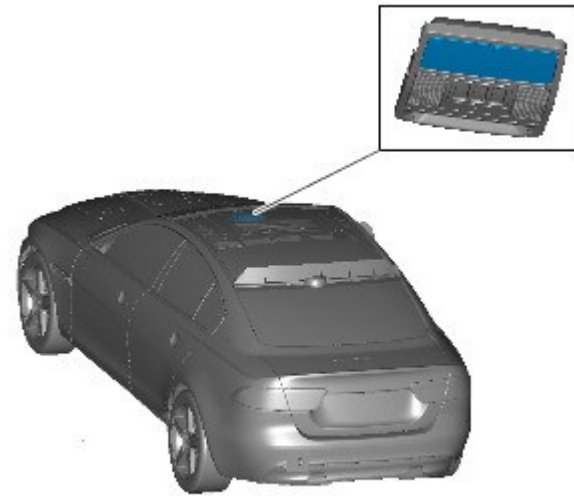
E184931

Component location.
