Subject: UNUSUAL NOISE FROM EXHAUST PIPE SEAL RING	Bulletin No: 01-016/12
	Last Issued: 10/19/2012

2009-2012 Mazda6 2.5L with automatic transmission

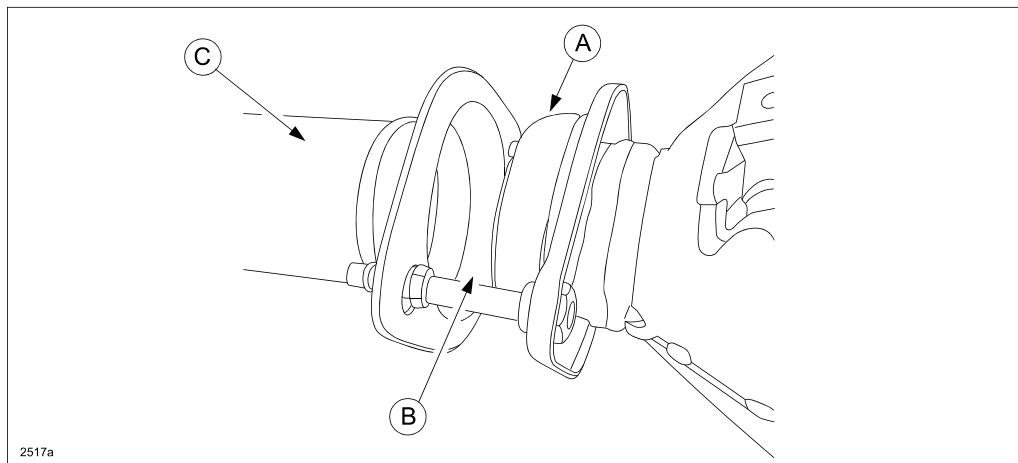
Due to engine vibration and a lack of seal ring lubrication, the mesh in the seal ring (A) rides in the flared portion (B) of the catalytic converter (C) resulting in a slight noise from the exhaust system while the engine is running. **The friction between the exhaust system parts and the resulting slight noise are normal.** This friction does not cause breakage, gas leakage, or other functional problems with the vehicle's exhaust system.

During normal vehicle aging, the noise level may change as the surface of the metal flange deteriorates. Usually this noise cannot be heard when the engine is running, however the noise may be heard in a quiet environment when the customer is outside the vehicle or when a door or window is open.

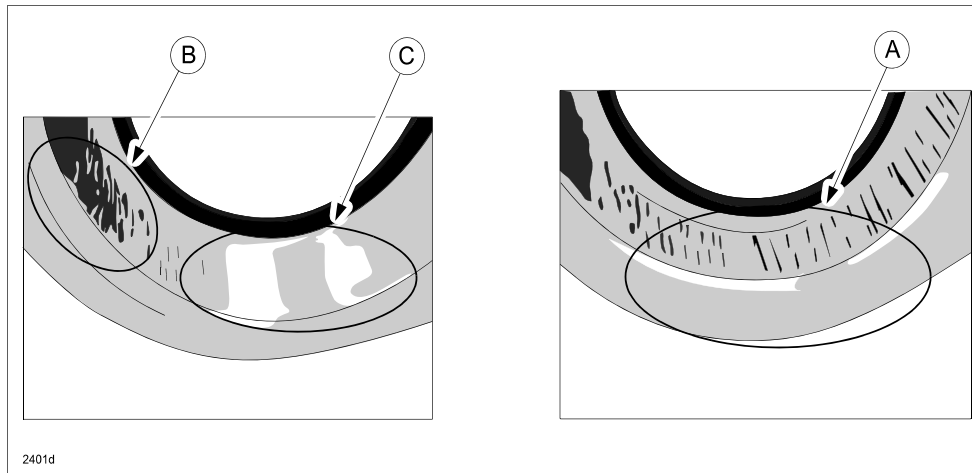
12. If severe damage appears on round surface of catalytic converter-side flared flange (A), replace catalytic converter.

NOTE: If the catalytic converter is replaced and a black coating (B) remains on the round surface of the flared flange, the white coating of the seal ring will stick to the black coating, which may cause noise. Be sure to sufficiently polish the flange (C).

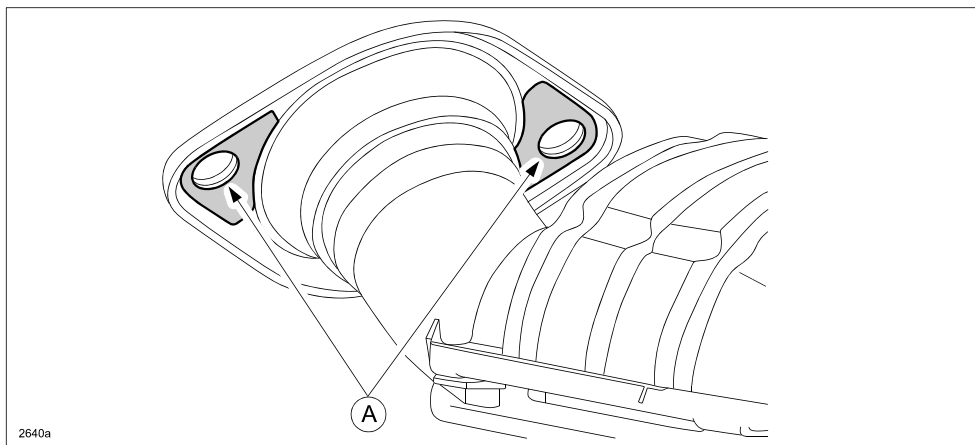
- In case where catalytic converter is NOT replaced:
 - a. Install a new exhaust stud.
 - b. Confirm if patch (A) exists behind the catalytic converter flange.

If YES (patch exists) - Install washer listed in the Part(s) Information to reduce spring tension.
NEVER use an originally equipped washer.

If NO (patch does not exist) - Washer installation is NOT necessary.

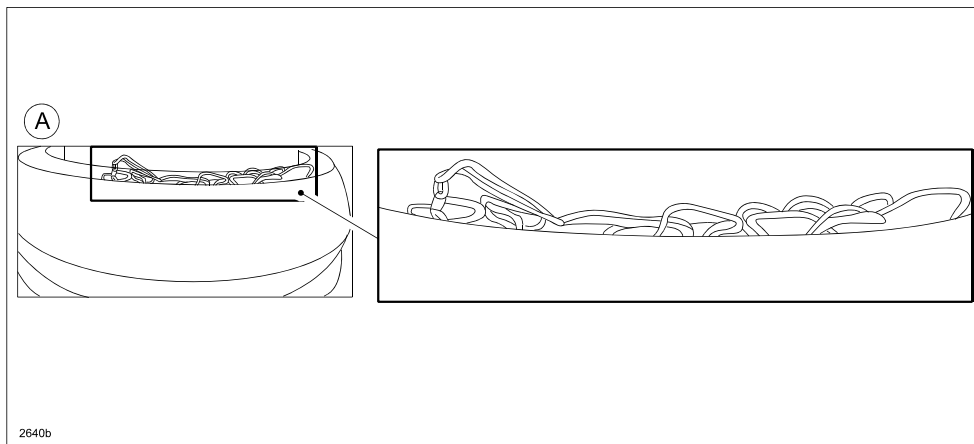
19. If the seal ring is NOT installed straight, mesh wire (A) will come out from the seal ring which will then contact the exhaust pipe flange.

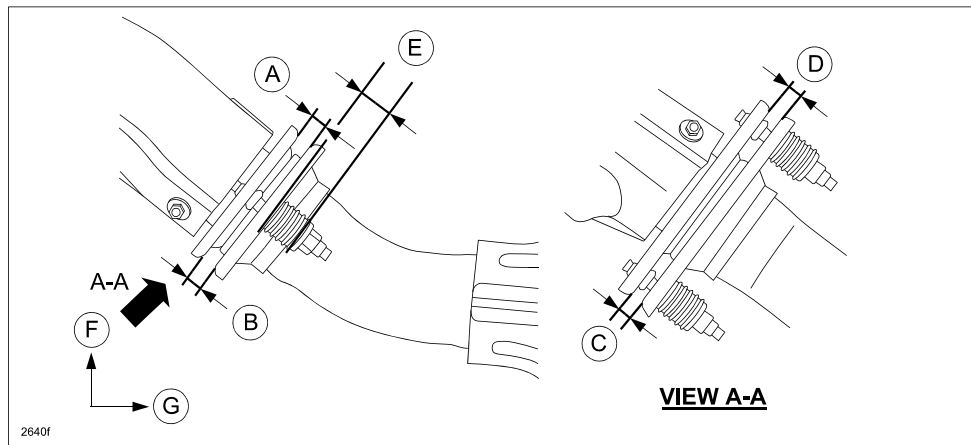
A	Upper	9-12 mm
B	Lower	7-10 mm
C	Right	6-9 mm
D	Left	6-9 mm
E	Spring length (end-to-end)	29-31 mm
F	Vehicle upper	
G	Vehicle lower

23. Measure the length and clearance between the flanges of the exhaust manifold and U/F catalytic converter. Verify that they are within the specification shown.

NOTE: If the clearance or spring length is out of range, verify the cause and repair.
