© 2012 Mazda Motor of America, Inc.

| Subject: DRIVER SEAT RATTLE NOISE WHEN STOPPING OR STARTING THE VEHICLE | Bulletin No: 09-043/12 |

APPLICABLE MODEL(S)/VINS

2011-2013 Mazda2 (with manual seat lifter)

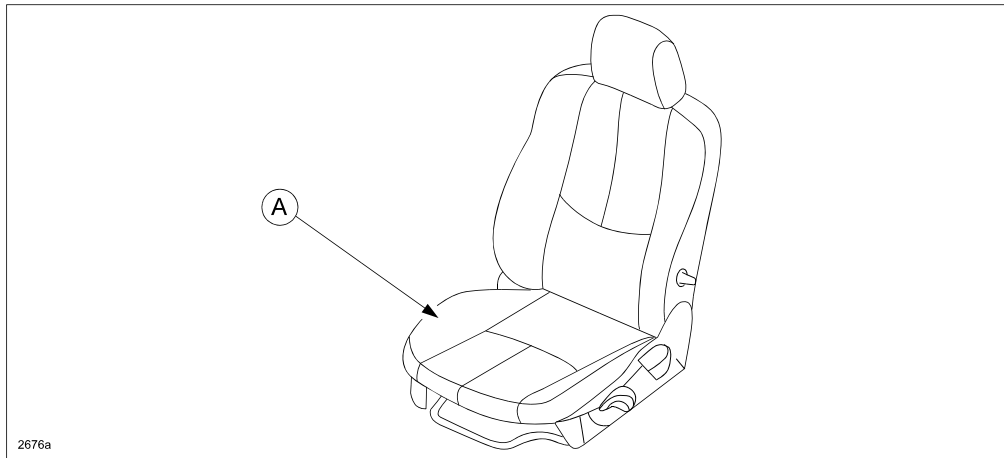
Some customer's may complain about a rattle noise in the driver's seat (A) when stopping or starting the vehicle. This rattle noise is caused by a gap between the seat frame and the link bracket. To correct the problem, a bracket and seat spring are attached to the inner and outer seat frames.
