© 2012 Mazda Motor of America, Inc.

<b>Subject:</b> <b>CONDENSATION / FOG IN FRONT AND REAR COMBINATION LIGHTS</b>	<b>Bulletin No:</b> 09-046/12
	<b>Last Issued:</b> 12/21/2012

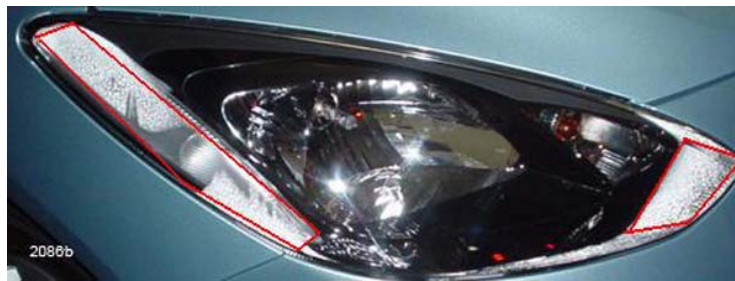
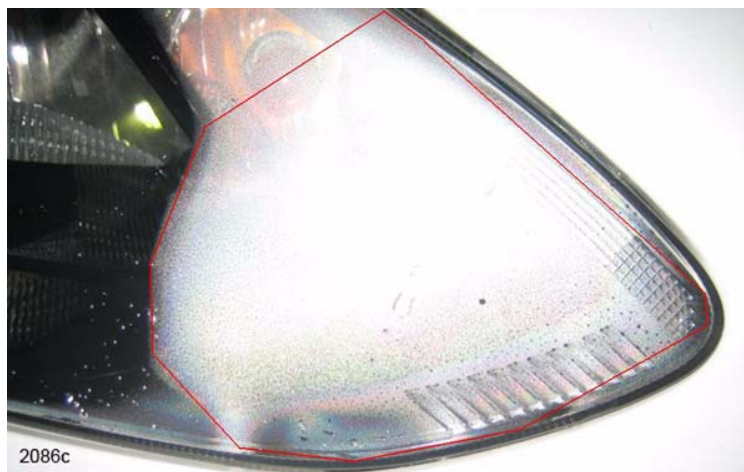
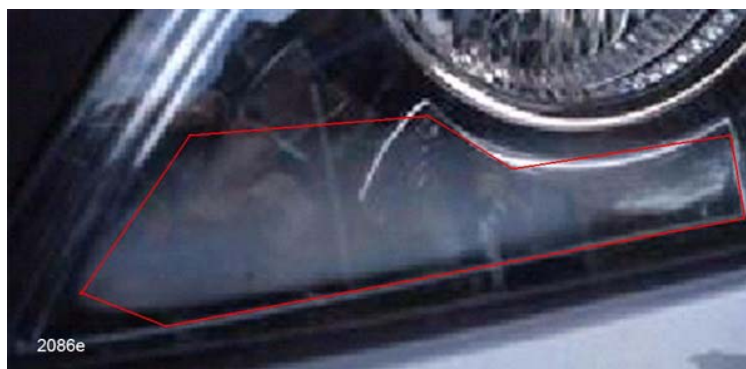
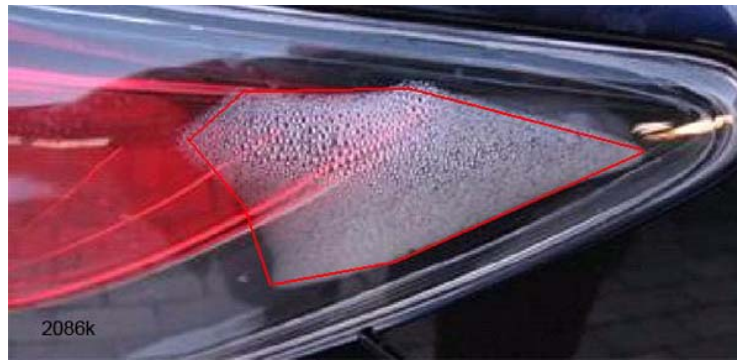
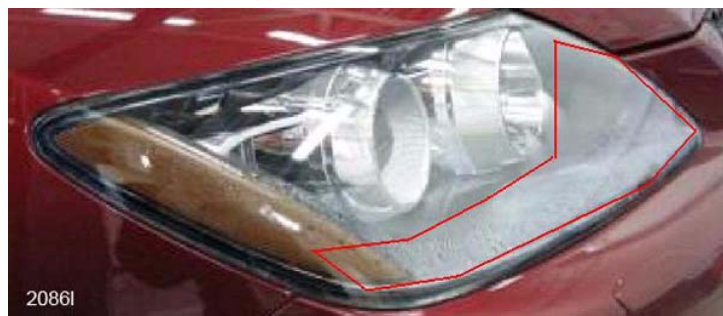
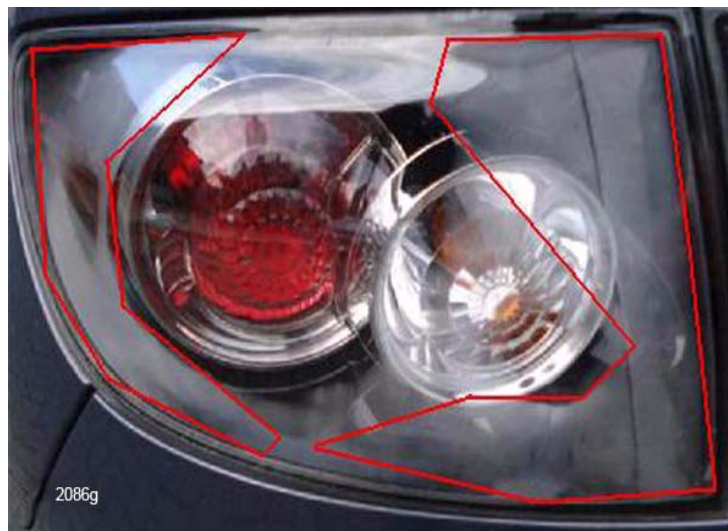
**Examples of Light Units With Condensation/Fog That Should NOT Be Replaced**

Condensation/fogging along the edges and in the corners is considered normal.

Explain to the customer that this is a natural phenomenon and not a quality defect. DO NOT attempt repairs as this is considered normal, and is NOT covered under Warranty. Replacing the light unit will not correct this symptom.

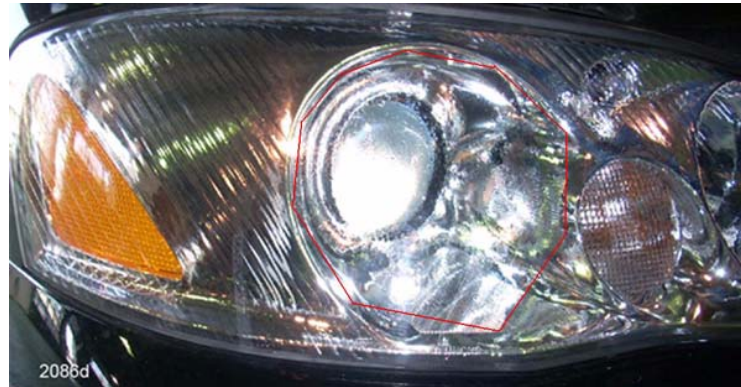
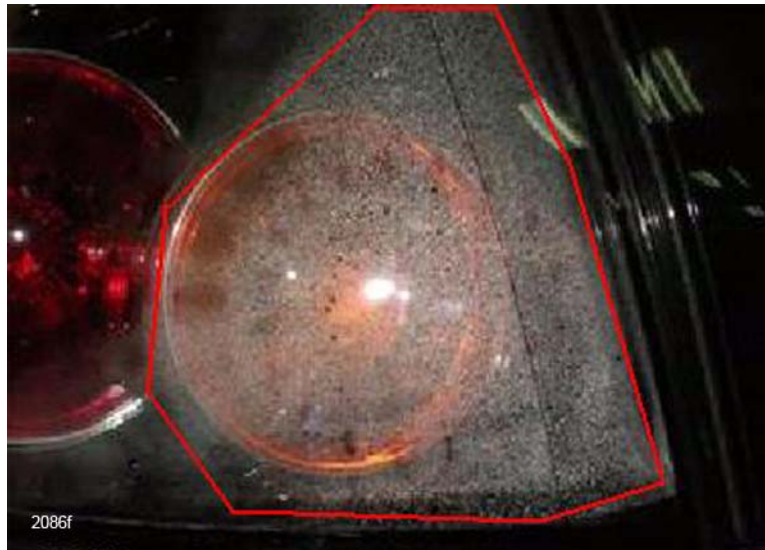
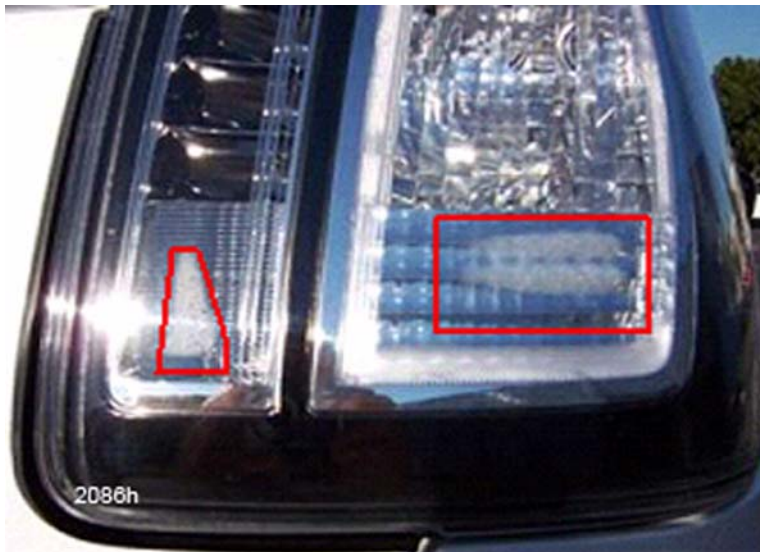
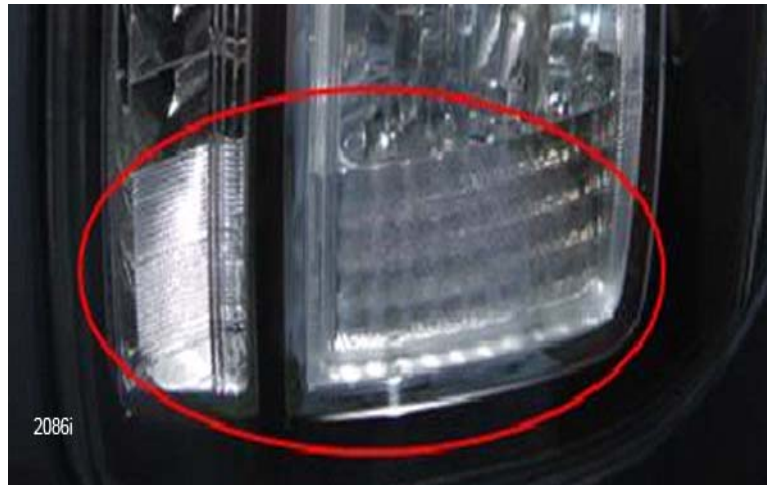
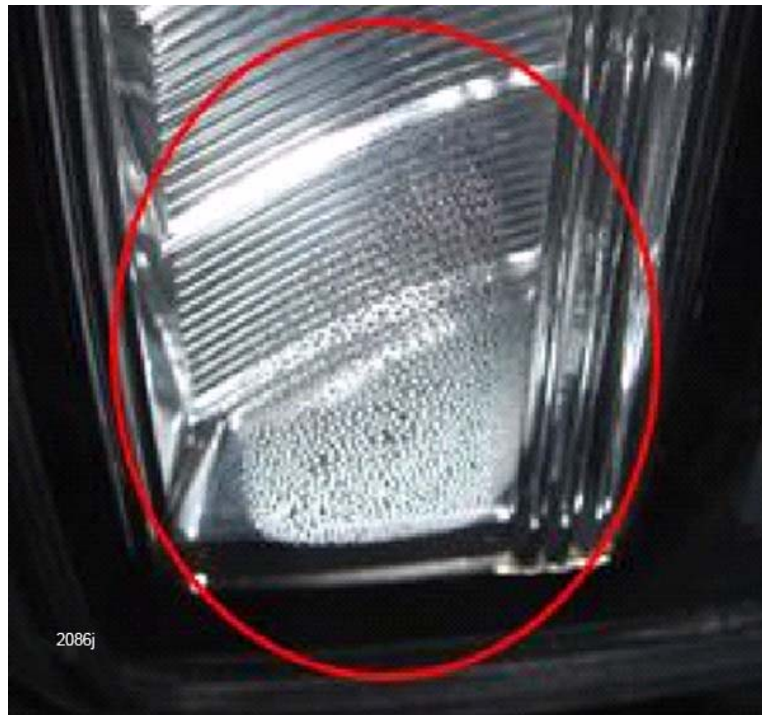
Some condensation/fogging on the lens is considered normal.

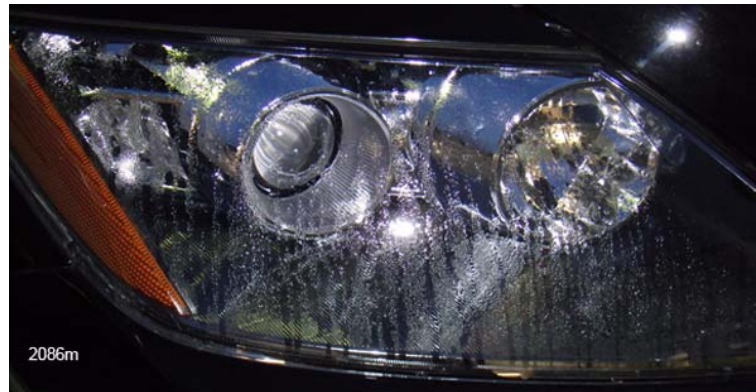
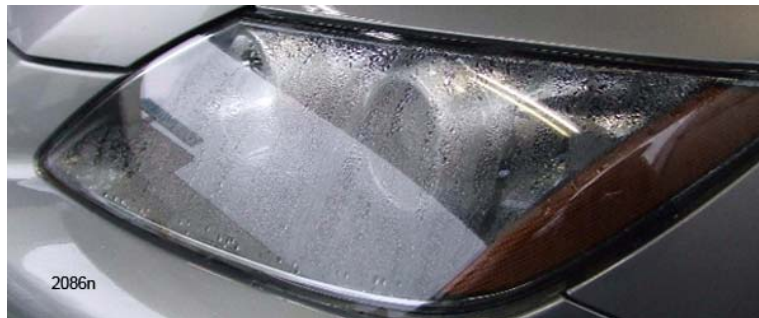
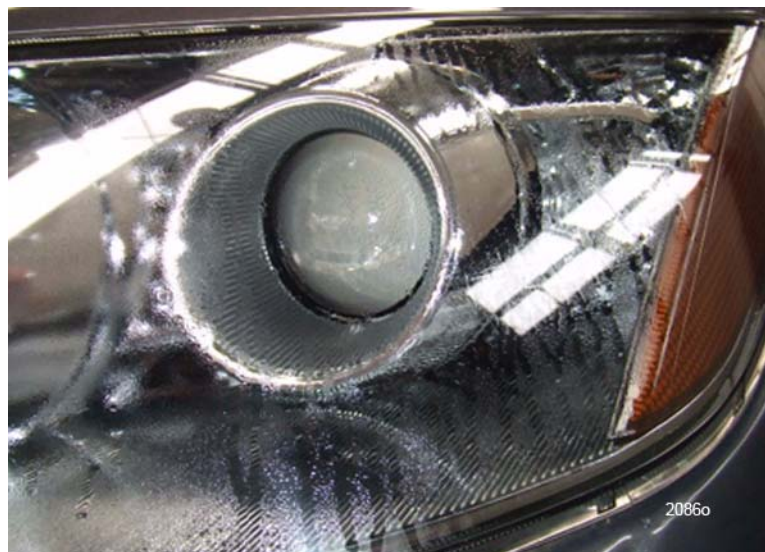
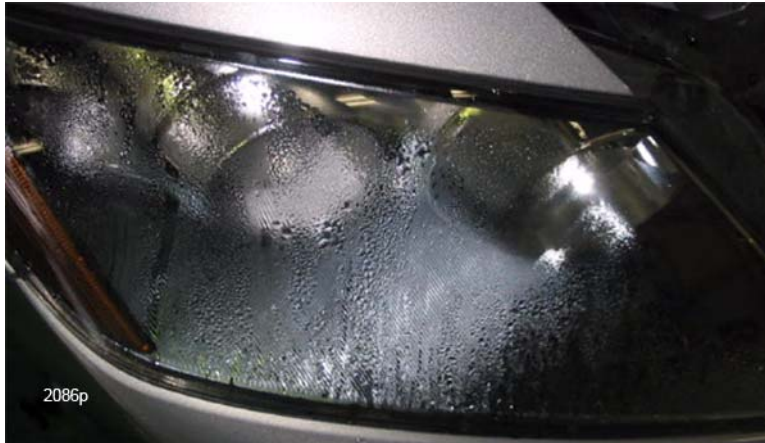
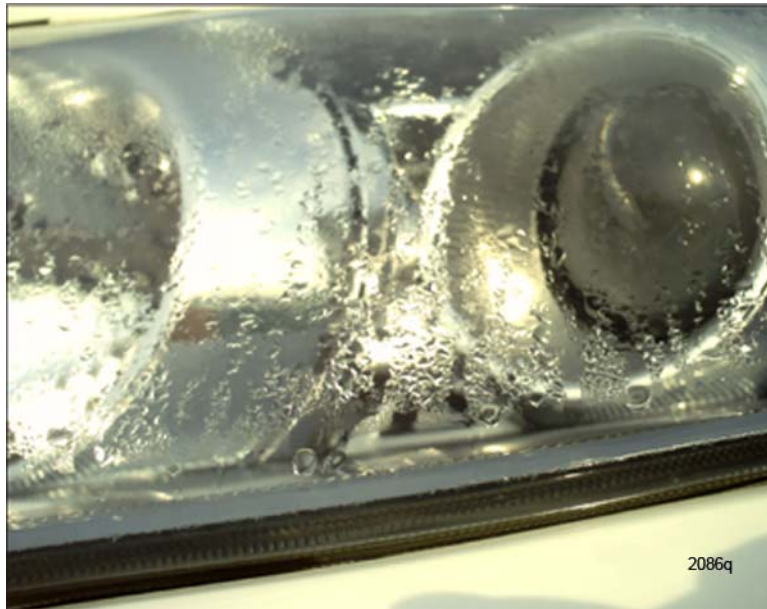
**Examples of Light Units With Condensation/Fog That Should Be Replaced**

Heavy/large amount of condensation on the lens is not normal.

- The location where the bulbs are fitted has a high air volume with good air circulation, therefore, if a large or heavy amount of condensation appears here, the light unit should be replaced. A small amount of condensation here is considered normal and should clear after the lights have been on for some time and the light unit should not be replaced. Refer to the following pictures for examples.
- If the outside conditions are unfavorable (cold and damp), even fog (dew concentration) as shown in the following pictures will take some time to clear up. Therefore, be careful in making a decision. A picture will be required with every claim for Warranty. If a light unit is found with no problem, and no picture is sent in, the claim may be later debited. You can also perform the following test to determine if the light unit should be replaced.

- If the condensation/fog clears, it is normal, and the light unit should not be replaced.
- If the condensation/fog does not clear, it is abnormal (water entry is suspected), and the light unit should be replaced.
