Subject: CONDENSATION / FOG IN FRONT AND REAR COMBINATION LIGHTS	Bulletin No: 09-007/14
	Last Issued: 01/24/2014

APPLICABLE MODEL(S)/VINS

2011-2014 Mazda2	2003-2015 Mazda6	2007-2012 Mazda CX-7
2004-2014 Mazda3	2006-2014 Mazda MX-5	2007-2014 Mazda CX-9
2006-2014 Mazda5	2013-2015 Mazda CX-5	2004-2011 Mazda RX-8

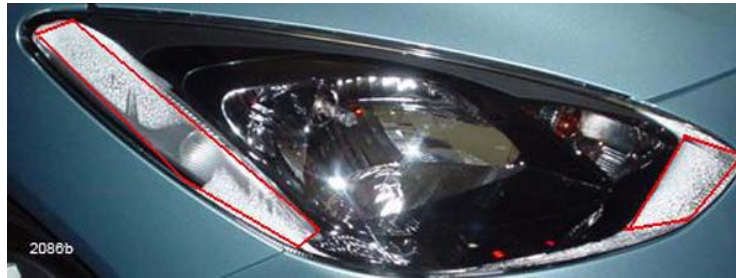
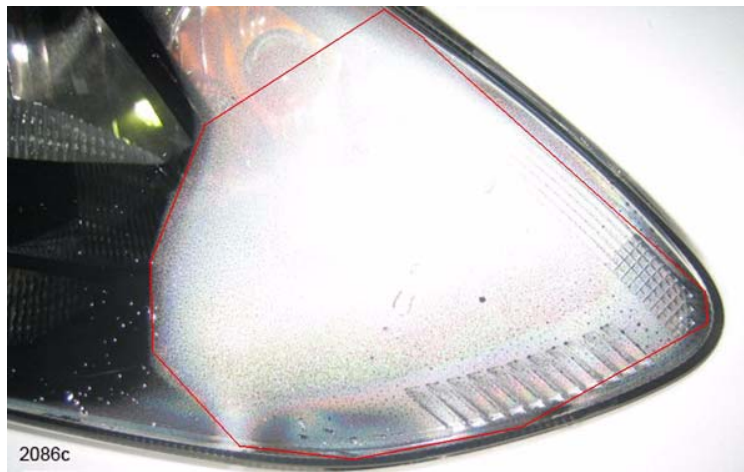
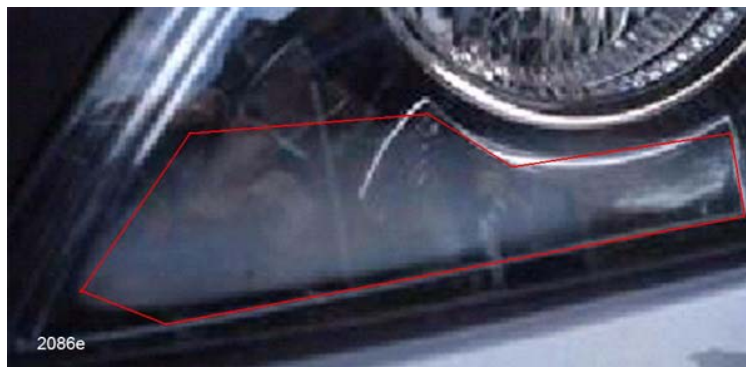
Examples of Light Units With Condensation/Fog That Should NOT Be Replaced

Condensation/fogging along the edges and in the corners is considered normal.

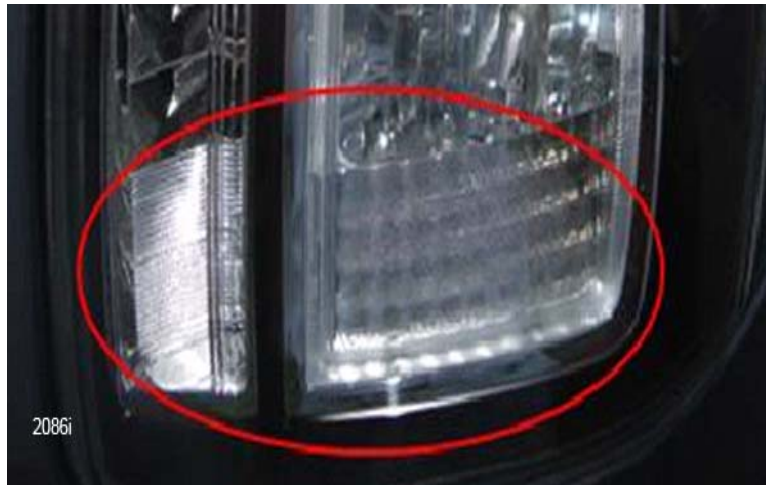
Some condensation/fogging on the lens is considered normal.
