Subject: SHIFT SHOCK - TRANSMISSION CONTROL MODULE (TCM) REFLASH	Bulletin No: 05-007/14
	Last Issued: 04/30/2014

All 2002 - 2003 MPV with VINs up to JM3LW28**30367821

DESCRIPTION

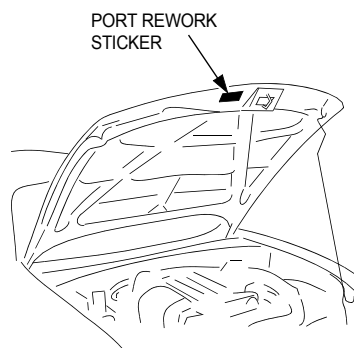
Inspect the vehicle for a "Port Campaign" rework sticker affixed to the underside of the hood.

- If a "Port Campaign" rework sticker with the number "04/B0/02" is affixed to the hood, the TCM Re-flash has already been performed at the port. DO NOT re-flash the TCM. Use M-MDS to check for DTCs and repair the ATX according to the workshop manual.
- If there is no "Port Campaign" rework sticker affixed to the hood, perform the TCM Re-flash. Proceed to the "REPAIR PROCEDURE".
