<b>Subject:</b> <b>CHECK ENGINE LIGHT AND AUTOMATIC TRANSAXLE WARNING LIGHT ON WITH DTC P0842, P0847, P0872, P0877, P0780, AND/OR P1738 STORED IN TCM MEMORY</b>	<b>Bulletin No:</b> 05-005/14
	<b>Last Issued:</b> 04/29/2014

2012-2014 Mazda3 (with SKYACTIV 6AT)

2013-2015 CX-5 (with SKYACTIV 6AT)

2014-2015 Mazda6 (with SKYACTIV 6AT)

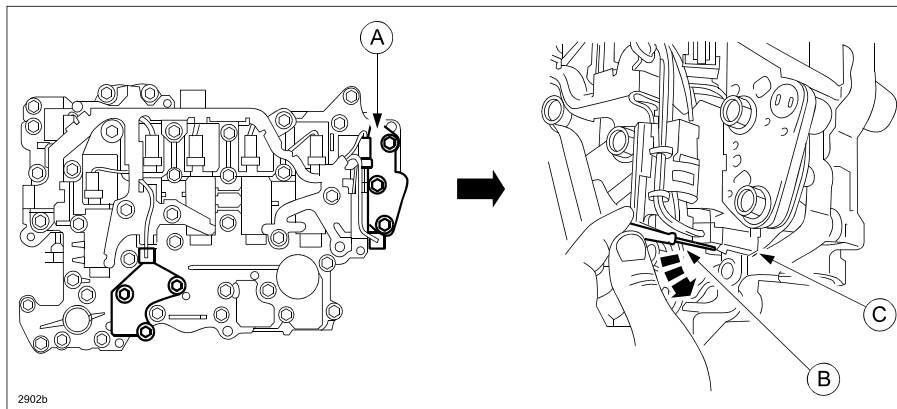
This is caused by the oil pressure switch A and/or B at the control valve body temporarily or permanently getting stuck due to contamination entering the passage. To correct the problem, some mass production changes have been implemented to reduce contamination and improve the DTC diagnostic logic.

5. Remove oil pressure switch A.  
a. At oil pressure switch A, insert a precision flathead screwdriver (B) and move it in the direction of the arrow in the figure to disconnect the oil pressure switch A connector (C).
