| <b>Subject:</b><br><br><p style="text-align: center;"><b>CHECK ENGINE LIGHT ON WITH DTC P0456</b></p> | <b>Bulletin No:</b> 01-014/14 |
| | <b>Last Issued:</b> 06/10/2014 |

2011-2013 Mazda3

2007-2014 CX-9

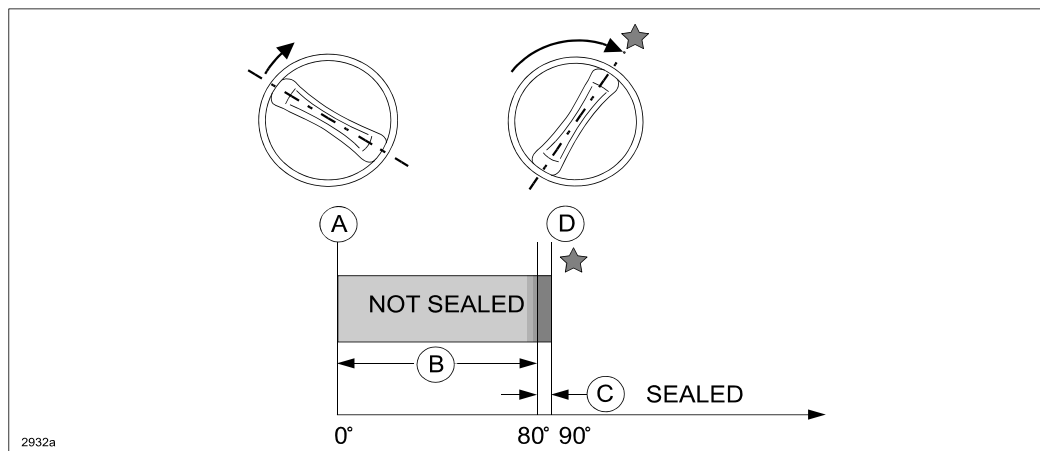
2932a

- **DO NOT** replace any parts without detecting a leak using MS3 / Workshop Manual diagnostics.
- **Explain to the customer that the fuel cap must be turned at least 80 degrees (C) or until two (2) or more click sounds are heard (D) to be properly sealed.**
- If the fuel cap is not completely closed, it may stay in the B range, (because the C range is so small) and will likely leak.

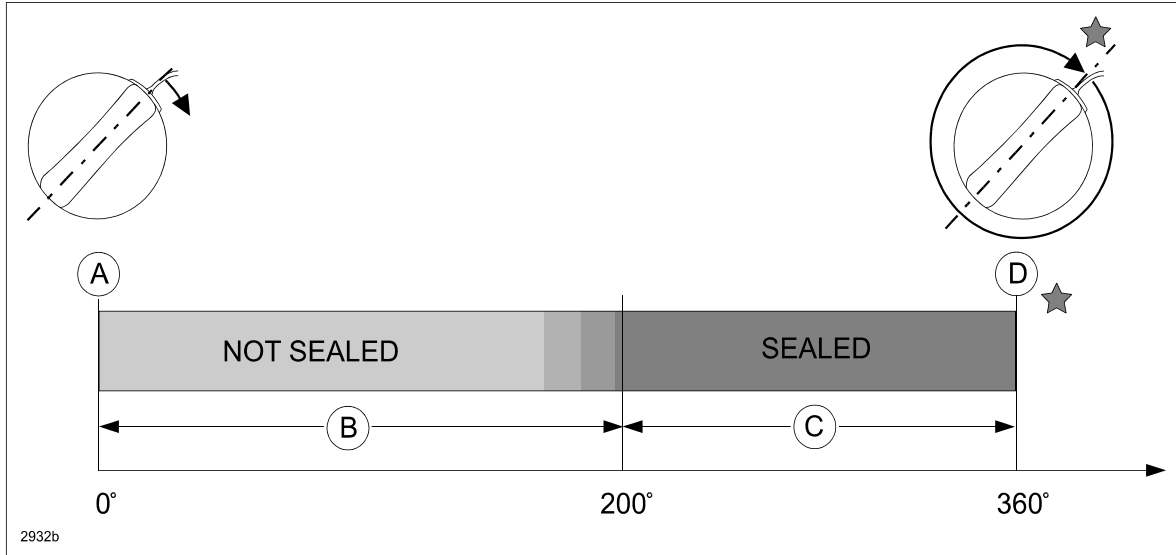
- If the fuel cap is turned less than 200 degrees (B), it is not sealed.
- If the fuel cap is turned between 200 ~ 360 degrees (C), it is sealed.
- If the fuel cap is turned 360 degrees or more, it is sealed and a clicking noise (D) is also heard.

**NOTE:** The fuel cap may stay within the (C) range, since it is a large range. A leak is unlikely to occur, even if the fuel cap was not closed completely (until clicking sound is heard (D)).
