Subject: INFORMATION DISPLAY SHOWS "FOW INSPECTION REQUIRED" AND DTC C1A67:78 IS STORED	Bulletin No: 01-016/14
	Last Issued: 07/08/2014

2014 Mazda6 vehicles with VINs lower than JM1 GJ ***** 149082 (produced before October 01, 2013)

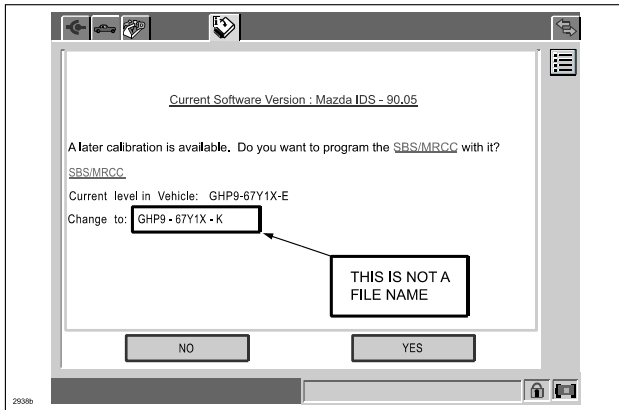
Figure 1: Subject for VCM reprogramming

- b. Either of the following screens (Figure 1 or 2) is displayed.
- If the Figure 1 is displayed, the VCM is before the latest calibration. Click “YES” and follow the M-MDS instructions to reprogram the VCM.
 - If the Figure 2 is displayed, the VCM is already the latest calibration. This Service Information does not apply and refer to Workshop Manual for troubleshooting and repair.

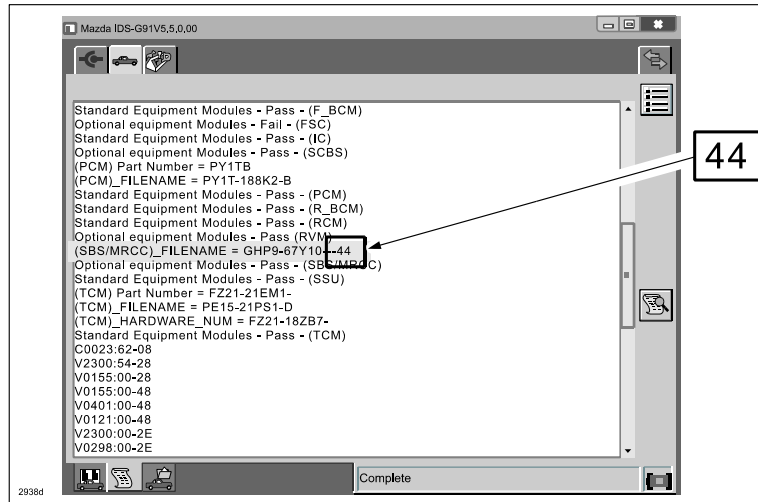
- c. After reprogramming, close the session. Then, open a new session and go to the “Log Viewer” screen. The programmed file name is displayed as shown in figure below. If the last two letters are “44”, the reprogramming has been successfully completed.
