Service Bulletin Mazda North American Operations

SEAT CUSHION TRIM COMING APART AT SEAMS - (CLOTH SEATS ONLY)

Bulletin No: 09-029/14

2010-2013 Mazda6 vehicles equipped with cloth seats

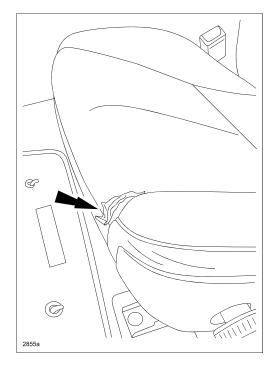
Some vehicles may exhibit a condition where the front and/or rear seat cushion trim is coming apart at the seams.

Seat cushion trim(s) with increased strength are available to eliminate this concern.

- 1. Verify the customer concern.
- 2. Replace only the affected seat cushion trim(s) with a new one according to the instructions on MS3 online or the Workshop Manual (section 09-13 FRONT SEAT CUSHION TRIM REMOVAL/INSTALLATION) and/or (section 09-13 REAR SEAT CUSHION TRIM REMOVAL/INSTALLATION).
- 3. Verify the repair.
