TECHNICAL BULLETIN
K404 UPS4616-4bNAS1
24 JUN 2016

SECTION: 303-03C

Update Prior to Sale: V6 Petrol Coolant Hose Chafe

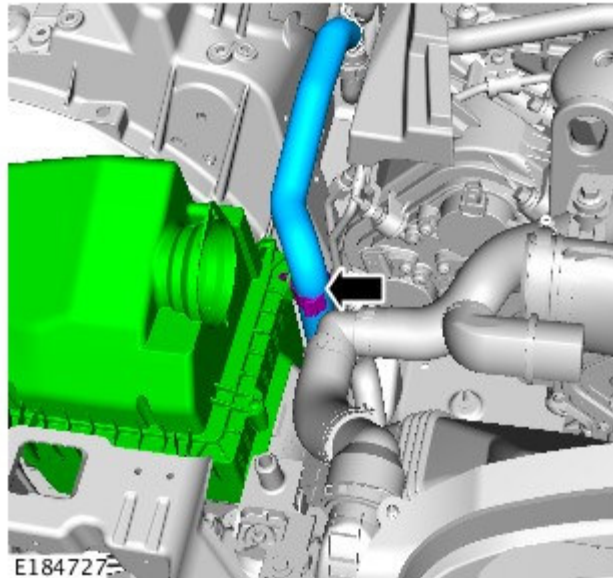
2. **NOTE: Components removed for clarity.**

Check that the fir tree clip for the coolant hose is installed and located and secure on the right-hand air cleaner.

- If the fir tree clip for the coolant hose is installed on the right-hand air cleaner and not securely attached to the coolant hose, check the coolant hose for damage.
 - If the coolant hose is not damaged, latch the coolant hose into the fir tree clip, and release the vehicle. No further action required.
 - If the coolant hose is damaged, continue to Step 3.

- If the fir tree clip for the coolant hose is installed on the right-hand air cleaner and securely attached to the coolant hose, release the vehicle. No further action required.
