Technical Service Bulletin

SUBJECT:		No: TSB-17-31-001	
ILLUMINATED TPMS WARNING LIGHT		DATE: February, 2017	
		MODEL: 2016-17 Outlander	
CIRCULATE TO:	<input type="checkbox"/> GENERAL MANAGER	<input checked="" type="checkbox"/> PARTS MANAGER	<input checked="" type="checkbox"/> TECHNICIAN
<input checked="" type="checkbox"/> SERVICE ADVISOR	<input checked="" type="checkbox"/> SERVICE MANAGER	<input checked="" type="checkbox"/> WARRANTY PROCESSOR	<input type="checkbox"/> SALES MANAGER

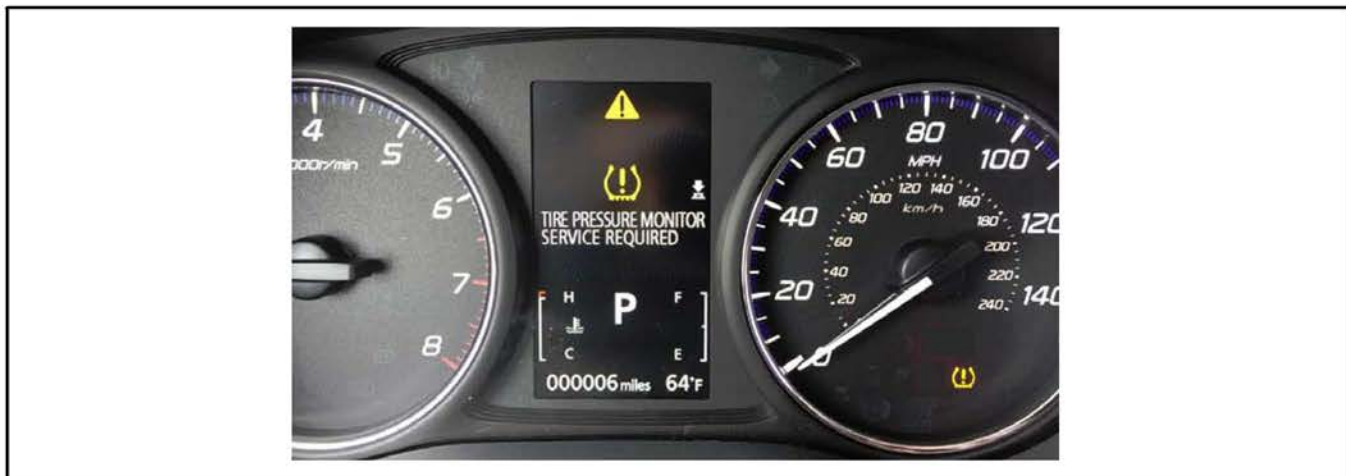
When the 12V auxiliary battery voltage becomes abnormally low, or completely goes dead, and subsequently the 12V auxiliary battery is recharged or the vehicle is jump-started, the TPMS warning light will start flashing for about 1 minute and 20 seconds, and then remains ON after engine start-up. The MID display will also read "TIRE PRESSURE MONITOR SERVICE REQUIRED." An initial check of DTCs (Diagnostic Trouble Codes) may indicate low voltage DTCs, but even after all DTCs are erased, the TPMS warning light remains ON.

This TSB instructs dealers to reprogram the ETACS ECU (with MUT3-SE) to resolve the issue.
