FORD:

2011-2015 Explorer

This article supersedes TSB **14-16-NA** and **14-04-NA** to update the Service Procedure.

ISSUE

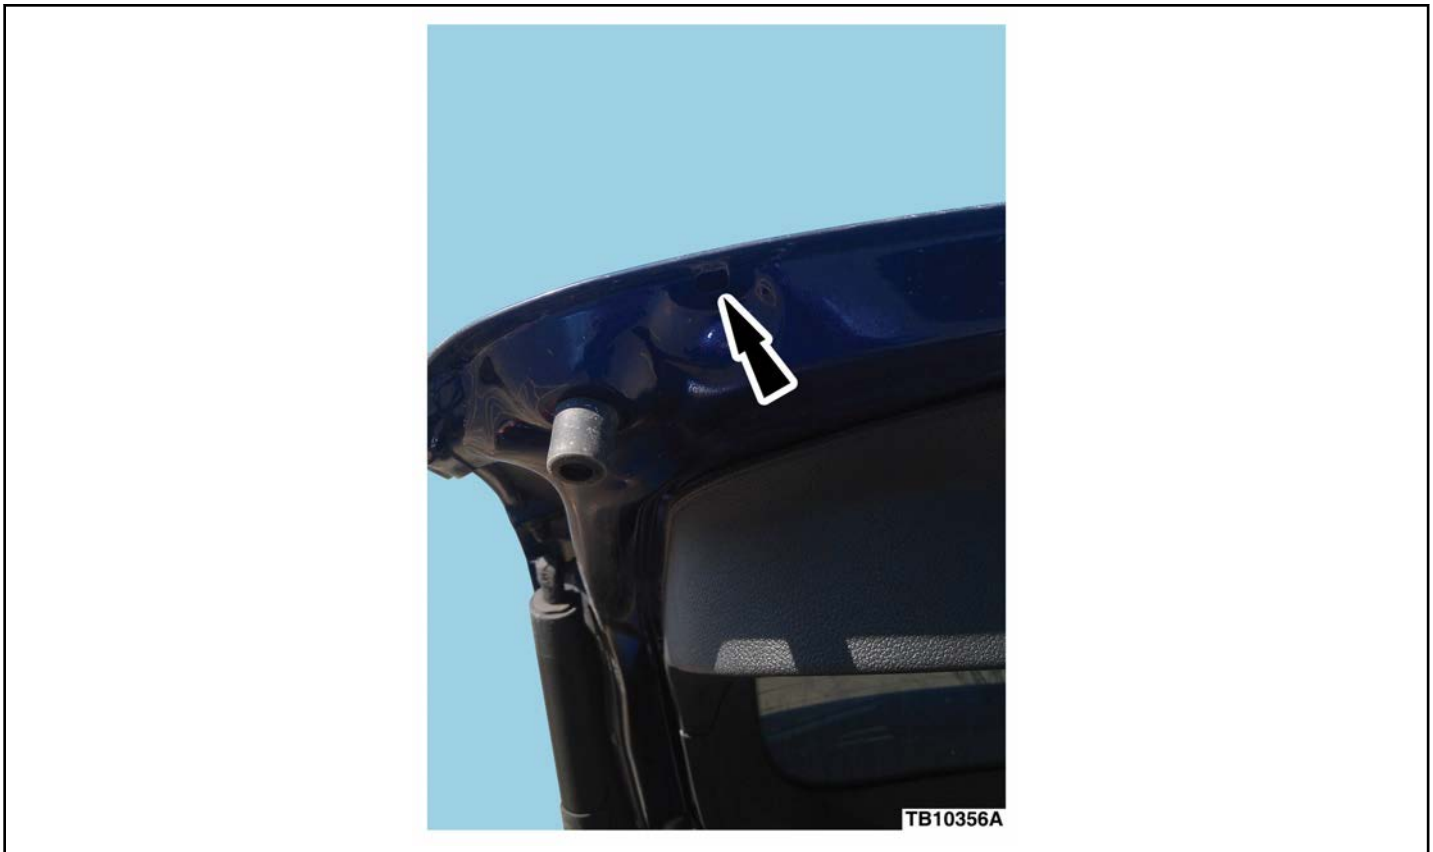
Figure 1 - Article 17-0029

1. Remove the rear bumper cover. Refer to Workshop Manual (WSM), Section 501-19.
2. Remove the left and right tail lamps. Refer to WSM, Section 417-01.
3. Remove the wheel lip mouldings. Refer to WSM, Section 501-08.
4. Open the liftgate and inspect for presence of drain valves in the two (2) drain holes on the left and right side of the liftgate. Are the drain valves present? (Figure 1)

- a. Yes - proceed to Step 6.
 - b. No - proceed to Step 5.
5. Install a new drain valve in each of the two (2) drain holes on the left and right side of the liftgate. (Figure 1)
 6. Inspect the liftgate seal for damage and proper fit/contact pattern. Adjusting the rear liftgate striker so that the rear hatch seals tighter to the liftgate seal is important. This can be done by loosening the striker and moving it to increase the liftgate sealing pressure.
 7. Inspect the left and right side air extractors for proper fit to the body and operation/sealing of the rubber flaps.
 - a. Replace the air extractor if it is warped or damaged or flaps do not lay flush to their sealing surface. (Figure 2)

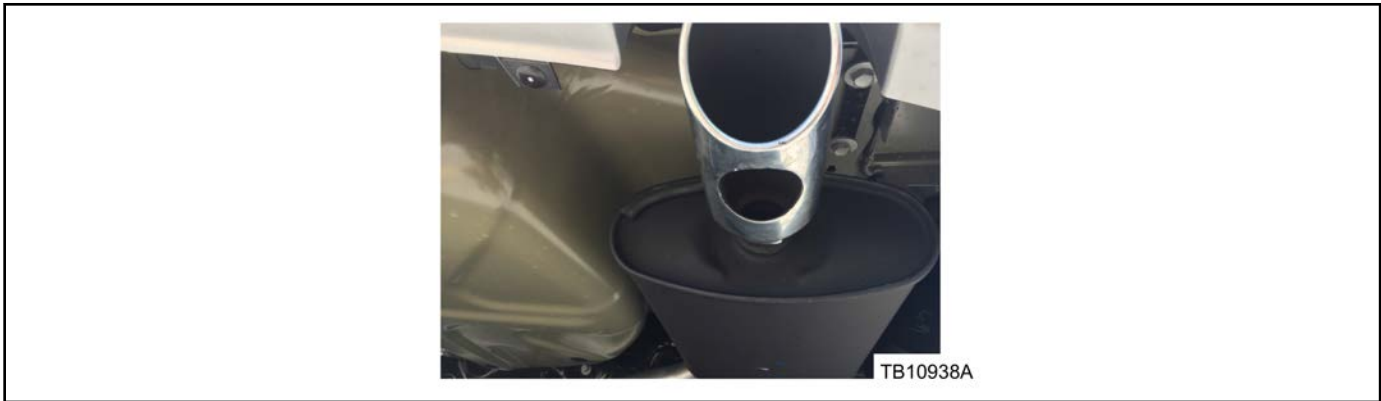
Figure 8 - Article 17-0029

18. Inspect the exhaust tips. Are down turned exhaust tips present? (Figure 8)
 - a. Yes - proceed to Step 19.
 - b. No - remove the rear section of the exhaust system and proceed to Step 20. Refer to WSM, Section 309-00.

- a. Yes - inform the customer of the redesigned exhaust tips and that appearance will remain the same but the exhaust will exit the tip from bottom. Upon acceptance, replace the muffler assembly with the updated part containing the down turned exhaust tips. Refer to WSM, Section 309-00. (Figures 7-8)
