Subject: OIL SEEPAGE FROM POWER STEERING OIL PRESSURE SWITCH	Bulletin No: 06-003/14
	Last Issued: 12/18/2014

2010-2015 CX-9

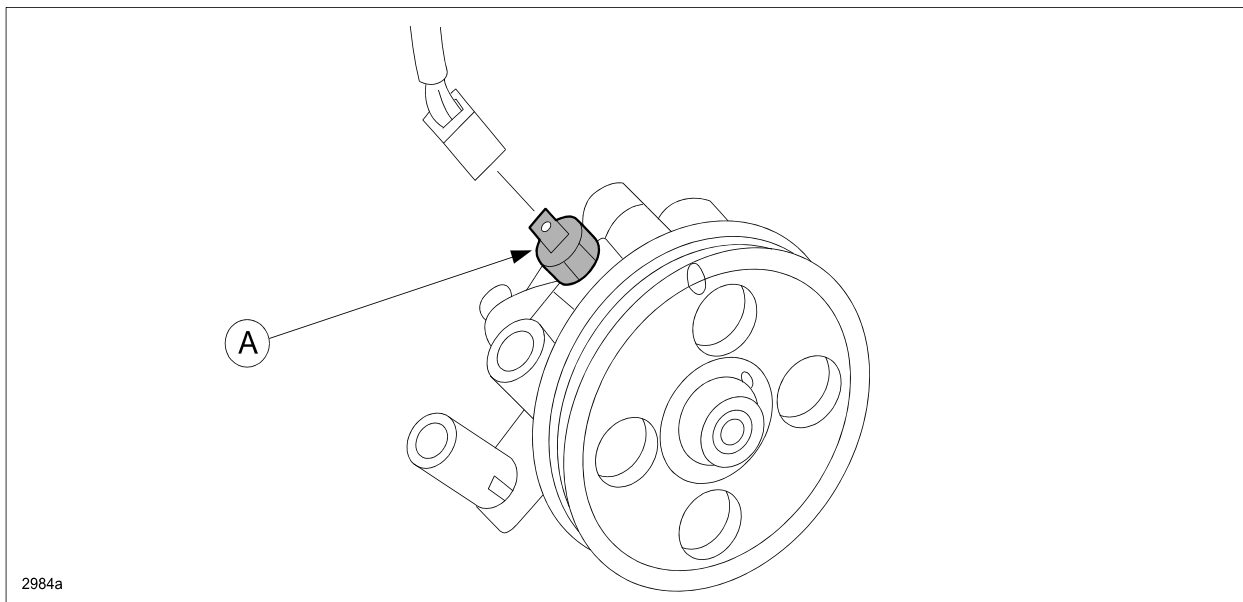
Some vehicles may exhibit an abnormal steering feel and/or noise while driving the vehicle in freezing temperatures, however, there is no loss of steering control.

This may be due to oil seepage from the power steering oil pump pressure switch (A).

The oil seepage is caused by poor sealing of the oil pressure switch o-ring at low temperature. The shape and material of the o-ring has been changed to improve low temperature sealing performance.

1. Verify the customer concern.
2. Replace the power steering oil pump pressure switch with a modified part according to the instructions on MS3 online or the Workshop Manual (section 06-14 POWER STEERING OIL PUMP DISSASSEMBLY/ ASSEMBLY).
