# **Service Bulletin**

MIL ILLUMINATION WITH DTCs P219A:00 AND/OR P219B:00

2011-2015 CX-9

<b>Bulletin No:</b> 01-006/15	Last Issued: 04/24/2015
© 2015 Mazda Motor of America, Inc.

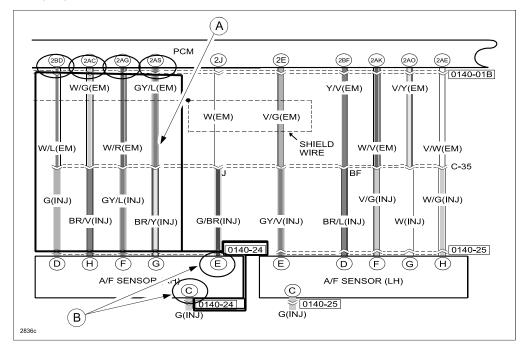
- (A) = Install short cord
- (B) = A/F Sensor (RH) terminals C and E

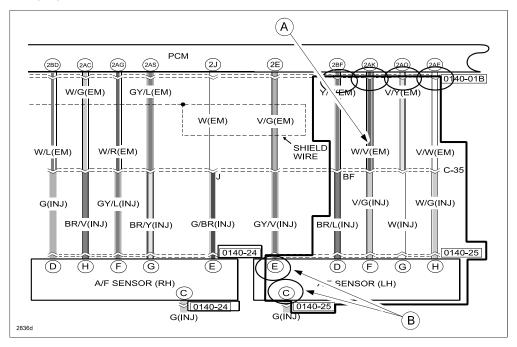
- (A) = Install short cord
- (B) = A/F Sensor (LH) terminals C and E
