<b>Subject:</b> REPLACEMENT PROCEDURES FOR THE TRANSFER OIL SEALS (RIGHT SIDE)	<b>Bulletin No:</b> 03-005/15
	<b>Last Issued:</b> 02/27/2015

2010-2015 CX-9 equipped with AWD

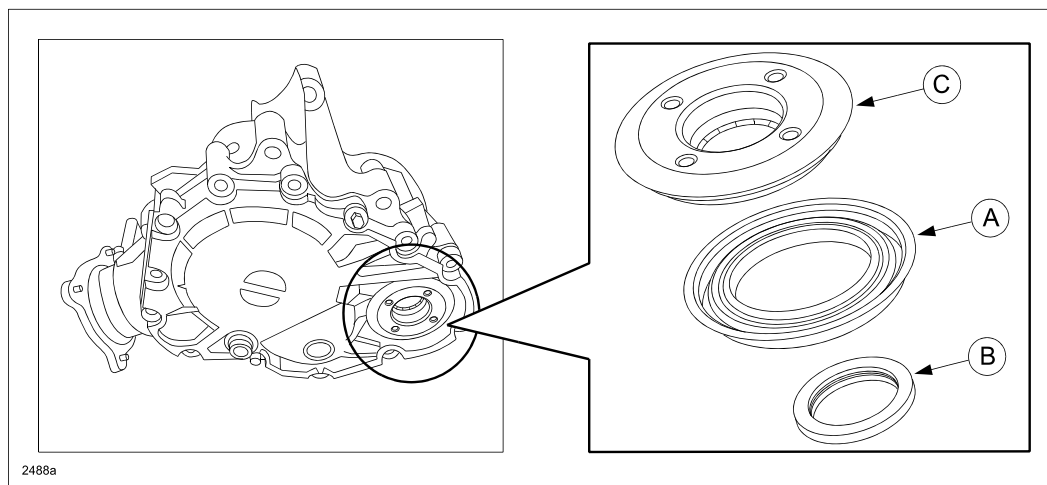
If replacement of the right side (RH) transfer oil seal (A), and transfer dust seal (B) are necessary, use the following REPAIR PROCEDURE to install the new oil seals.

**NOTE:** Deflector (C) may not be reused.

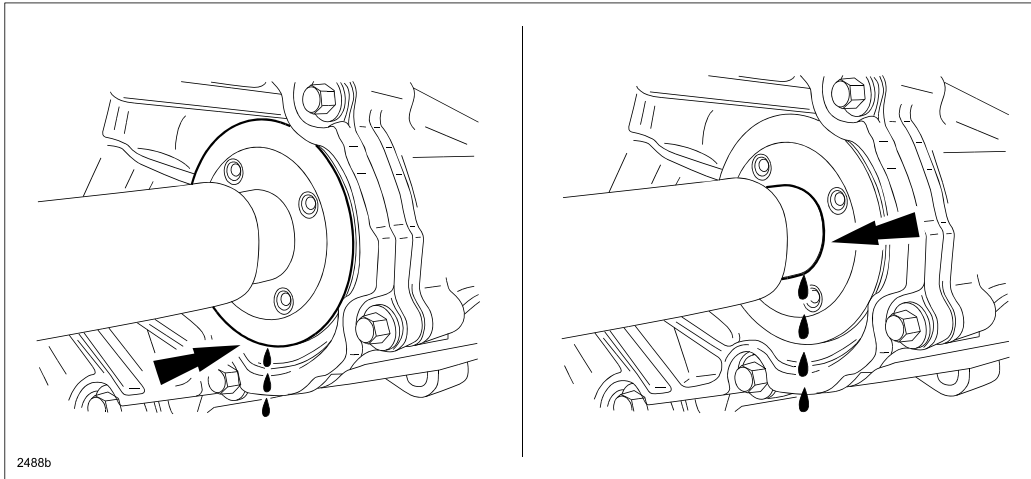
1. Lift the vehicle. For additional information, refer to MS3 online or Workshop Manual (section 00-00 JACKING POSITIONS, VEHICLE LIFT (2 SUPPORTS) AND SAFETY STAND (RIGID RACK) POSITIONS).
2. Is there a fluid leak from the RH side of the transfer?

- Yes - Proceed to Step 3.
  - No - This bulletin does not apply. Refer to normal Workshop Manual diagnosis.
3. Inspect the transfer vent located on top of the transfer. Is the transfer vent restricted (mud/debris)?
    - Yes - Clear external restrictions from the transfer vent and proceed to step 25.
    - No - Proceed to step 4.
  4. What is the color of the fluid leak?
    - Tan/brown/black (transfer gear oil leak) - Proceed to Step 5.
    - Red ATF leak - This bulletin does not apply. Red ATF leak indicates the transaxle seal is leaking and needs to be replaced. Refer to MS3 online or Workshop Manual (section 05-17 OIL SEAL (DIFFERENTIAL) REPLACEMENT [AY6A-EL, AY6AX-EL]).
  5. Remove the RH wheel.
  6. Remove the RH side cover.
