Subject: OPERATIONAL CONCERNS WHEN PLAYING A MEDIA DEVICE (IPOD, USB MEMORY STICK, ETC.) CONNECTED VIA USB	Bulletin No: 09-008/15
	Last Issued: 02/23/2015

2013 Mazda3

2013-15 CX-5

2014-15 Mazda6

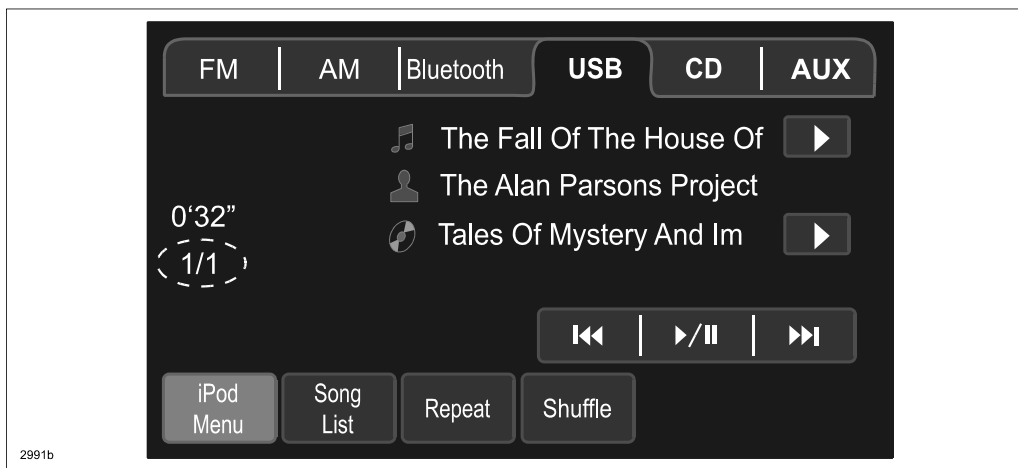
1. Playback will start with the song that was last playing in the vehicle, even if the device was playing a different track outside the vehicle.
2. After the ignition is turned ON, the screen will display “1/1” instead of “1/12” (for example). “1/1” will continuously be displayed until loading is completed.

NOTE: A device with a large number of files will take longer to catalogue (and load) than one with a smaller number of files.

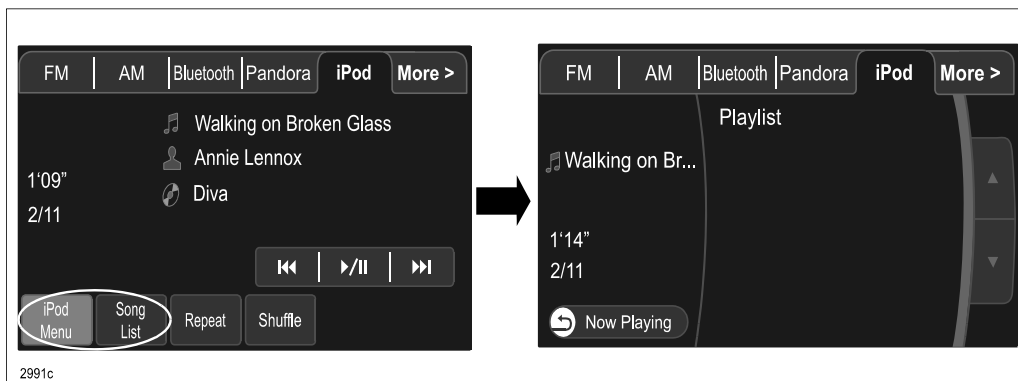
3. A blank playlist is displayed if the iPod menu or the Song List button is tapped during cataloguing. The screen will not change automatically, even after the cataloguing is finished. If the iPod Menu or the Song List button is tapped again, the display returns to normal.

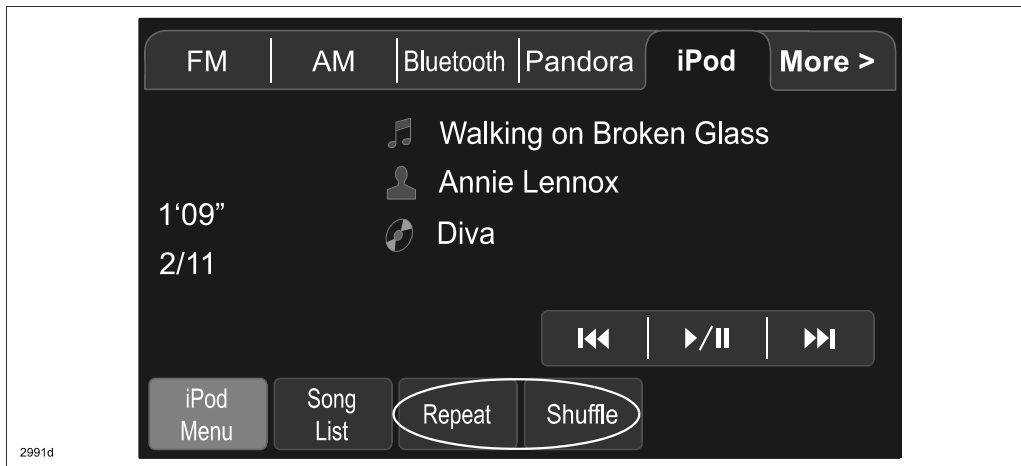
- RPT (Repeat) and RDM (Shuffle) do not function during cataloguing, and selection of Playlist/Artist/Album/Genres using Voice Recognition is not possible.

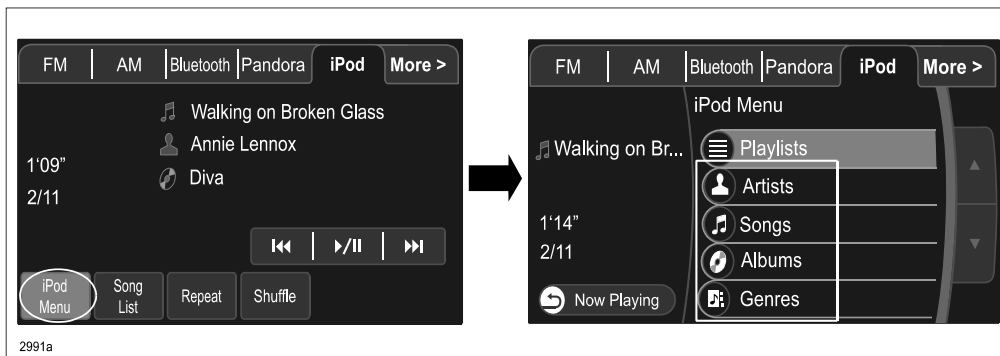
- Playback will start from the first song on the device after the ignition is turned OFF if you select the Playlist category of the iPod menu. To start playback from the last playing song after the ignition is turned OFF, select a different category other than Playlists, such as Artists, Songs, etc.

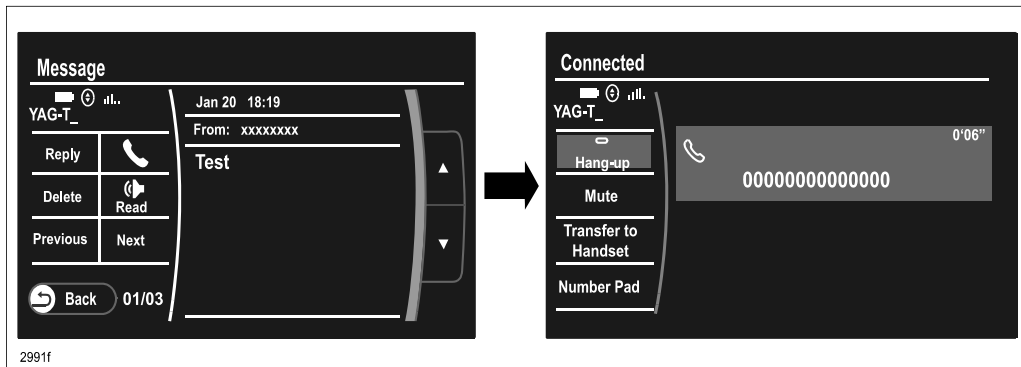
- **When a SMS is received from a telephone number registered in the contact list:**
 - Calls cannot be made by pushing the “Receiver” button. “000000000000” is displayed on the screen.

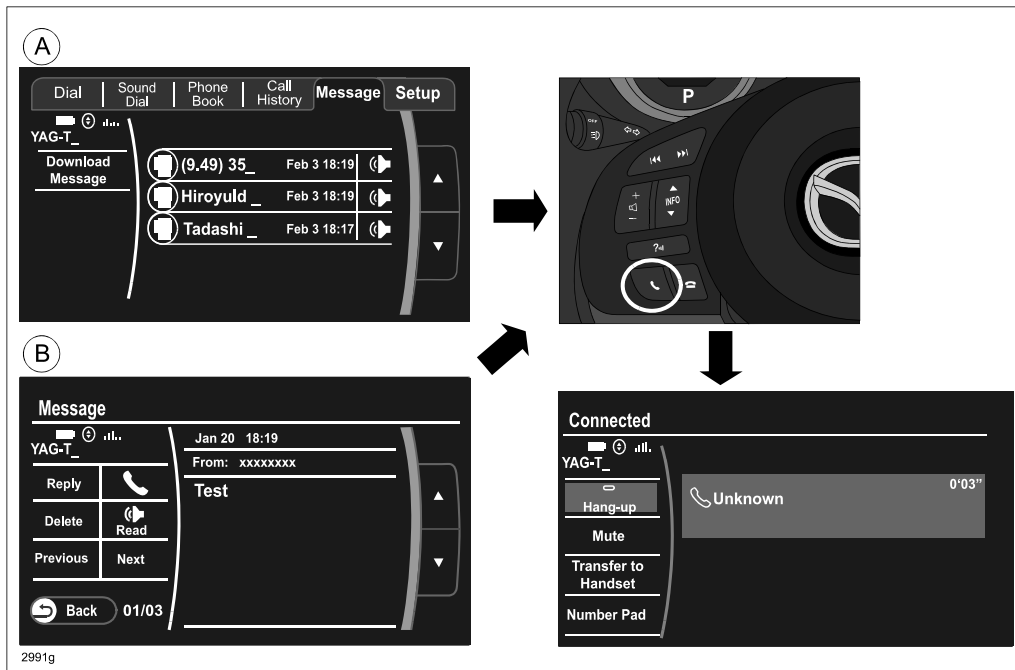
- Calls cannot be made even if you touch the “Speaker” button on the “Message” screen (A) or the “MessageRead” screen (B) and then push the pick-up button during VoicePrompt. No telephone number (Unknown) is displayed on the “Calling” screen.

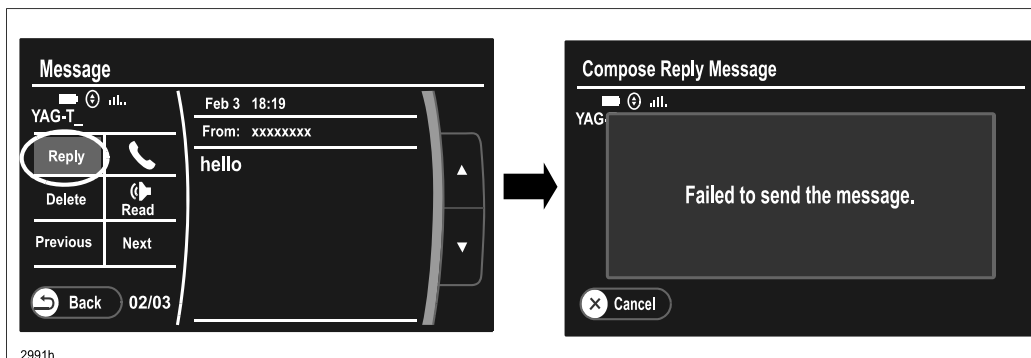
- The “Reply” button on the “Message” screen cannot be used (does not function).

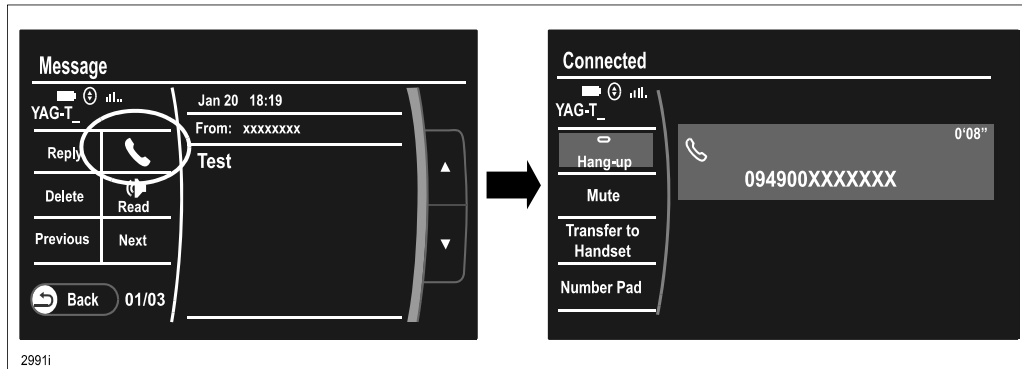
- **When a SMS is received from a telephone number NOT registered in the contact list:**
 - The system will dial an incorrect telephone number if you push the “Receiver” button on the “Message” screen,.

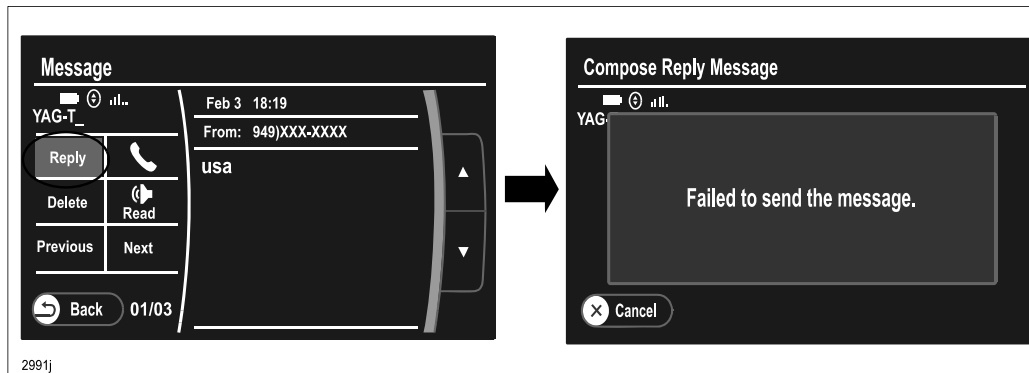
- The “Reply” button on the “MessageRead” screen does not function (Restriction by iPhone).
