<b>Subject:</b> RATTLE AND/OR WIND NOISE FROM FRONT DOOR GLASS AREA	<b>Bulletin No:</b> 09-017/16
	<b>Last Issued:</b> 03/17/2016

2007-2015 CX-9

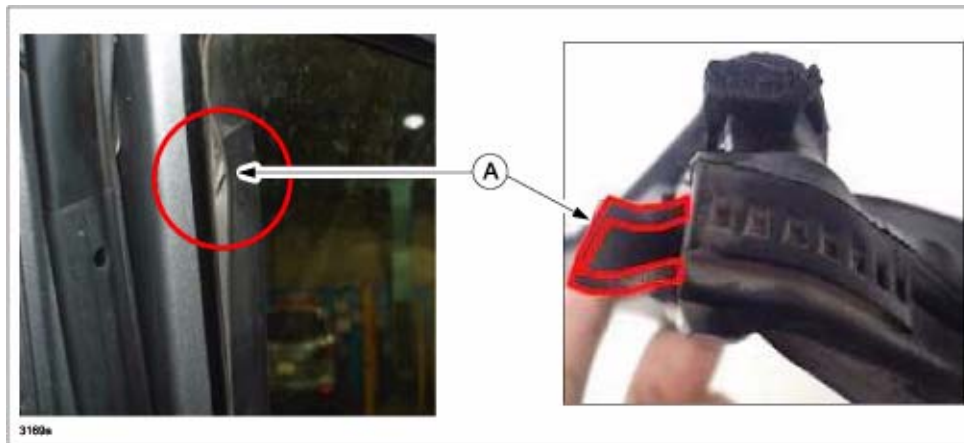
Some vehicles may exhibit a rattle noise and/or wind noise from the front door glass area while driving the vehicle. This is caused by a deformed glass run channel (A). The deformed area is located at the upper rear corner of the run channel and is caused by repeated door glass closures in very hot climates. The deformed area causes poor contact between the glass run channel and the door sash, which results in rattle noise and/or wind noise.

Customers having this concern should have their vehicle repaired using the following repair procedure.
