Reference	SSM72203
Models	Discovery Sport / L550 Range Rover Evoque / L538
Title	Sd card fails to initialise
Category	Electrical
Last modified	04-Mar-2015 00:00:00
Symptom	207000 Entertainment Systems
Attachments	SD Card Inspection.pdf
Content	Issue: SD card fails to initialise

SD Card Visual Inspection

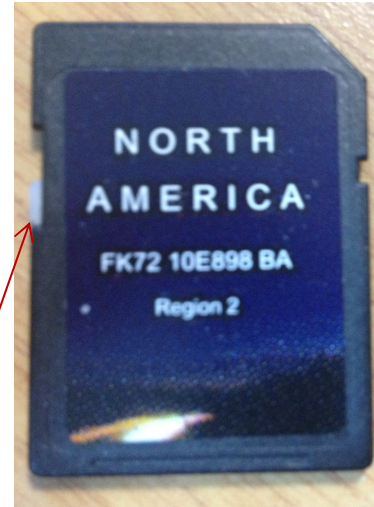
Locked

Cause: This issue may be caused by the SD micro switch being in the wrong position (i.e. Locked) when the SD card is in locked position the head unit may not detect the card.

Action: To check the SD switch position is always in the unlock position as per attachments,
If the SD card is found with the switch in the wrong position correct the switch position and reinsert into SD card slot and carry out the following process.
