Subject: NOISE FROM FUEL TANK INSULATOR	Bulletin No: 01-010/15
	Last Issued: 05/26/2015

2010-2015 CX-9 vehicles produced before April 1, 2015

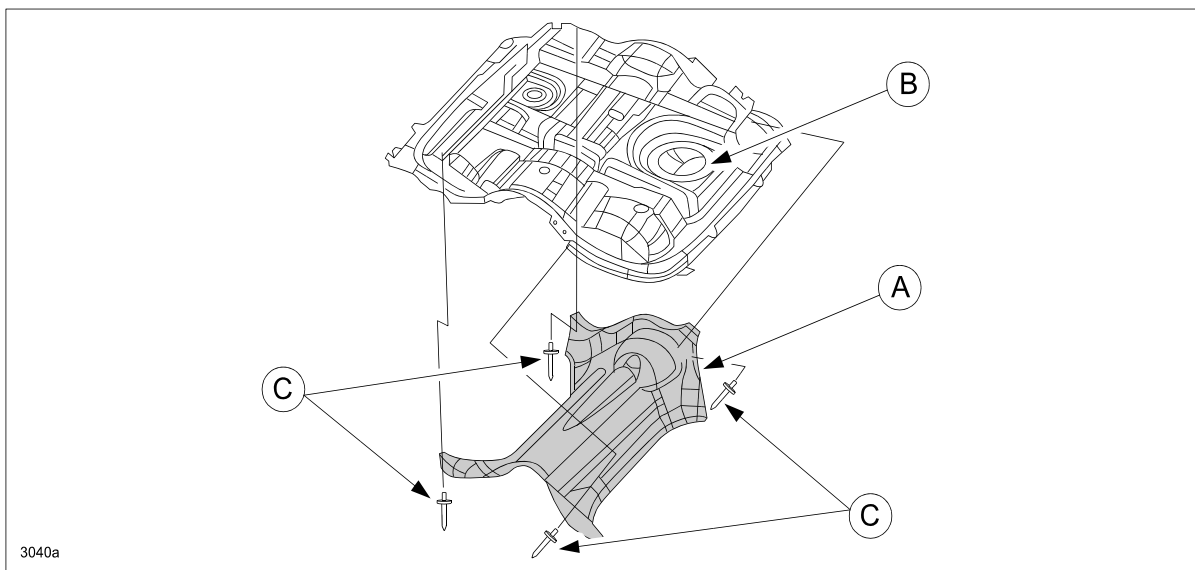
Some vehicles may exhibit an unusual noise while driving the vehicle. The noise may be caused by a broken fuel tank (B) insulator (A) that is hanging down and contacting the propeller shaft.

The rivets (C) may break when a load occurs. The rivet material has been changed to eliminate this concern. Customers having this concern should have their vehicle repaired using the following repair procedure.

1. Verify the customer concern.
2. Safely raise the vehicle on a hoist, then inspect the insulator for damaged at the rivet(s).
3. Remove the pre-silencer from the vehicle according to the instructions on MS3 online or the Workshop Manual (section 01-15 EXHAUST SYSTEM REMOVAL/INSTALLATION [MZI-3.7]).

4. Remove and discard the insulator from the fuel tank.

5. Install the new insulator with modified rivets.
