<b>Subject:</b>  FUEL FILLER LID DOES NOT OPEN OR CLOSE	<b>Bulletin No:</b> 09-029/15
	<b>Last Issued:</b> 08/04/2015

2011-14 Mazda2

2012-15 Mazda5 vehicles with VINs lower than JM1CW\*\*\*\*\*191244 (produced before June 2, 2015)

2013-16 CX-5 vehicles with VINs lower than JM3KE\*\*\*\*\*668045 (produced before May 20, 2015)

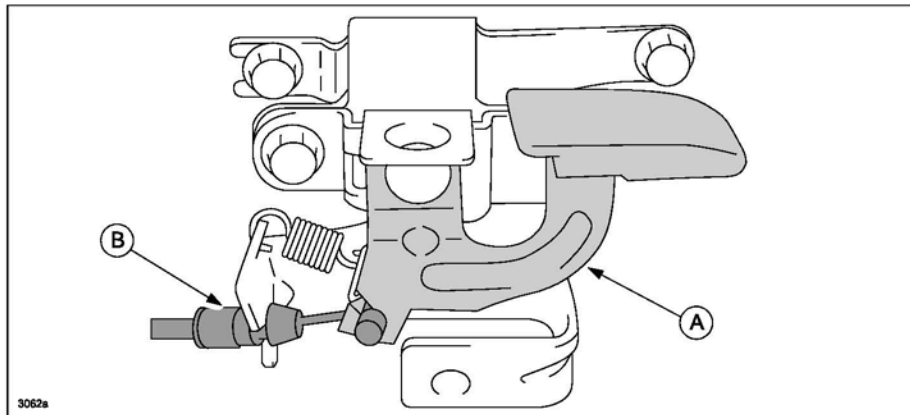
On some vehicles, the fuel filler lid will not open/close. This may be caused by snow with road salt being brought into the footwell area. The melted salt water then flows along the opener lever (A) and enters into the cable (B) causing the inner-cable to corrode and seize.

1. Verify customer complaint.
2. Replace the fuel-filler lid opener and fuel-filler lid opener cable with modified ones. Refer to MS3 online instructions or Workshop Manual section 09-10.
3. Verify repair.

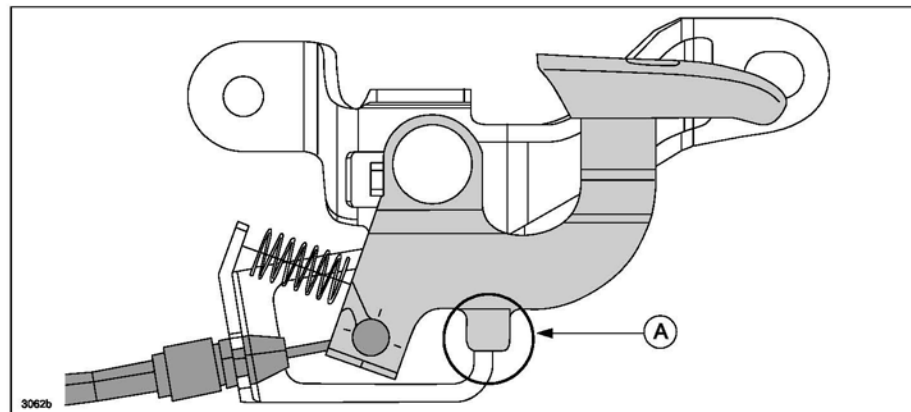
To correct the problem, a flange has been added to the fuel filler lid opener lever (A) to prevent water from flowing along the lever to the fuel filler lid cable.
