TECHNICAL BULLETIN
LTB00740NAS2
27 AUG 2015

SECTION: 307-01

'Gearbox Fault' Message Displayed In Instrument Cluster

Range Rover Evoque (LV)

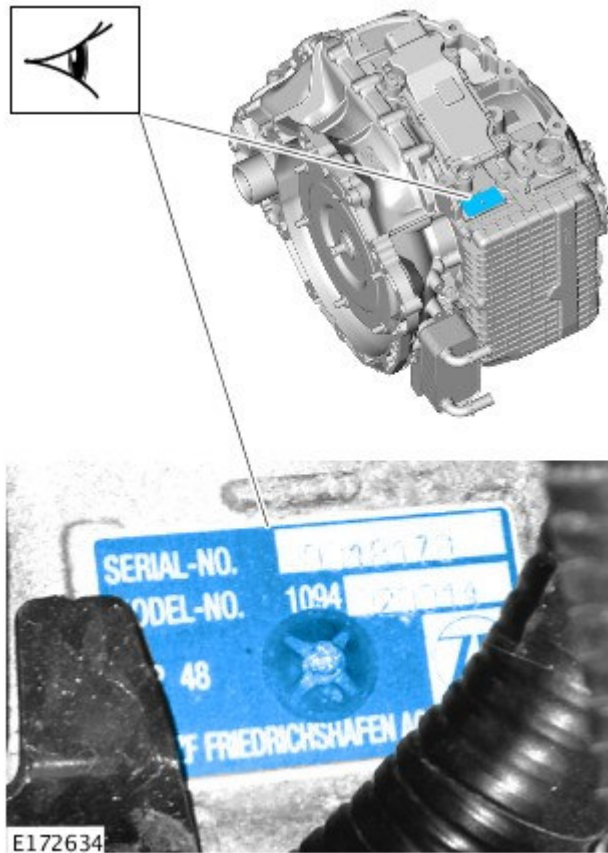
1. Inspect the Transmission serial number.

- If the serial number is **141772 or lower**, continue to step 2.
- If the serial number is **141773 or higher**, do not continue with this Technical Bulletin.
 - Follow a normal diagnostic process using the instructions listed in TOPIx Workshop Manual, section 100-00).
