Reference	SSM72542
Models	Discovery Sport / L550
Title	Touch Screen Error Message #1009 Displayed
Category	Electrical
Last modified	29-Nov-2015 00:00:00
Symptom	207000 Entertainment Systems
Attachments	Error 1009 Screen Shot.jpg (Error 1009 Screen Shot.jpg)

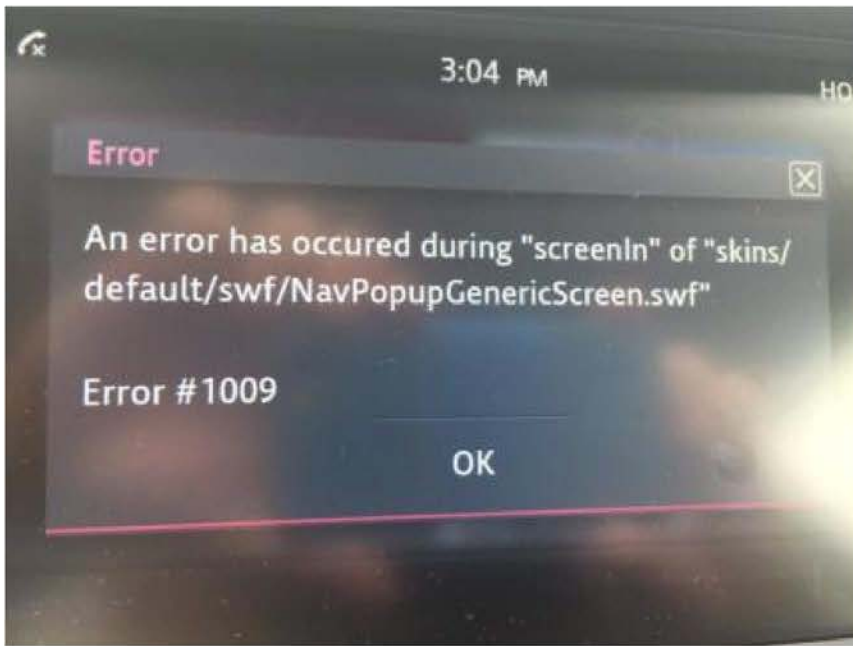
Issue: 2015 and some 2016 Land Rover Discovery Sport Models may display the following error message on the touch screen display when attempting to use the navigation system:

An error has occurred during “screenin” of “skins/default/swf/NavPopupGenericScreen.swf”

Cause: Audio Head Unit software concern.

Action: Should this message be encountered follow the steps below to update the Audio Head Unit software.

- Select the 'Selected Symptoms' tab, and then select the following: Electrical - Information and entertainment system – Entertainment system
 - Read and close any publication from the list of recommended candidates to expose the 'Extras' tab.
- Select the 'Extras' tab.
- From the Recommendations tab, select Run to perform the 'Configure existing module - Audio head unit - Low line' option.

Note: SDD DVD 143 patch file 3 or later is required for this repair.
