TECHNICAL BULLETIN LTB00866NAS1 22 DEC 2015

SECTION: 501-10

'Rattle' Noise From The Second Row Seat Area

Discovery Sport (LC)

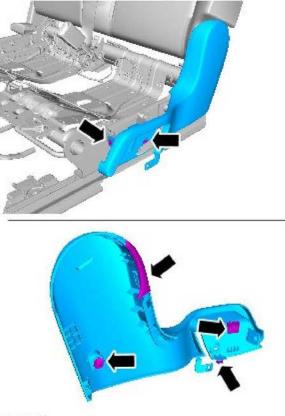
E175084

6Remove the Torx screw and the trim clip from the outer valance cover.

- Remove and discard the outer valance cover.
- Pull the rear edge of the outer valance cover upwards to release the outer valance cover from the mounting points.
