TECHNICAL BULLETIN
LTB00896NAS1
19 FEB 2016

Powered Tailgate Anti-Pinch Strip Modification

Discovery Sport (LC)

Model Year: 2015 Onwards
VIN: 500429 Onwards
Assembly Plant: Halewood

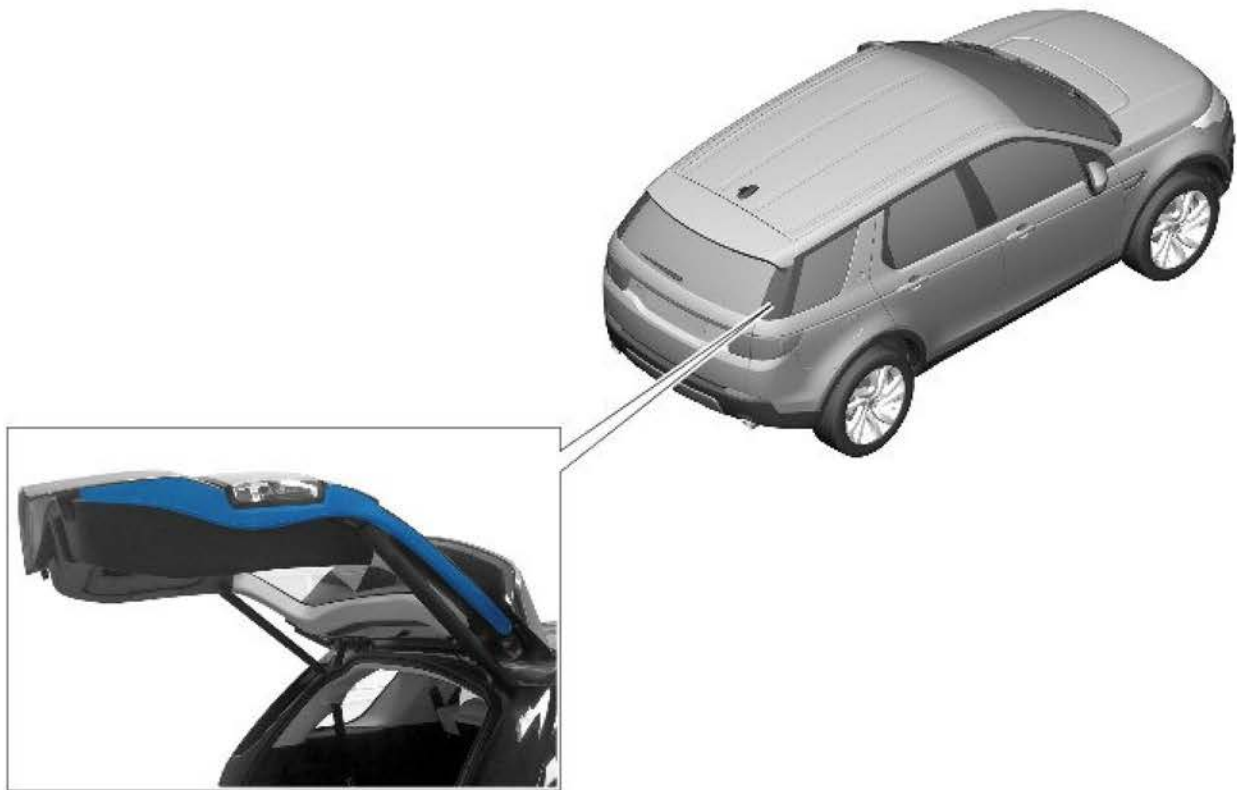
E187979

Component location.
