Technical Service Bulletin

91 MMI 3G+ MMI inop; blank screen at startup; various technical issues (K0942 ZUG update; supersedes K0814 update)

91 16 67 2030465/10 August 18, 2016. Supersedes Technical Service Bulletin Group 91 number 16-49 dated June 23, 2016 for reasons listed below.

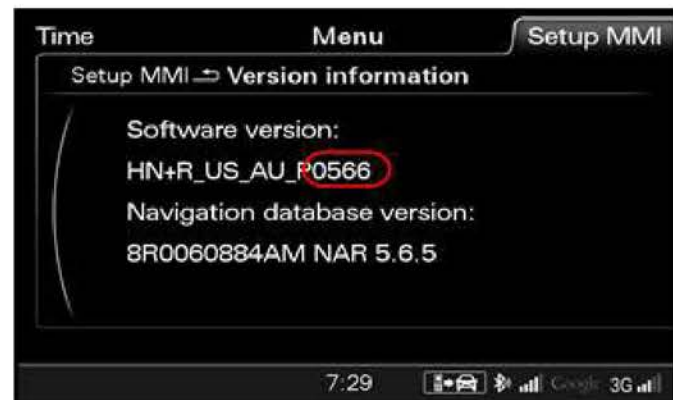
Tip: The MMI software version can be found under *Menu >> Setup MMI >> Version Information*. The software version will show the 4-digit software version number with a "P" or "K" prefix ("P" for Production and "K" for Service") (Figure 1).

Figure 1. Example showing MMI software version (0566).

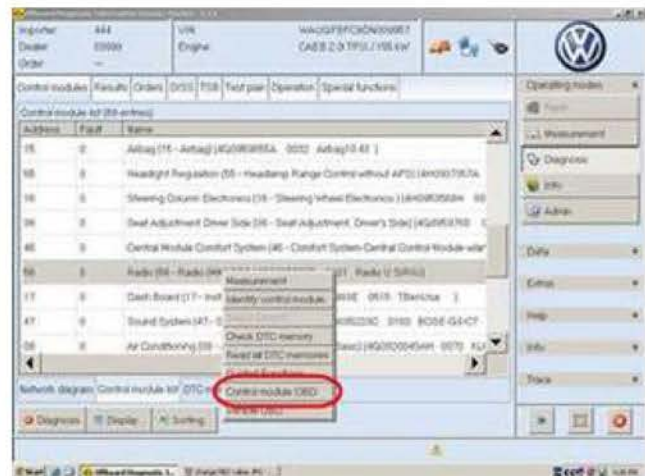
Figure 2. Radio self-diagnosis.

1. Verify the HD radio is enabled in the MMI by navigating to *Radio >> Settings*.
 - If the HD radio options are present in the MMI menu, proceed directly to Step 6.
 - If the HD radio options are not present in the MMI menu, continue with Step 2.
2. Using ODIS, right-click on 56 – *Radio* in the Control module list, and select *Control Module OBD* (Figure 2).

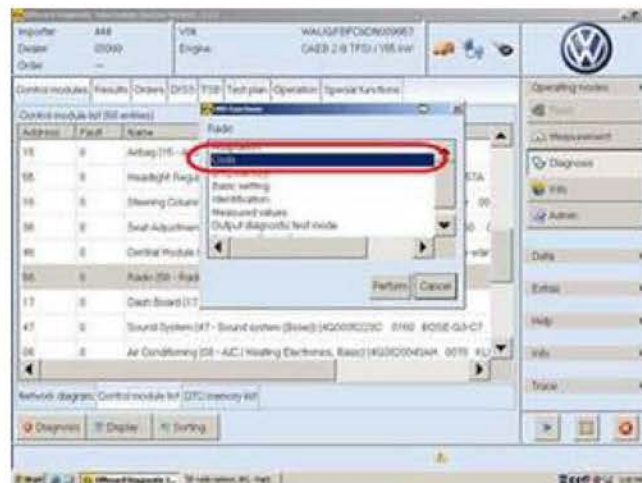
Figure 3. Code radio option.

3. Select *Code* (Figure 3).

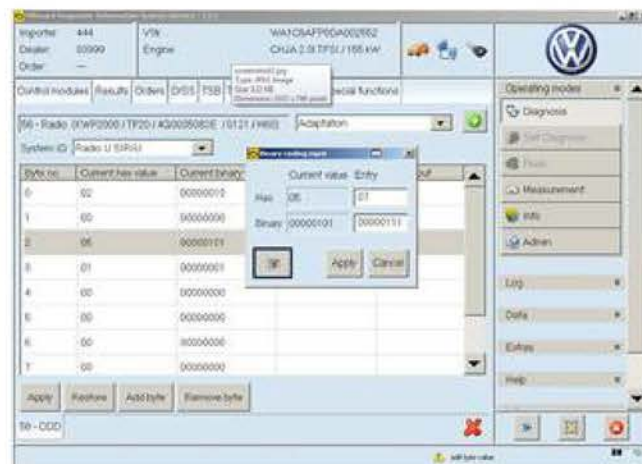
Figure 4. Changed radio coding.

4. Verify the coding in byte 2 is HEX 07.

- If it is not HEX 07, change the coding to HEX 07. Apply changes (Figure 4).

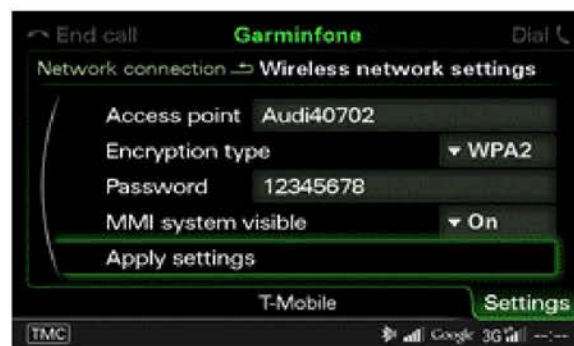
Figure 5. Wireless network settings.

6. As part of the update, wireless settings and paired devices will be deleted. All devices will need to be re-paired after the update, and all wireless settings restored to the customer's settings. To access the Wireless network settings on the MMI (Figure 5), press *TEL >> Settings >> Wireless network connection >> Wireless network settings*. Record all settings so they can be re-entered at the end of the update.

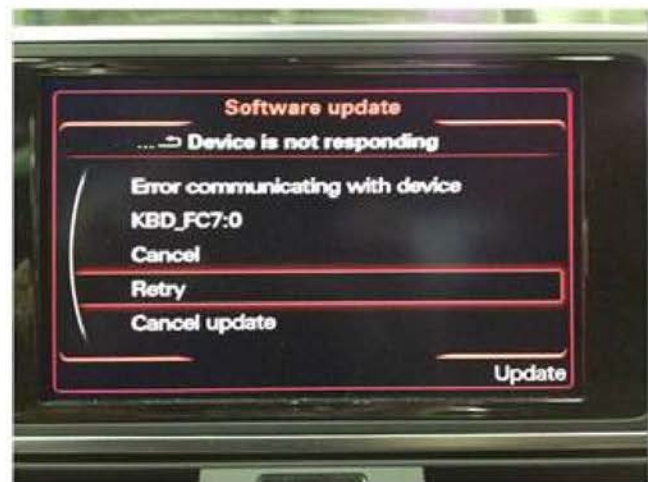
Some earlier model year 2012 vehicles, or vehicles equipped with Bose® sound systems may experience certain modules that will not update properly during Step 16 of TSB 2028141. If this should occur, either choose 'Cancel' (Figure 6), or 'Skip device' (Figure 7), depending on the type of error. Do *not* choose 'Cancel update', as this may cause the software update to fail entirely. After the update is finished and the summary page is shown, select 'Retry' at the bottom of the list if it is available to attempt to update the modules again. If 'Retry' is greyed out, then the software update was successful. Select 'Continue' to proceed. In some cases 'Retry' may have to be repeated two or three times to get all modules to update successfully.

Figure 6. A device requiring a 'Cancel' selection.

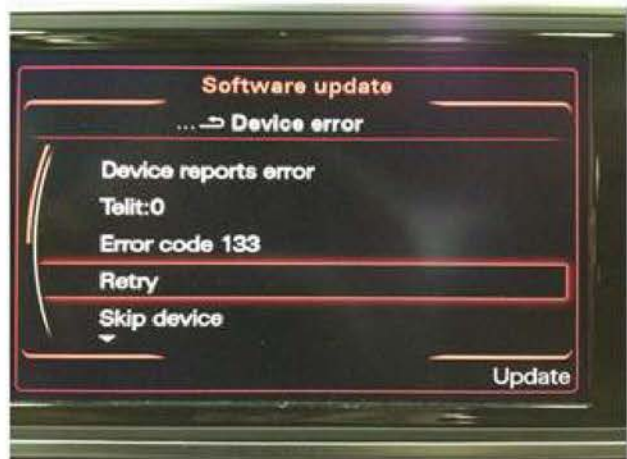
Figure 7. A device requiring a 'Skip device' selection.

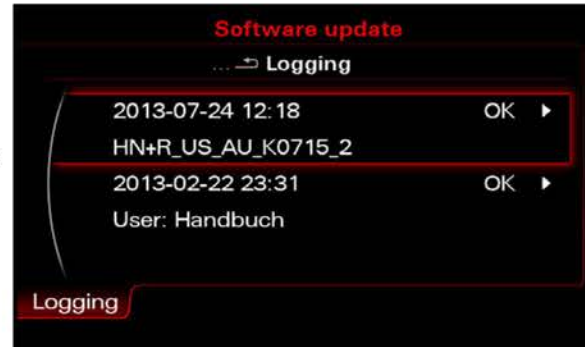
Figure 8. Software update log showing a successful software installation.

- Verify that the software update has been completed successfully by accessing the logging page (Figure 8). To access this screen, proceed to step 8 in TSB 2028141 and press the lower left softkey. A successful update will show the date the update was performed and the software that was installed (HN+R_US_AU_K0715_X), with 'OK' listed on the right (example 0715 installation). The 'X' may be one of several different numbers. If K0715_X does not have any rows with 'OK', the update must be retried until it is successful. For the latest P0942 update, this line would show K0942_X.

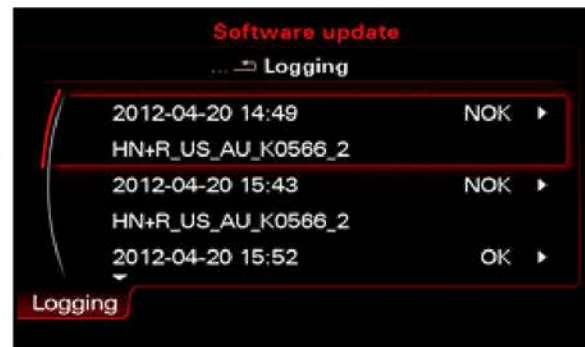
Figure 9. Software update log showing 2 failed attempts before a successful installation.

Tip: If the update must be performed two or more times due to modules not updating correctly, a screenshot of the software update log is required (Figure 9). This should be kept on-hand for warranty auditing purposes. To take a screenshot, insert an SD Card into slot 1. For A6/A7/A8/Q7, press and hold the left and right arrow keys at the same time. For A4/A5/Q5, press and hold the bottom two softkeys at the same time. All 4 softkeys will flash when the screenshot is taken. A screenshot should be taken of each page in the logging display.
