02206 Version 1

Transmission End Cover Leaks (9-Speed A/T)

AFFECTED VEHICLES

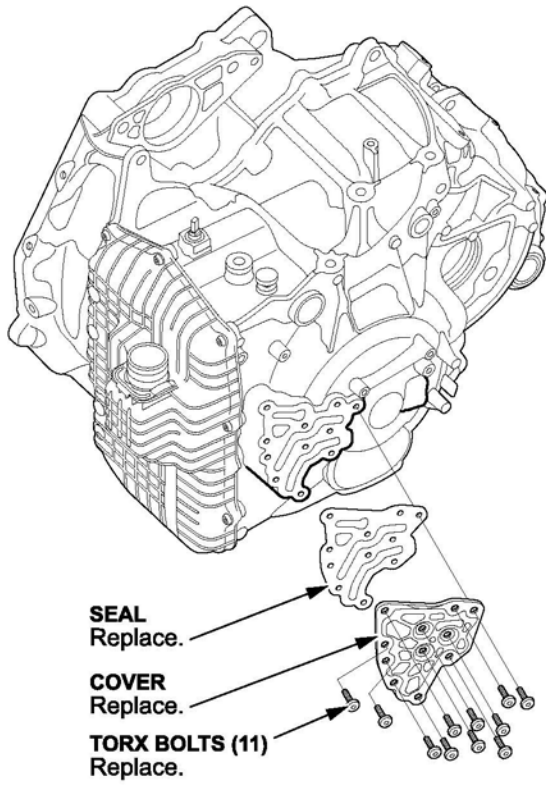
During assembly, the transmission end cover sealing gasket gets torn.

6. Remove the 11 T-30 Torx bolts from the end cover.
