# Service Bulletin

Bulletin No.: 06-03-09-004H

**Subject:** Squeak Noise from Rear of Vehicle (Lubricate Rear Leaf Springs)

**Models:** 1999-2007 Chevrolet Silverado (Classic)  
2007-2012 Chevrolet Colorado  
2007-2016 Chevrolet Silverado  
2015-2016 Chevrolet Colorado  
1999-2007 GMC Sierra (Classic)  
2007-2012 GMC Canyon  
2007-2016 GMC Sierra  
2015-2016 GMC Canyon  
2007-2010 HUMMER H3, H3T

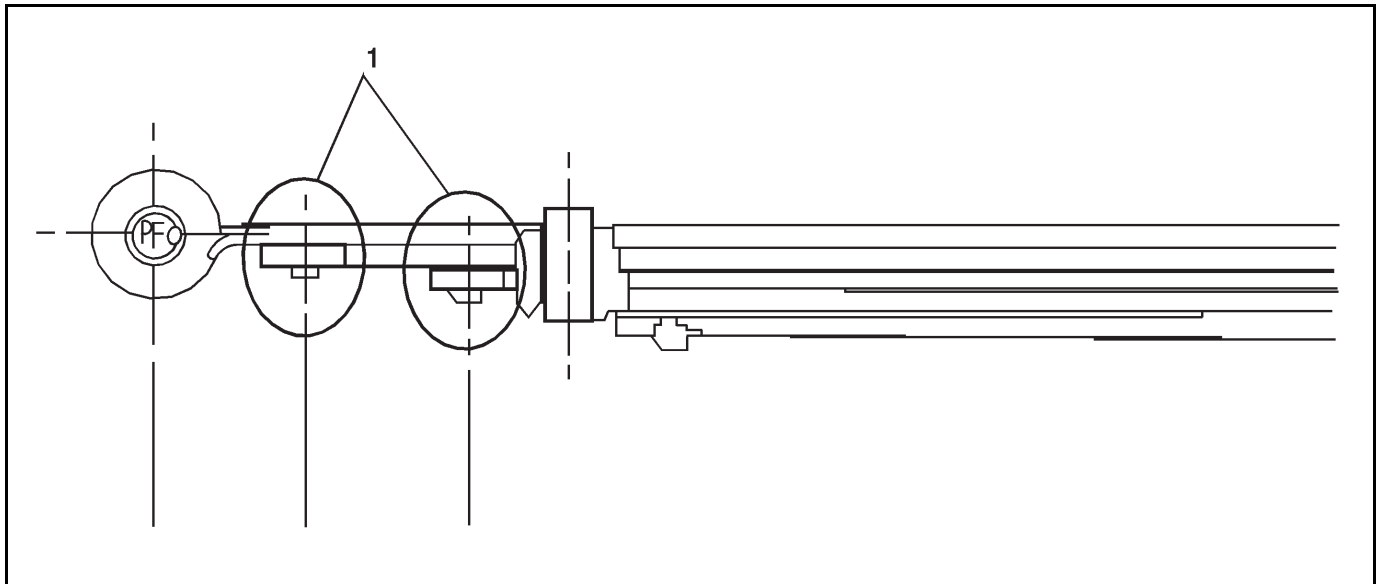
1826776

This condition may be due to debris getting between the leaf springs.

**Note:** Ensure any tool used to gently pry the tip inserts or spring leaves is protected to prevent damage to the spring leaves.

5. Apply a liberal amount of grease, P/N 12345996 (in Canada, use P/N 10953501), both underneath and on top of the front and rear tip inserts for the #2 and #3 leaves, as indicated below. A screwdriver can be used to gently pry up the tip insert; however, a rag around the screwdriver must be used to prevent damage to the spring. Use a flat-bladed tool, such as a gasket scraper to properly distribute the grease.
6. Lower the vehicle to the ground and test drive to verify the repair.
