PRODUCT CAMPAIGN BULLETIN

APPLICABILITY: 2022 MY Outback 2.4L (turbo)

NUMBER: WRC-22

SUBJECT: Safety Recall - Engine Harness and ECM replacement

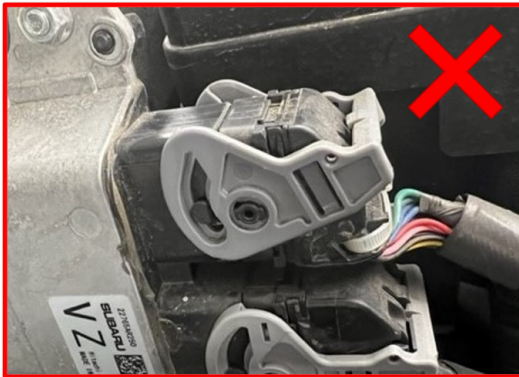
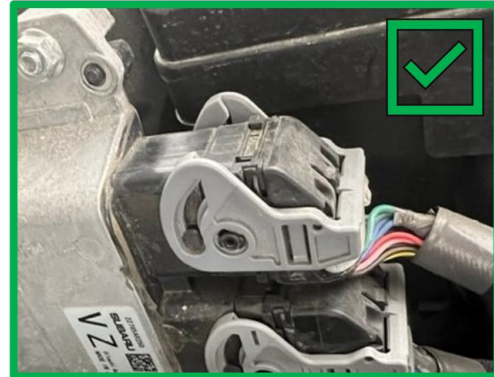
- **ALWAYS** confirm the connector levers are in the fully locked position. See images below.

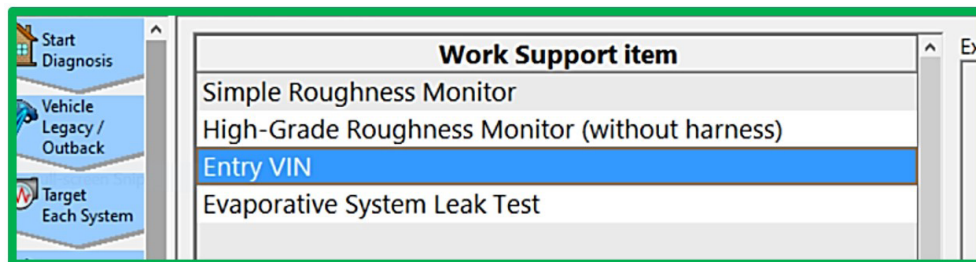
- **ALWAYS** perform the “Entry VIN” procedure using SSM.

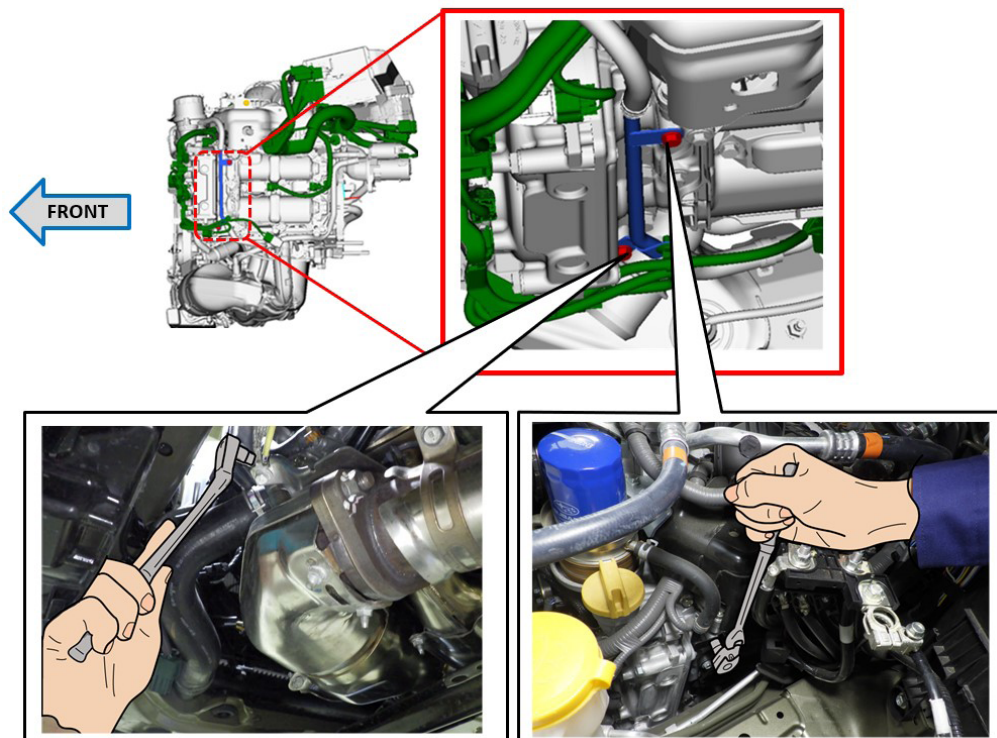
TIP 2) Remove the two bolts securing the engine oil cooler pipe. DO NOT remove the water hose. This eliminates engine coolant loss.

NOTE: The lower bolt can be removed easily with the vehicle on a lift.

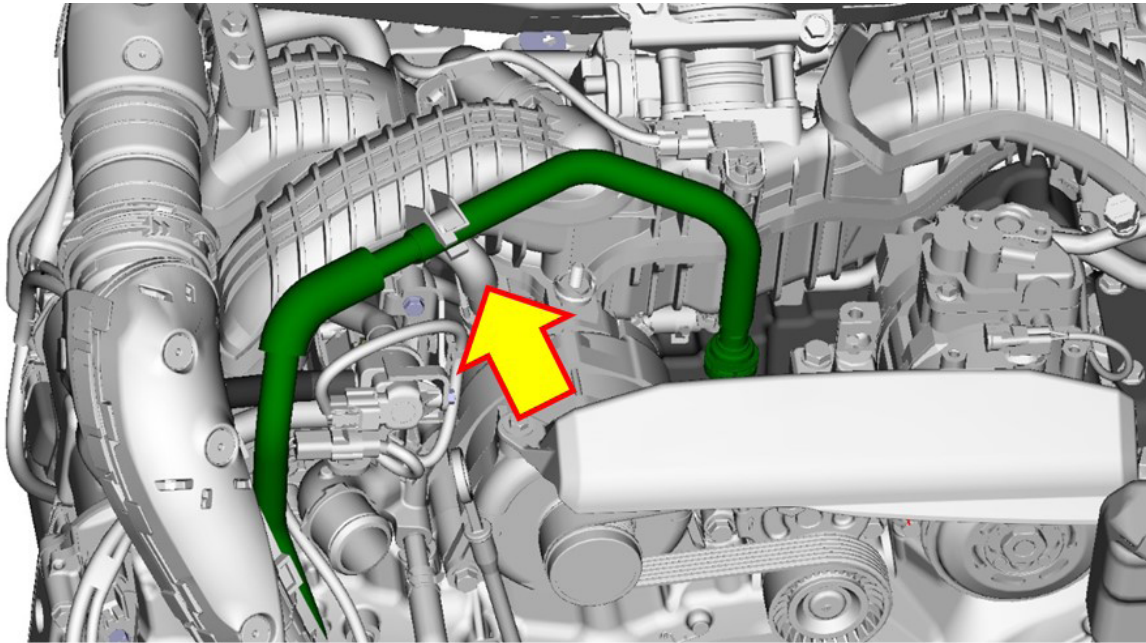
TIP 3) It is not necessary to remove the entire PCV pipe. Detach the pipe from the holding clamp. This will avoid replacement of the PCV pipe which is a one-time use part.

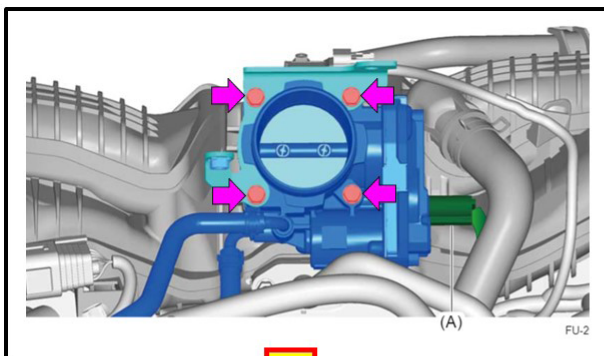
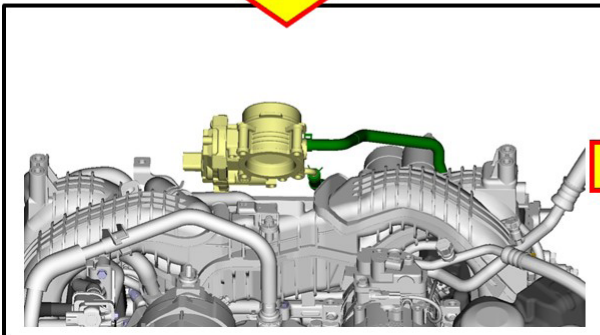
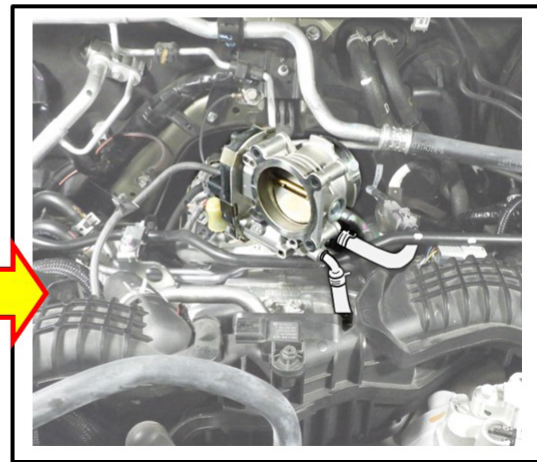
TIP 4) The throttle body assembly does not have to be fully removed. Remove the four mounting bolts and disconnect the wiring harness connection. The throttle body assembly can be repositioned with the pre-heater (coolant) hoses attached to gain sufficient access. Use CAUTION to not damage the throttle plate during this procedure.

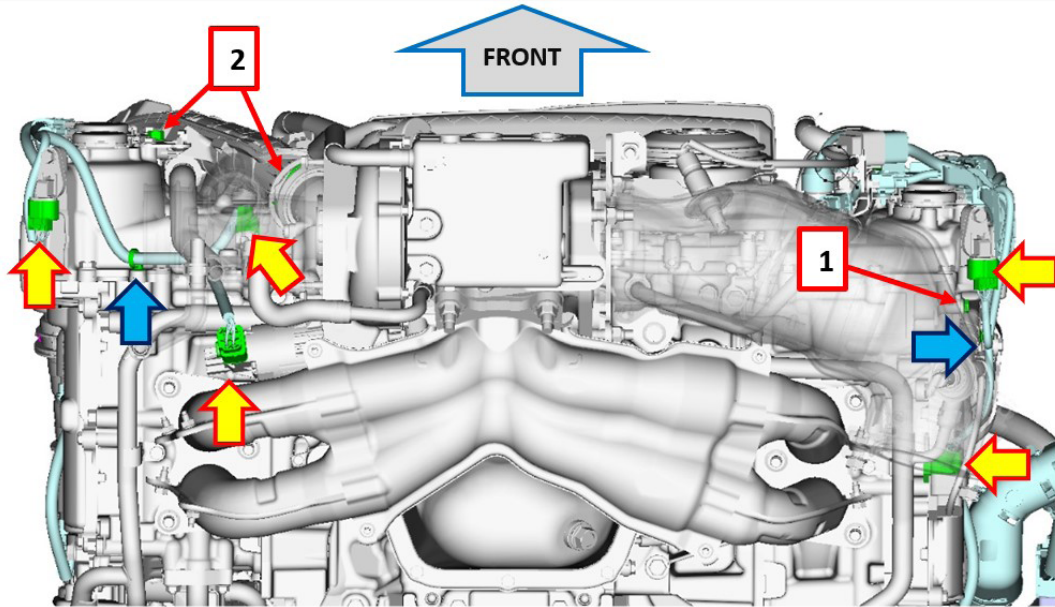
TIP 5) CAREFULLY raise the vehicle and disconnect the five electrical connectors and the harness mounting clips. Remove the mounting bolt and the spring lock on the intake duct. Refer to the images below.

- 1** Lower Oil Cooler Pipe Mounting Bolt
- 2** Mounting Bolt and Spring Lock for the Intake Duct
-
