PUBLISHED BY THE NATIONAL SERVICE TRAINING & SUPPORT DEPARTMENT

TechNet Times

Volume 23 Issue 7

October 2013

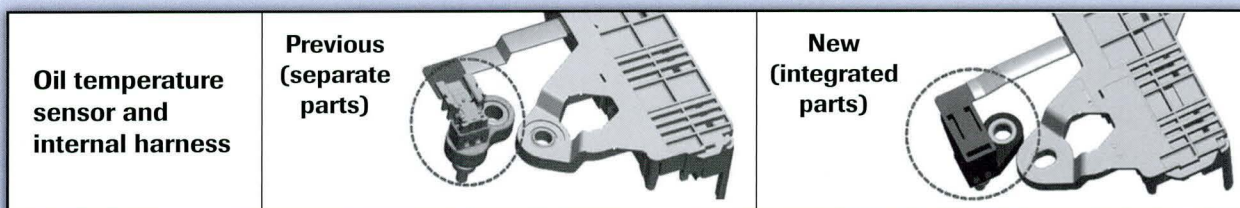
Automatic Transaxle (6-Speed) Oil Temperature Sensor DTC P0711, P0712 & P0713

Do not replace the transaxle for the following DTC listed below. Instead, follow the repair procedure listed in TSB 13-AT-012-1 and replace the related part.

The oil temperature sensor has been integrated with the internal harness from early March, 2013. The oil temperature sensor is not available separately for these models: Tucson (LM), Santa Fe (CM/AN/NC), Sonata (YF), Elantra (UD/MD/GD/JK), Accent (RB), Azera (TG/HG), Veloster Turbo (FS). See TSB 13-AT-012-1 for parts listing.

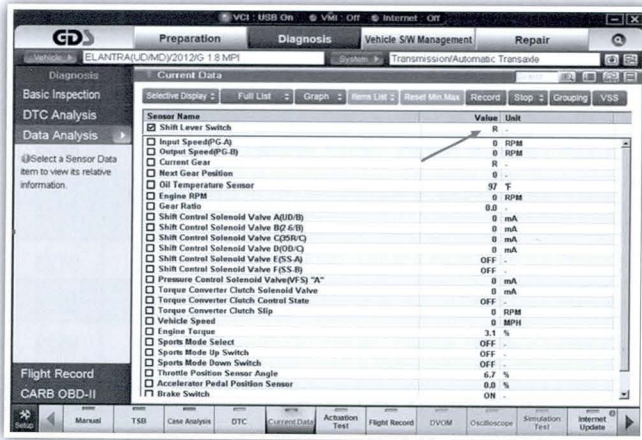
AUTOMATIC TRANSAXLE (6-SPEED) INHIBITOR SWITCH DTC P0705, P0706, P0707 & P0708

An improperly adjusted or improperly operating inhibitor switch (range switch) may result in the following conditions:

- Diagnostic trouble codes:
 - P0705 - Range switch sensor circuit
 - P0707 - Range switch - open circuit
 - P0706 - Range switch range/performance
 - P0708 - Range switch - short circuit or multiple inputs
- Malfunction Indicator Light (MIL) illuminated
- Impossible engine start in "P" or "N"

1. Turn the ignition key to the ON position or push the Start/Stop Button two times.
2. Using a GDS, check for DTC in the “Automatic Transaxle” menu. **Record the DTC and description.** Delete the DTC.
3. Select the following parameters. Move the shift lever through all gears and monitor the sensors.
 - Vehicle and A/T menu.
 - “Current Data”
 - Shift Lever Switch.

4. If the Shift Lever Switch shows:
 - The correct shift lever position, the wiring **currently** has no open/short circuits. Go to Step 6.
 - Does not show the correct shift lever position, go to Step 5.
5. Visually check the wiring harness between the PCM and inhibitor switch for a damaged wire or open circuit/short circuit to ground. Check for a damaged pin or pin not fully inserted into the connector.
 - If damage exists, repair or replace the control wiring and drive the vehicle to confirm the repair.
 - If no damage or open/short circuit is found, go to Step 6.
6. Place the shift lever to the “N” position. Turn the ignition switch to the OFF position.
7. Remove the air duct and air cleaner, if needed, to access the inhibitor switch.
8. Remove the battery, if needed, to access the inhibitor switch.
