# SERVICE BULLETIN

Classification:	Reference:	Date:
EC16-040	NTB16-124	December 19, 2016

## 2017 ARMADA AND TITAN/TITAN XD; MIL IS ON WITH DTC P2080 AND/OR P2082

**APPLIED VEHICLES:** 2017 Armada (Y62)  
2017 Titan/Titan XD (A61)  
**APPLIED ENGINE:** VK56VD (gasoline engine)

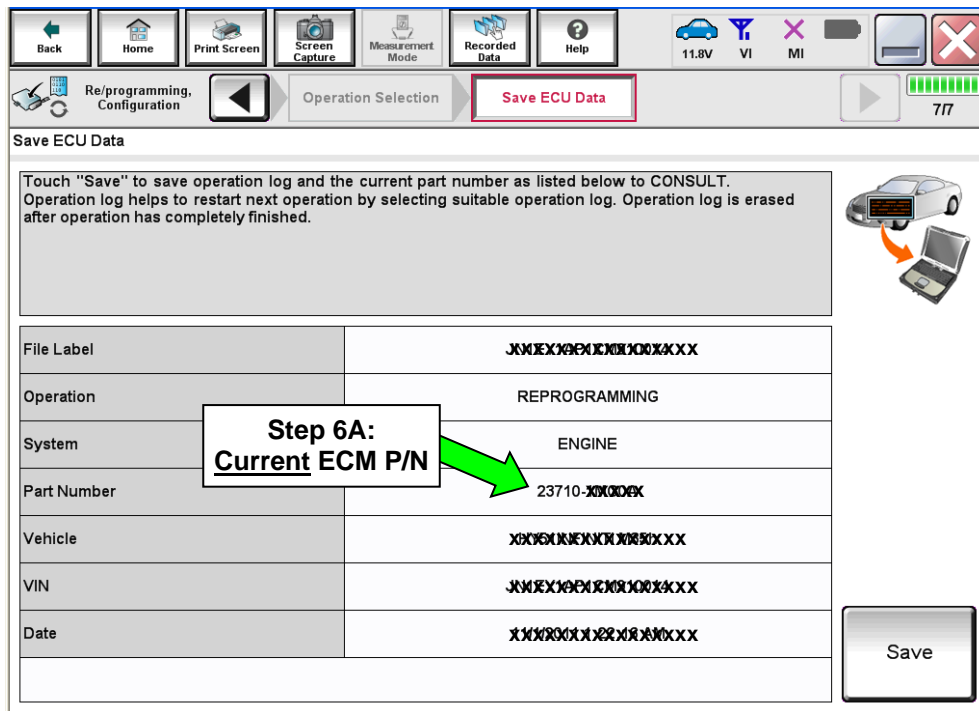
Figure 2

6. When you get to the screen shown in Figure 2, confirm this bulletin applies as follows.

A. Find the ECM **Part Number** and write it on the repair order.

**NOTE:** This is the current ECM Part Number (P/N).

B. Compare the P/N you wrote down to the numbers in the **Current ECM Part Number** column in **Table A** below.

- If there is a match, this bulletin applies. Continue with the reprogramming procedure.
- If there is not a match, this bulletin does not apply. Close C-III plus and refer to ASIST for further diagnostic information.

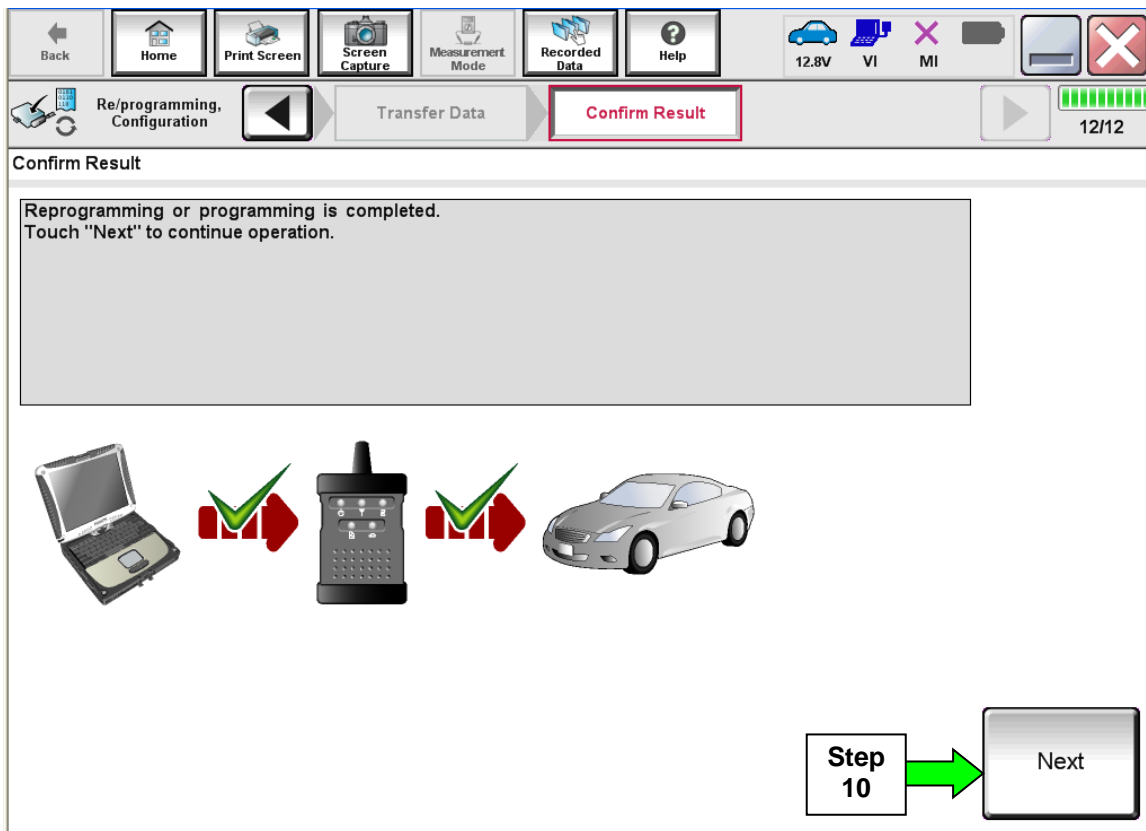
8. When the screen in Figure 4 displays, reprogramming is complete.

**NOTE:** If the screen in Figure 4 does not display (reprogramming does not complete), refer to ECM recovery on the next page.

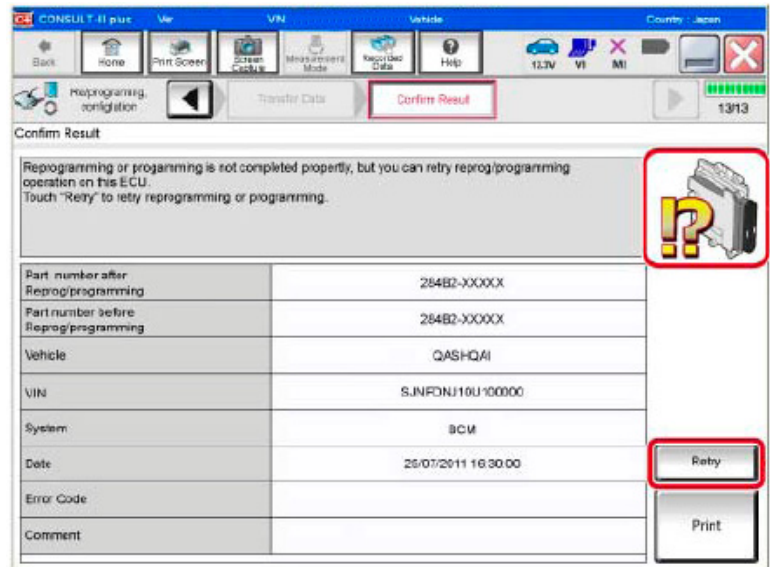
Figure 5

If reprogramming does not complete and the “!” icon displays as shown in Figure 5:

- Check battery voltage (12.0 - 15.5 V).
- Ignition is ON, engine OFF.
- External Bluetooth® devices are OFF.
- All electrical loads are OFF.
- **Select retry and follow the on screen instructions.**
- “Retry” may not go through on first attempt and can be selected more than once.

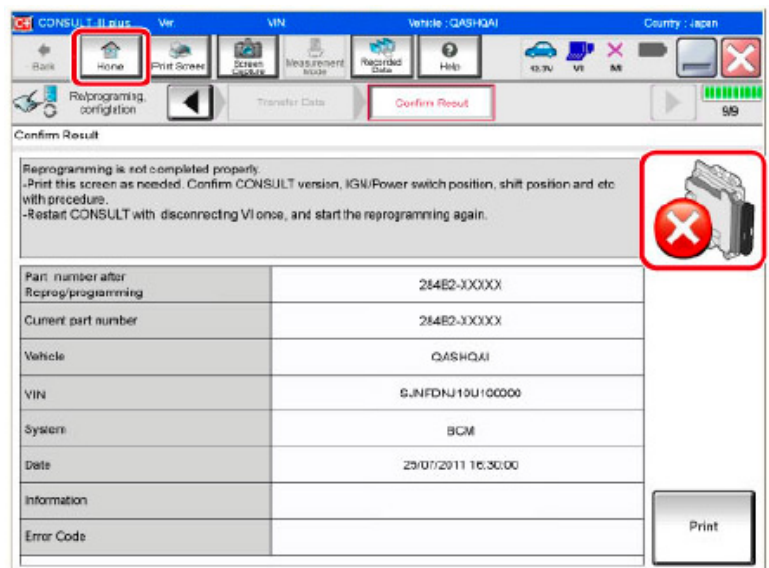
Figure 6

If reprogramming does not complete and the “X” icon displays as shown in Figure 6:

- Check battery voltage (12.0 - 15.5 V).
- CONSULT A/C adapter is plugged in.
- Ignition is ON, engine OFF.
- Transmission is in Park.
- All C-III plus / VI cables are securely connected.
- All C-III plus updates are installed.
- **Select Home, and restart the reprogram procedure from the beginning.**
