65/13 ENU 3734

PDK Transmission: Fault Codes P172D, P17F1 P17F2, P18CA, P18CB (65/13)

Concerns: PDK transmission

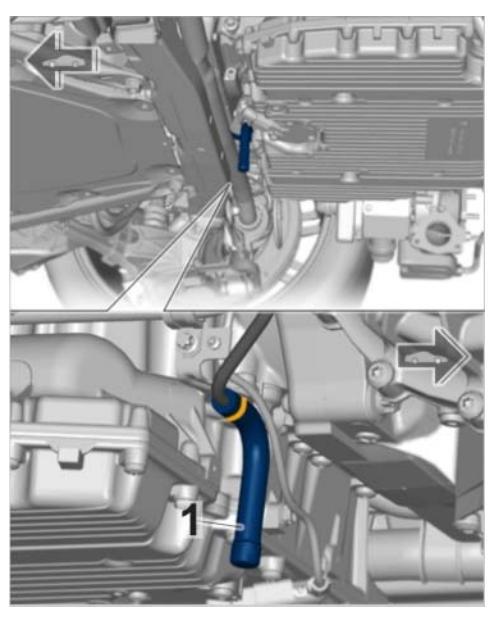
The breather hose (90° angled pipe) \Rightarrow Breather hose (90° angled pipe) -1 - fitted to the lower end of the vent line for the PDK transmission must be re-used when replacing the vent line (Remedial action 2).

It is important therefore to make sure that the breather hose \Rightarrow Breather hose (90° angled pipe)-1- is not damaged when removing the PDK transmission.

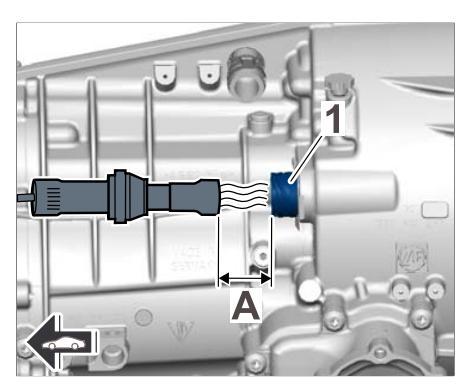
Heating connector contacts

To remove condensation adhering to the inner contacts (which are not visible) of the multiple plug connection for the PDK transmission, the contacts in the connector housing must be heated from the outside using a hot-air blower.

The application of heat to the outer contacts removes (evaporates) the condensation on the inner contacts (which are not visible) of the multiple plug connection.

2.2 Position the hot-air blower at a distance of **15 - 20 mm** (\Rightarrow *Heating connector contacts* -dimension A-) in front of the top PDK multiple plug connection \Rightarrow *Heating connector contacts* -**1**- and hold it at this position.

Apply hot air to the contacts in the top PDK multiple plug connection **continuously** for **20 minutes** in accordance with the specifications in the table.

The maximum temperature of 248° F (120° C) at the connector housing must not be exceeded.

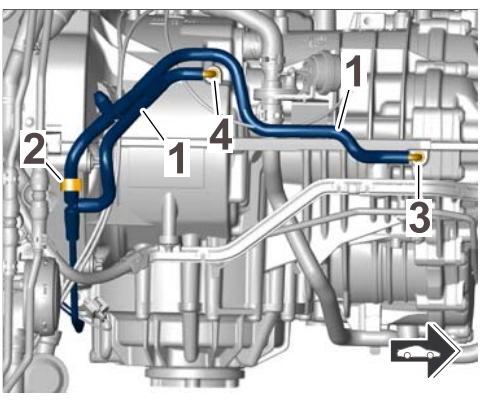
The line brackets for the original vent line are no longer required after conversion and have to be removed.

- 1 Remove vent line.
 - 1.1 Open line bracket \Rightarrow *Removing vent line* -2and remove vent line \Rightarrow *Removing vent line*

- 1.3 Pull vent line ⇒ Removing vent line -1 off ventilation connection for gear wheel set ⇒ Removing vent line -3 - and off ventilation connection for clutch chamber ⇒ Removing vent line -4 -.
- 1.4 Remove vent line \Rightarrow Removing vent line -1-.

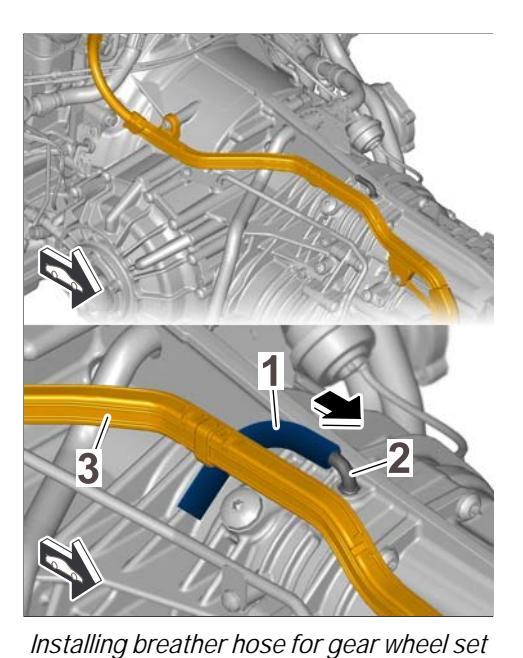
The cable duct remains on the vehicle when the PDK transmission is removed. As an example, the figure shows the required installation position of the breather hose after fitting the cable duct while re-installing the PDK transmission.

3.1 Position the breather hose (90° angled pipe)
 ⇒ Installing breather hose for gear wheel set
 -1- you removed previously from the vent line on the PDK transmission as shown in figure
 ⇒ Installing breather hose for gear wheel set. The breather hose must point to the lower right in direction of travel.

3.2 Slide the breather hose ⇒ *Installing breather hose for gear wheel set* -1- as far as it will go onto the ventilation connection for the gear wheel set ⇒ *Installing breather hose for gear wheel set* -2- (⇒ *Installing breather hose*
