WARRANTY BULLETIN

WB18-43

DATE :	November 2018	SECTION :	06 ELECTRICAL
EXPIRATION:	November 2020		
SUBJECT :	VECU MID 144 UPDATE – AUTO ENGINE BRAKE WITH I-SHIFT TRANSMISSION

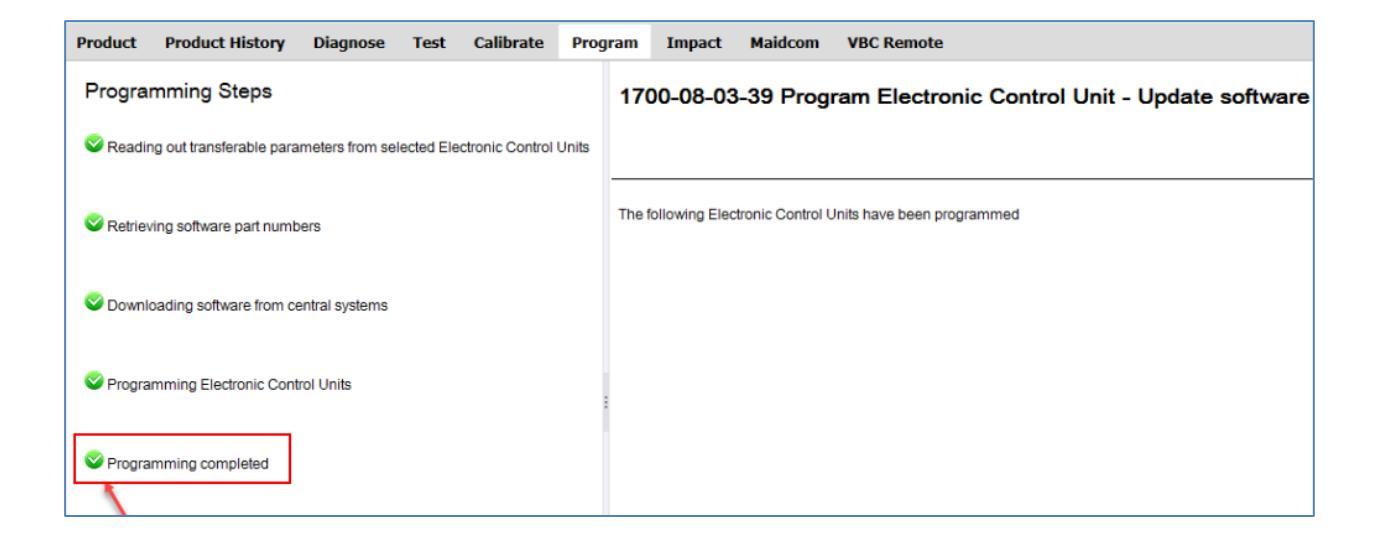
3. Confirm completion of the VECU programming with the Program > Update Software screen.
