SUBJECT:			No:	TSB-19-14-001
WATER PUMP COOLANT LEAKAGE:			DATE:	January 2019
INSPECTION PROCEDURE			MODEL: All models	
CIRCULATE TO:	[] GENERAL MANAGER	[X] PARTS MANAGER		[X] TECHNICIAN
[X] SERVICE ADVISOR	[X] SERVICE MANAGER	[ X ] WARRANTY PROCESSOR		[] SALES MANAGER

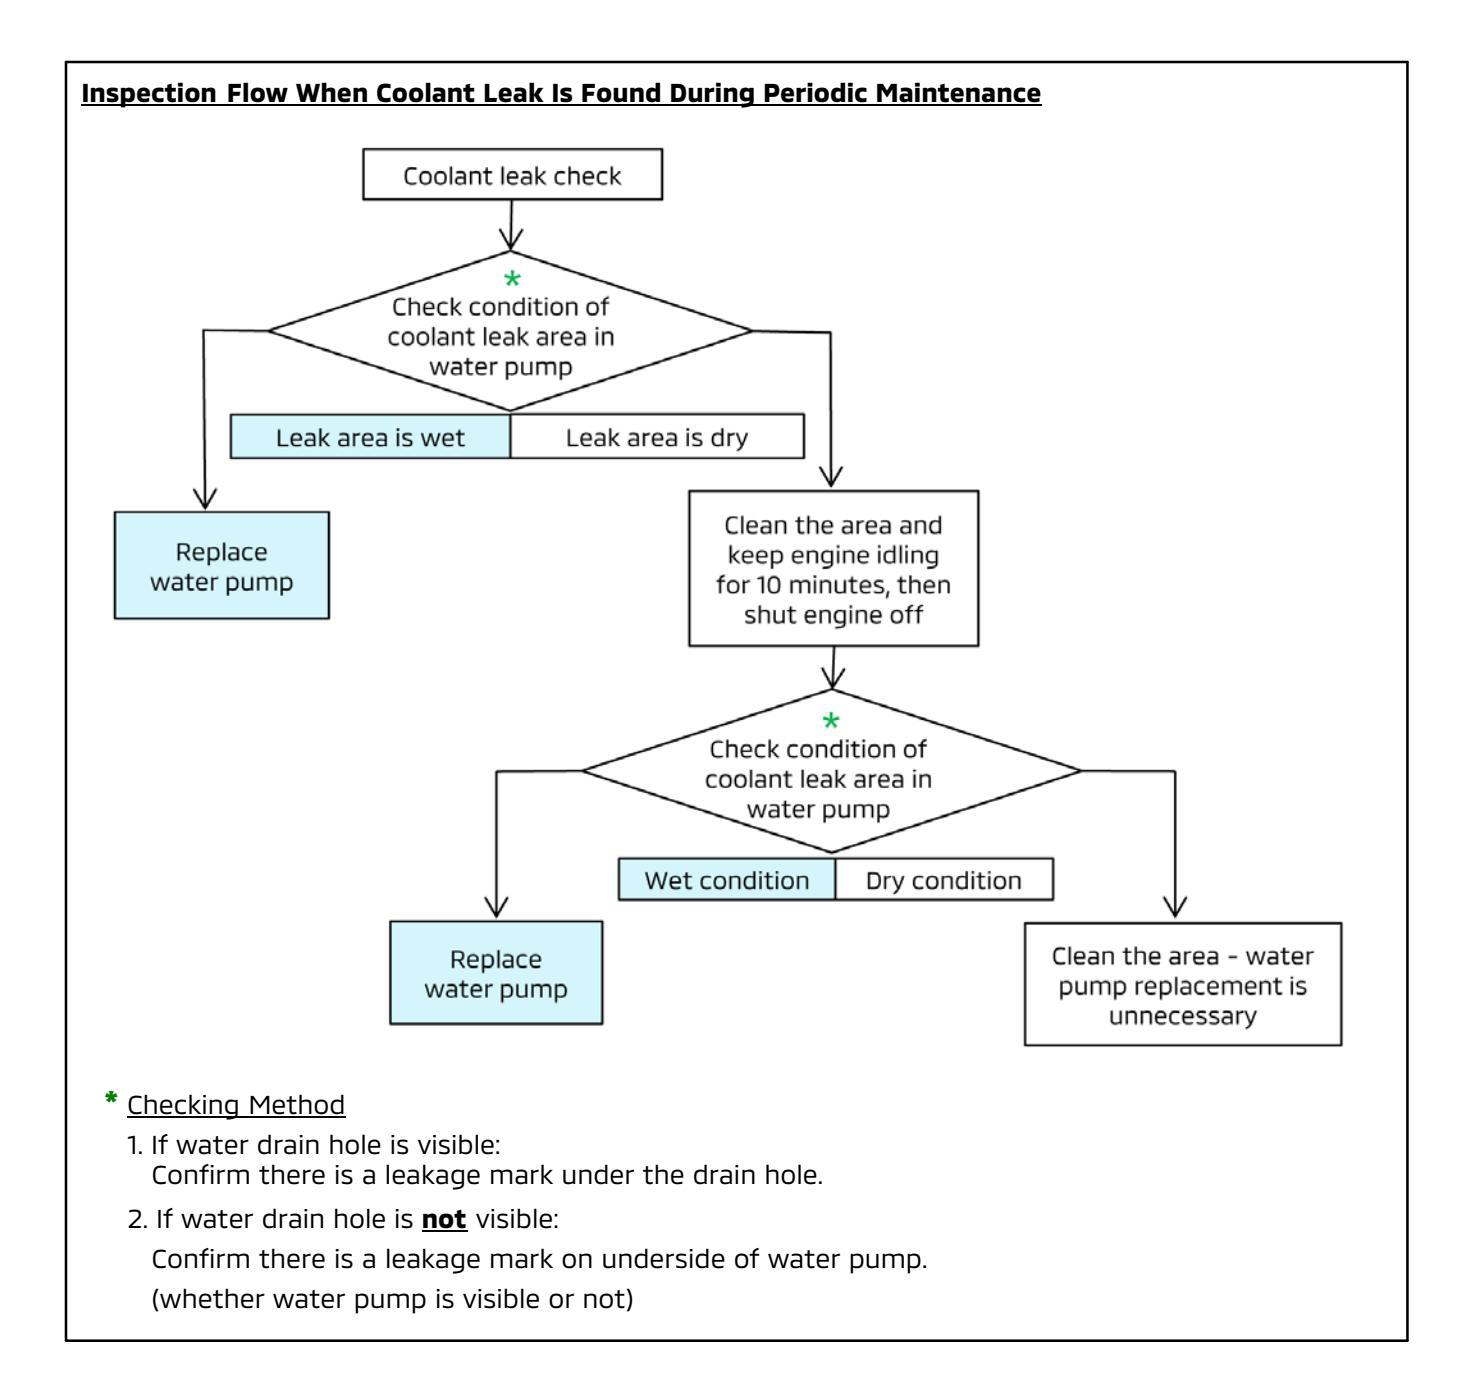
Refer to the Inspection Procedure that follows when coolant leakage is discovered near the steam vent hole or the water drain hole to determine if replacement of the water pump is necessary or not.

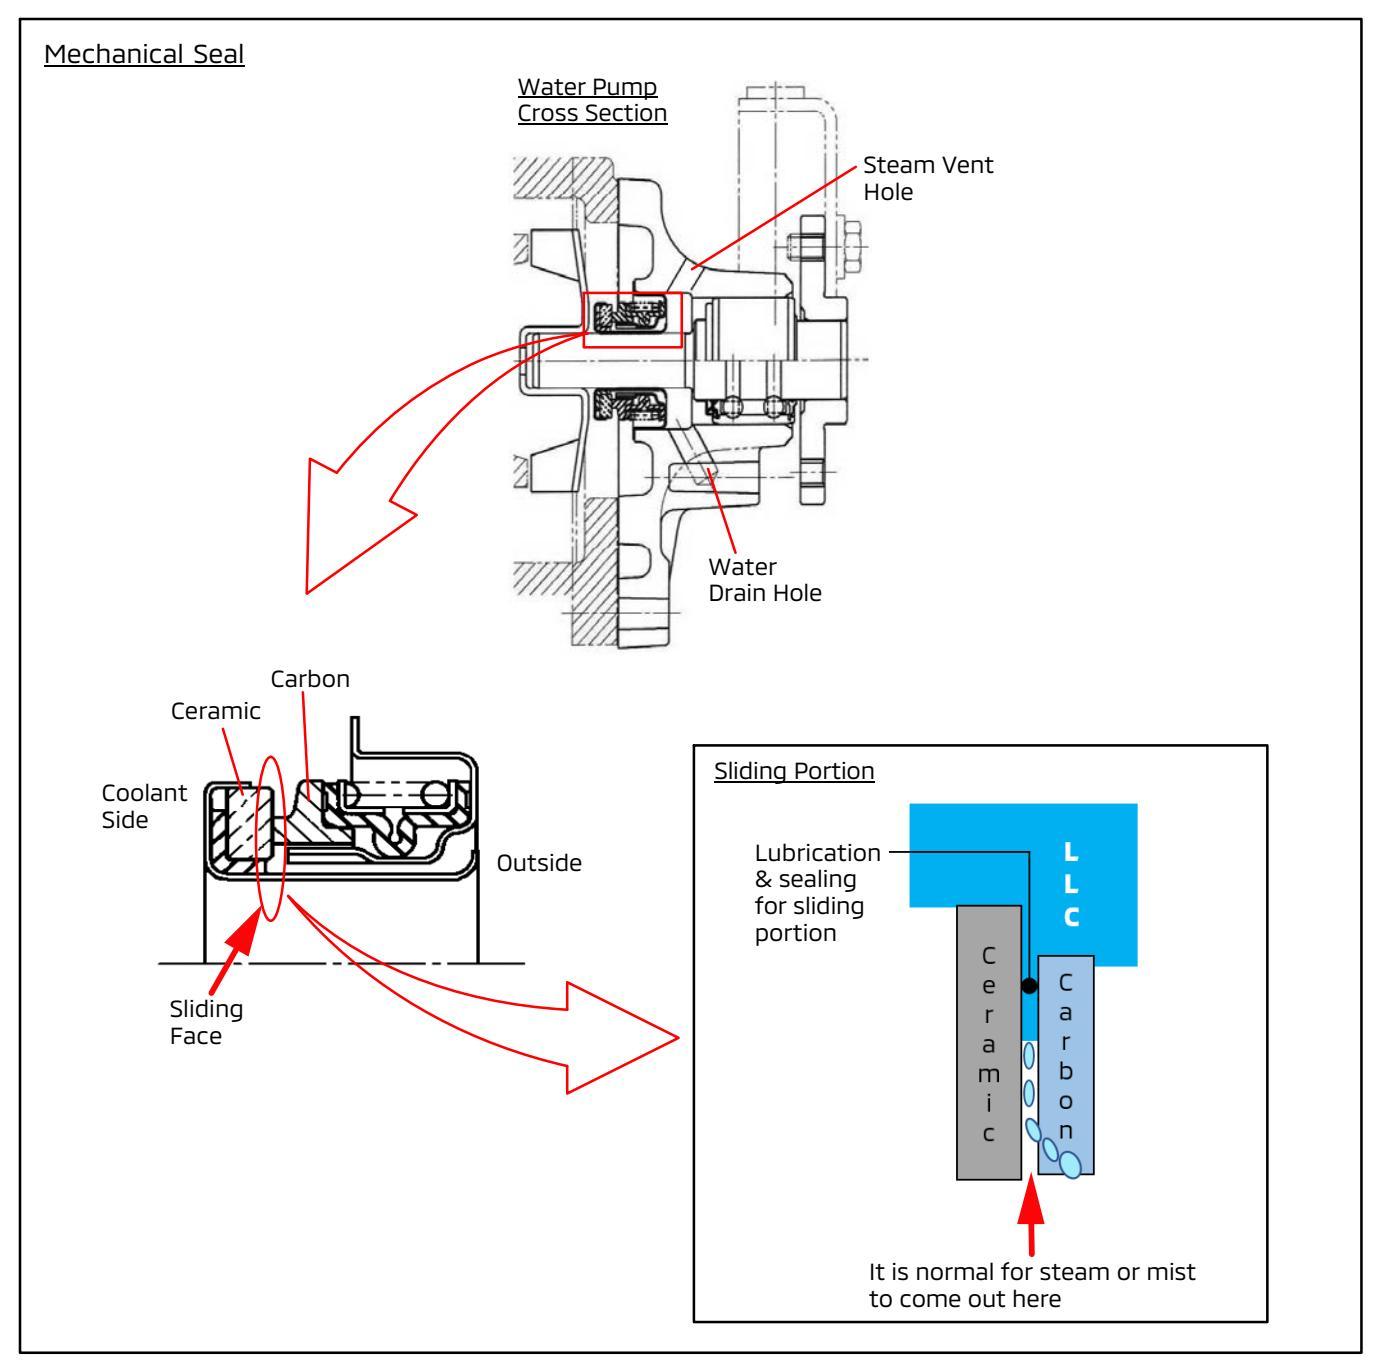
## **Mechanical Seal**

The water pump rotating shaft portion is sealed with a mechanical seal. Due to its structure, steam or mist escapes to the outside under normal conditions, and is sometimes misjudged to be coolant leakage.

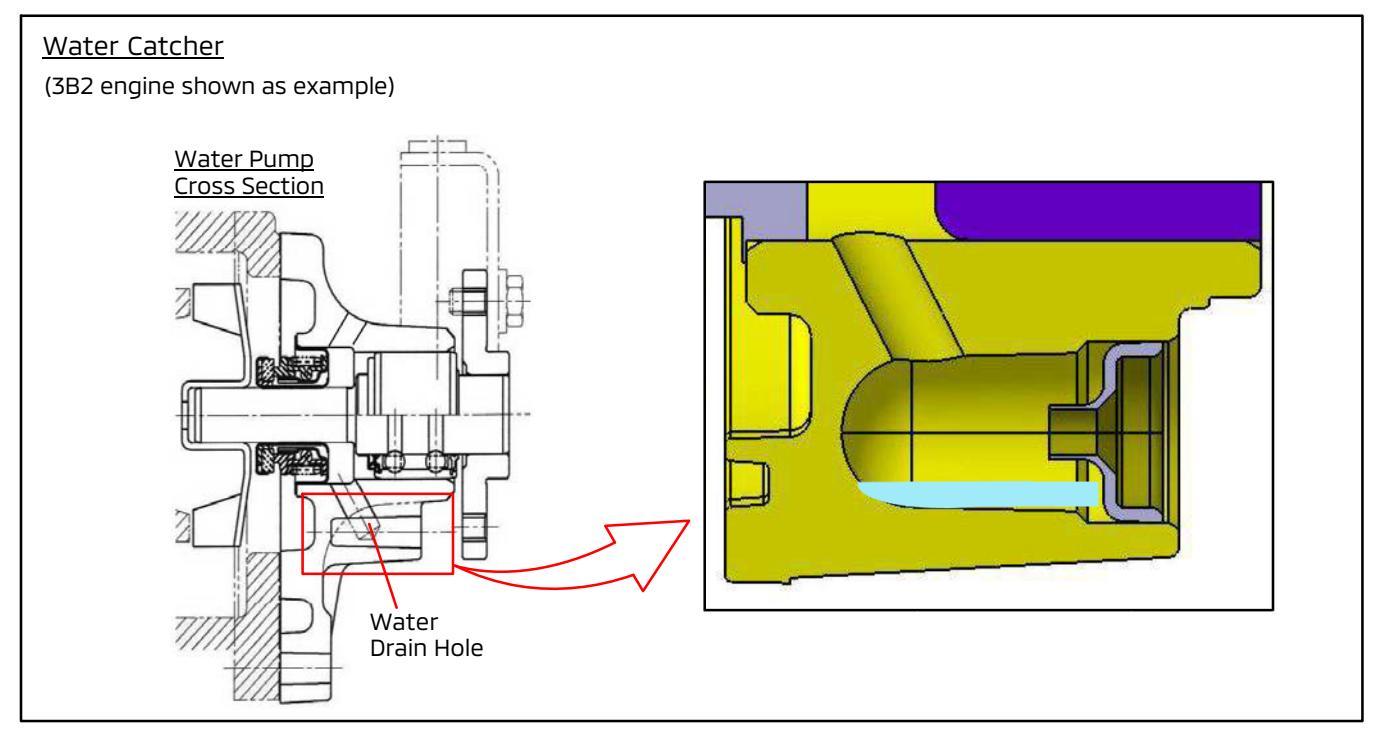
#### Water Catcher

On some engines, a water catcher is provided to prevent water leakage from the drain hole (as shown below). In this case, it could be considered abnormal if a wet water leakage mark is identified around the drain hole. **Refer to "Inspection Flow When Coolant Leak Is Found During Periodic Maintenance" earlier in this TSB.**

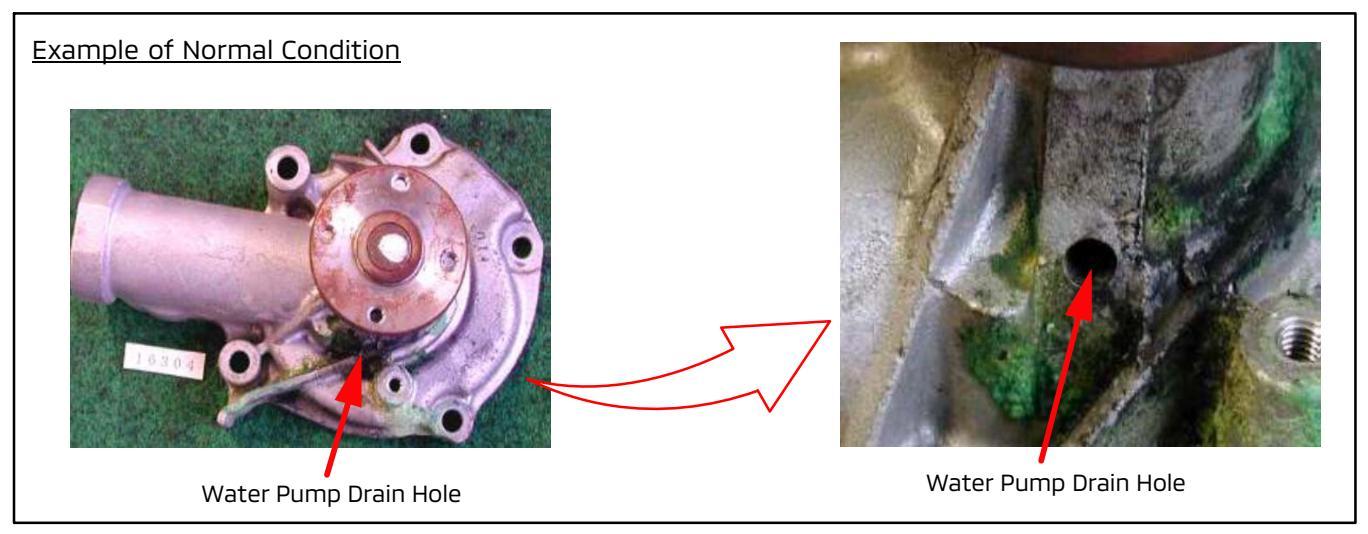
## **Normal Condition**

The photos below show an example of a normal condition of coolant leakage residue.
